This report shows all the responses to the Fire Risk Assessment survey, including raised tasks.

Asset ID: 8665 **Blk1 Group Home 2 Northfield 2 Northfield Road, Bradford**

Cover Sheet

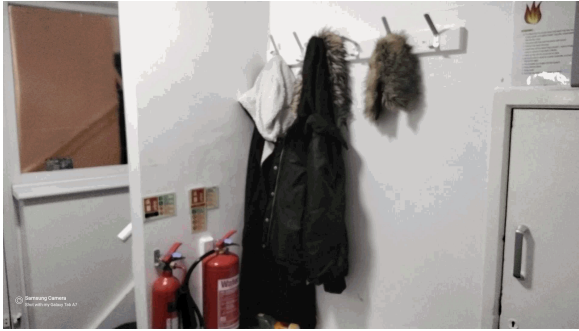
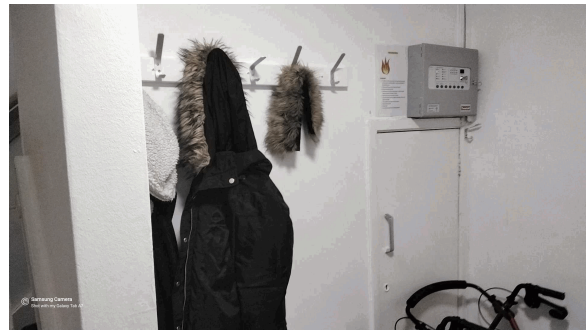
There are coats hung on pegs in the hallway, this is part of the means of escape. Coats should be contained in a cupboard. See photo

Observation	Priority	Referred To	Required By:	Task ID
Coats on hooks on the escape route, this has been highlighted in the past. Suggest a wardrobe or cupboard to store in hallway	Internal - High	Independent Living Coordinator

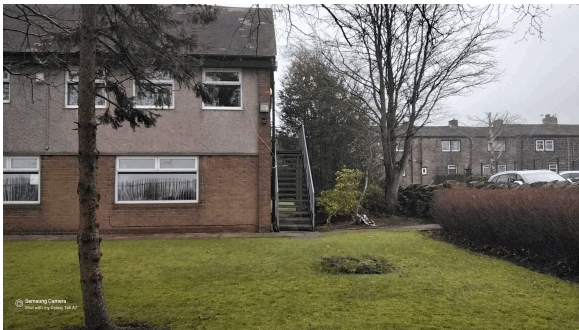
Observation	Priority	Referred To	Required By:	Task ID
External escape staircase

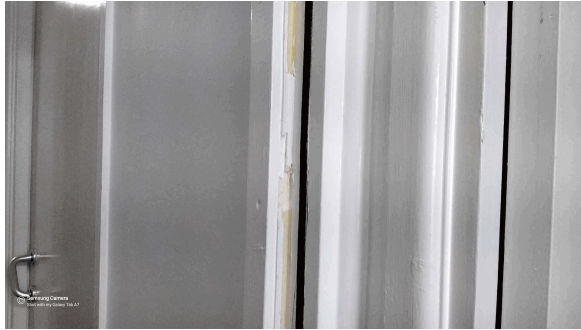
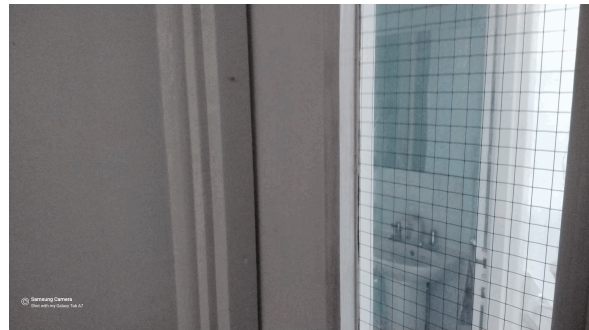
Communal Door at top of stairs has had insulation stuck to frame to stop door banging. Remove tape and adjust to close to frame without banging.	Internal - Medium	Building Safety Manager		
--------------------------------------------------------------------------------------------------------------------------------------------------	-------------------	-------------------------	--	--

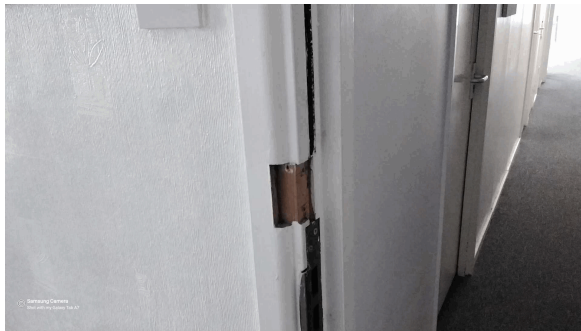
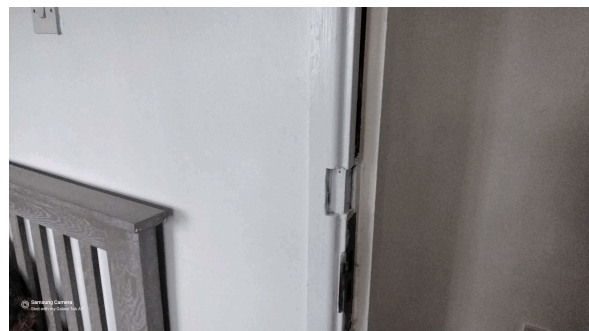
Some Doors to bedrooms have smoke seals missing and parts of frame where locks have been removed, a survey of all first floor bedrooms is required, adjust and repair as necessary. See photos	Internal - Medium	Building Safety Manager		
------------------------------------------------------------------------------------------------------------------------------------------------------------------------------------------------	-------------------	-------------------------	--	--

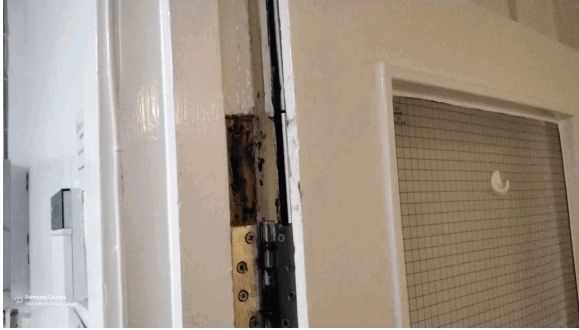
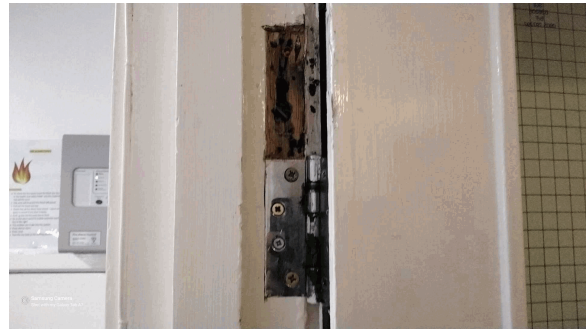
Observation	Priority	Referred To	Required By:	Task ID
Communal Fire door opposite main entrance has damage to frame. Requires repairing or replacing	Internal - Medium	Building Safety Manager

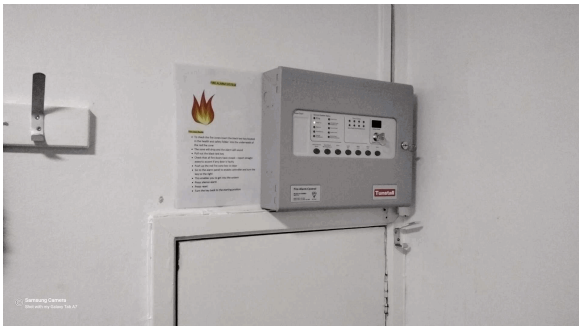
Fire panel

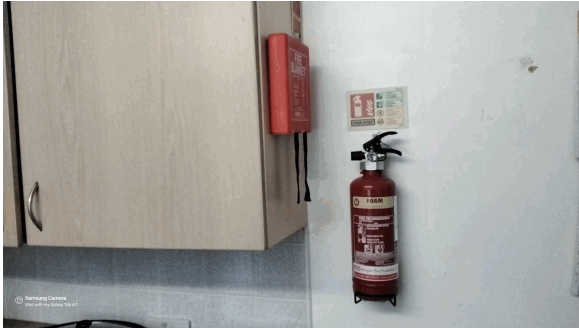
Fire extinguishers and blanket in kitchen
