This report shows all the responses to the Fire Risk Assessment survey, including raised tasks.

Asset ID: 9549 **15 Windsor Road Block 1-6 Windsor Road, Middlesbrough**

Fire Risk Assessment Survey Results

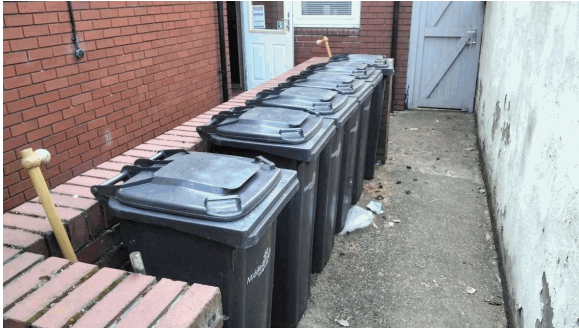
Designated refuse area

| Observation | Priority | Referred To | Required By: | Task ID |
|---|---|---|---|---|
| Designated refuse area | No Action | | | |

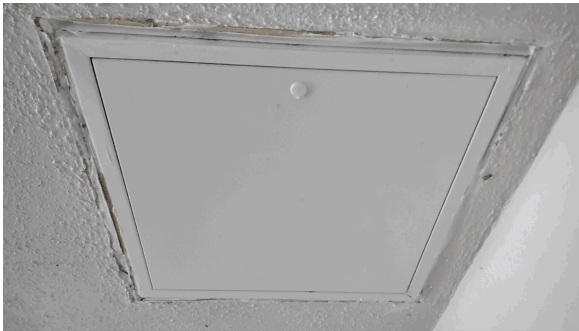
60 minute

| Observation | Priority | Referred To | Required By: | Task ID |
|---|---|---|---|---|
| Fire resistant loft hatch fitted | No Action | | | |

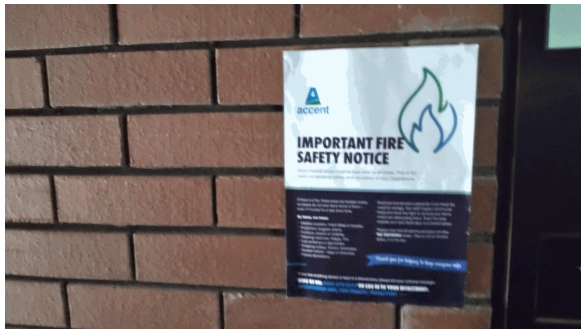
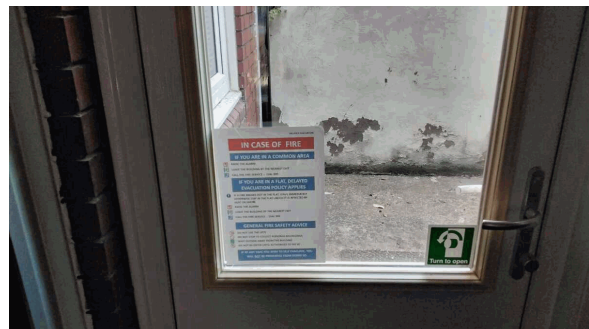
Fire advice notice
