Fire Risk Assessment Report

Asset ID: 8876 1-39 Holmfield Court Block 1-39 Holmfield Court, Bradford

Cover Sheet

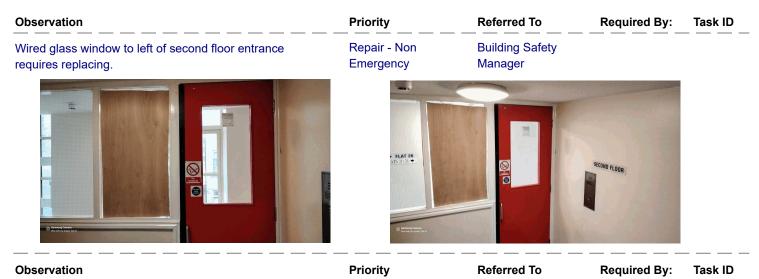
A survey was carried out by CLC. New communal Fire doors are bring fitted at the time of inspection

New communal Fire doors
