## ACCENT HOUSING - HEALTH & SAFETY ASSESSMENT

<b>Region :</b>	<b>East</b>
<b>Scheme Name :</b>	<b>Farlakes Drive</b>
<b>Scheme Address :</b>	<b>Hempstead Peterborough PE2 9EU</b>
<b>Date of Assessment:</b>	<b>31/03/2022</b>
<b>Date of Next Assessment:</b>	<b>30/03/2025</b>
<b>H&amp;S Frequency:</b>	<b>3 Yearly</b>
<b>Fire &amp; Safety Assessor</b>	<b>Lynn Betteridge</b>

This Health & Safety Risk Assessment has been conducted upon the instruction of Accent Housing.

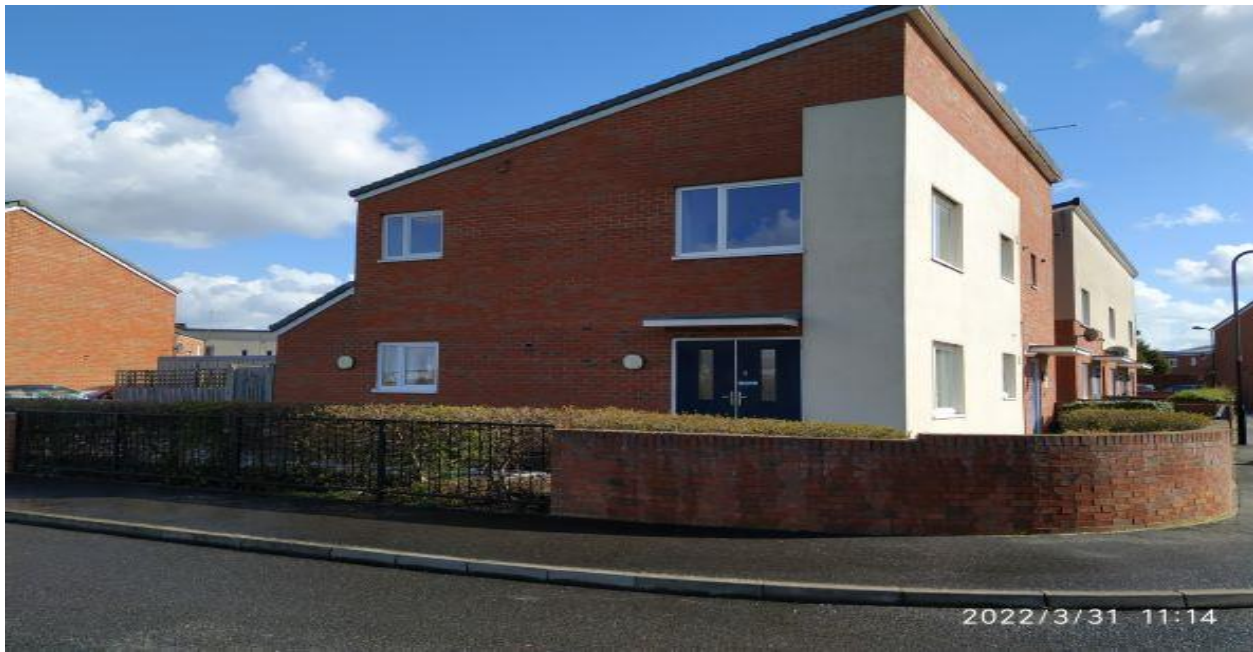
Photo No. 1

Note: Side Elevation Brick and Cement Render. Sloping Roof.

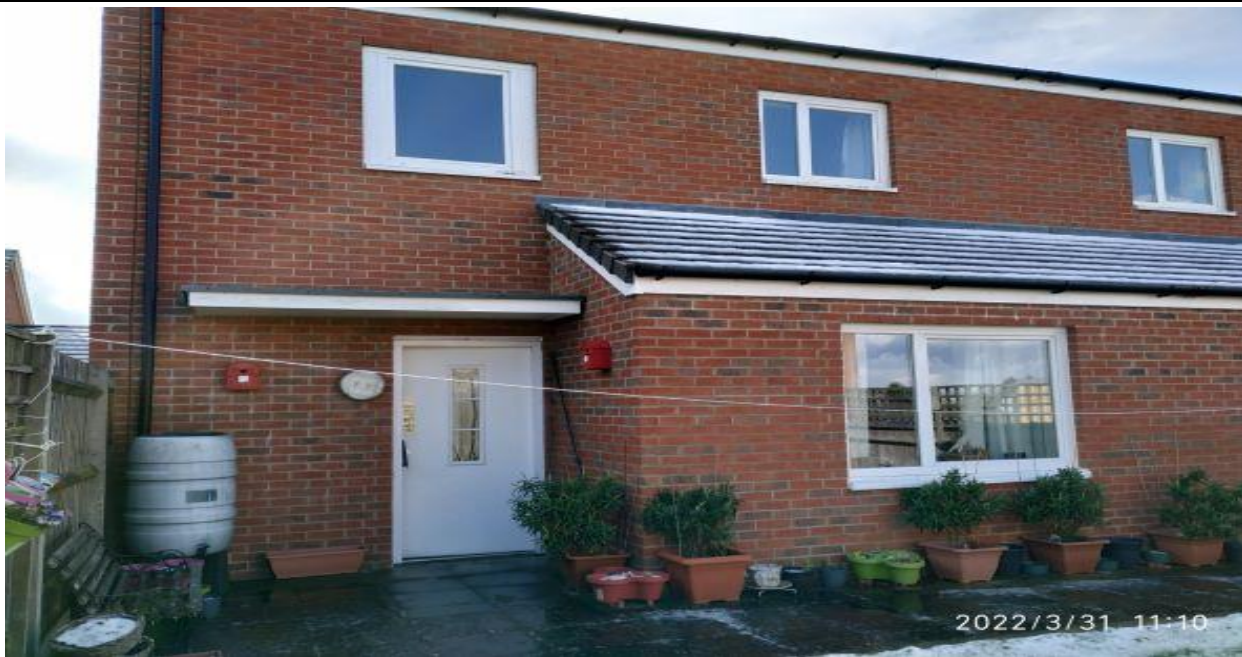
Photo No. 2

Note: Rear View from Garden.
