ACCENT HOUSING - HEALTH & SAFETY ASSESSMENT

Region :	East
Scheme Name :	Silver Hill
Scheme Address :	Hampton Peterborough PE7 8FF
Date of Assessment:	29/03/2022
Date of Next Assessment:	28/03/2025
H&S Frequency:	3 Yearly
Fire & Safety Assessor	Lynn Betteridge

This Health & Safety Risk Assessment has been conducted upon the instruction of Accent Housing.

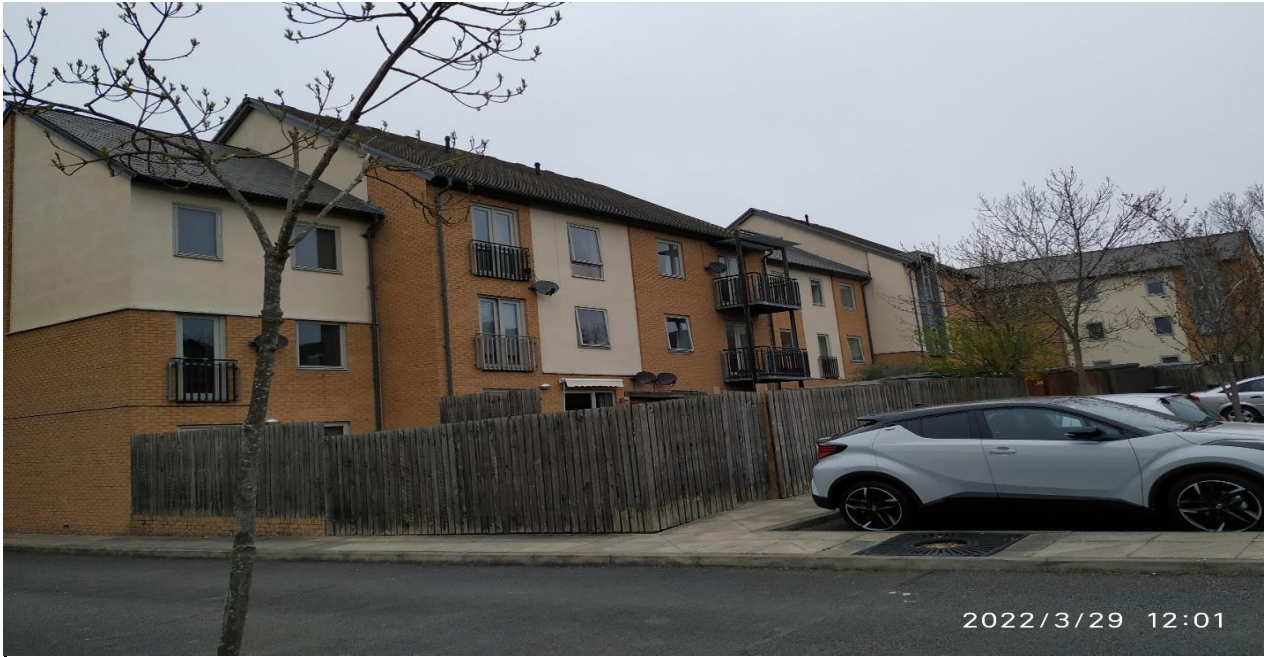
Photo No. 1

Note: Rear of Silver Hill and Lakeview.
