ACCENT HOUSING - HEALTH & SAFETY ASSESSMENT

Region :	East
Scheme Name :	1-5, 45-49 Lakeview Way
Scheme Address :	Hampton Hargate, Peterborough PE7 8FG
Date of Assessment:	28/03/2022
Date of Next Assessment:	27/03/2025
H&S Frequency:	3 Years
Fire & Safety Assessor	Lynn Betteridge

1-5, 45-49 Lakeview Way

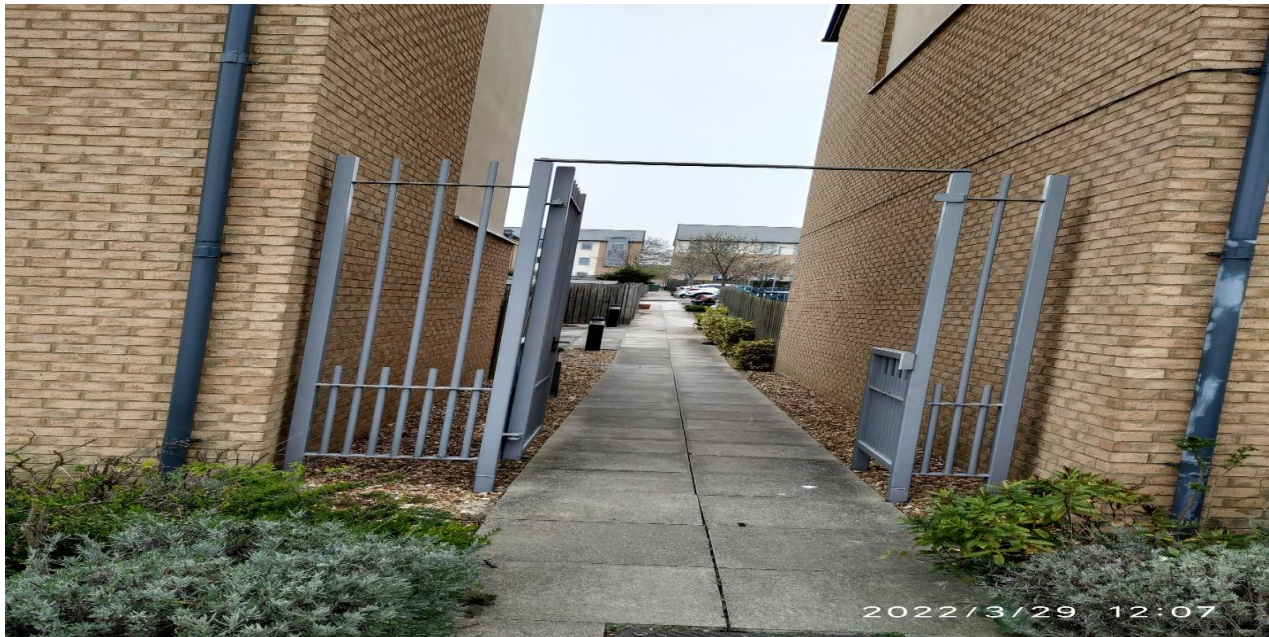
Photo No. 1

Note: Rear Access pedestal outdoor path lighting leading to St Edmunds.

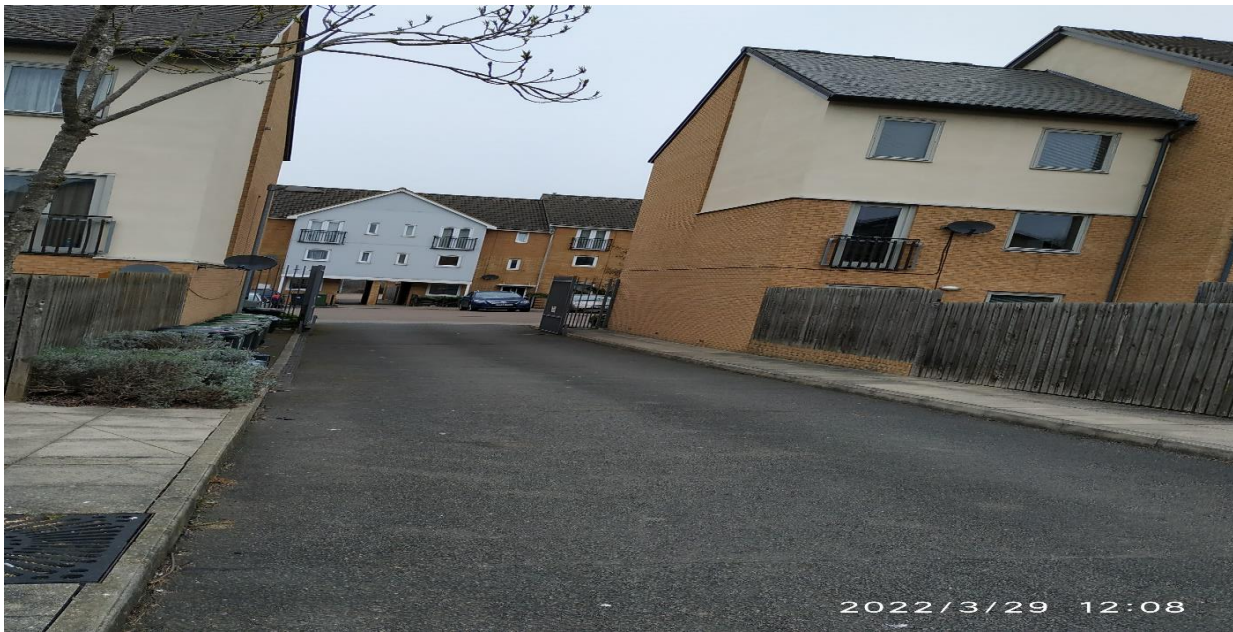
Photo No. 2

Note: Rear Carpark entrance.
