ACCENT HOUSING - FIRE RISK ASSESSMENT

Scheme Name: 1-21 Kilnbarn Court

Date of Assessment: 12/08/2022

Fire & Safety Assessor Gary Bredin

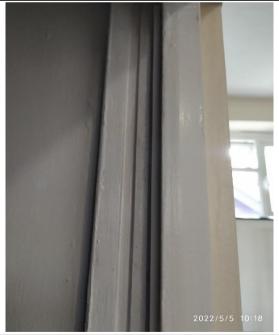
Photo No. 2

13.1	Do flat entrance doors open onto internal escape routes?	N _o	All Flats - No intumescent/smoke seals fitted to front entrance door. Recommendations - Fit combined intumescent/smoke seals to the prerouted groove within the door frame. AXIS 993699	Med	1/9/22	Home Ownership Manager
14	Flats with a single direction of escape to a	sing	le escape stairway. (External Balcony)

Observation - Pre-routed groove within residents front door frames. Job raised to fit Intrumescent strips and smoke seals.

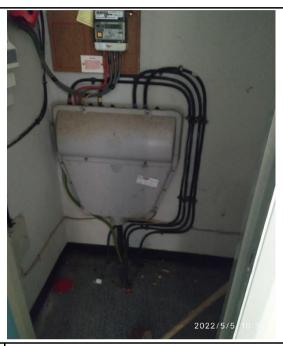
Photo No. 3 Observation - Electrical cupboard clear at the time of the audit.

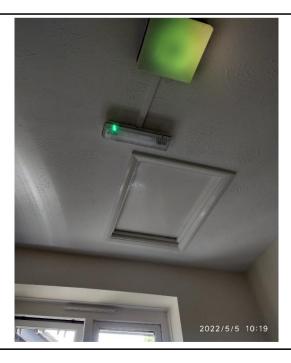
Photo No. 4

11.4	Compartmentation within roof spaces of a satisfactory standard?	Other	Findings previously submitted to compartment survey project			
11.5	Loft hatches fire resisting?	No	Communal area roof hatch's are of wooden construction and require replacing to 1hr fire rated steel hatch and frame to bring them in line with the latest standards. Job raised. Axis 993693	Low	1/12/22	Fire Safety Manager

Observation- Loft hatch do not comform to current standards. Job raised to fot steel 1hr Fire rated hatch and frame.

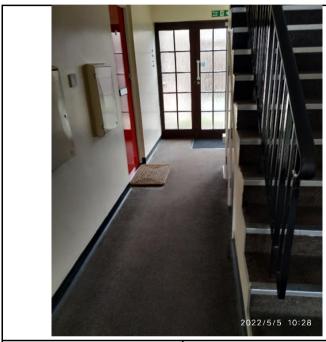
Photo No. 5

Observation- All areas clear at the time of the audit.

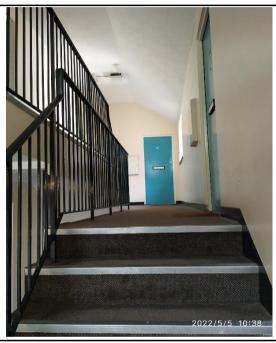
Photo No. 6

Observation - Stair treds and risers were found to be in good order.
