Fire Risk Assessment Report

Asset ID: 24569 **Windsor Court Road, Working**

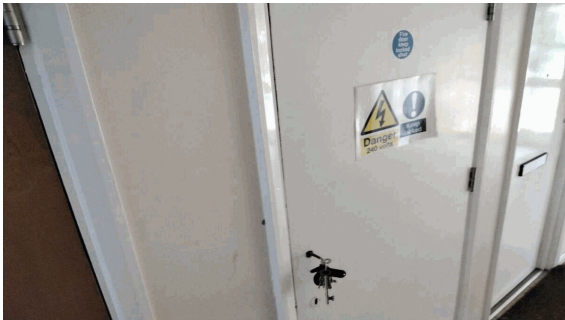
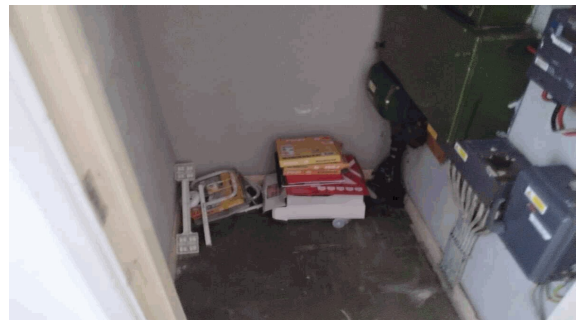
Contractors waste placed in the electrical cupboard. Housing partner to Job raised for removal.

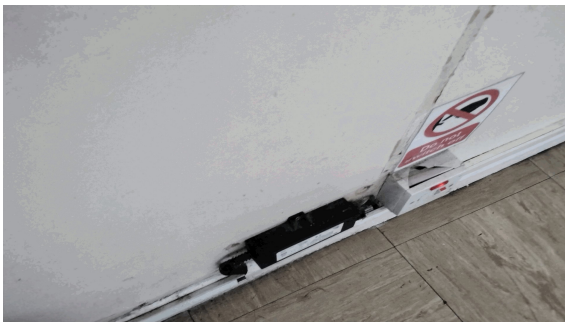
Electrical installation within common areas in good condition and no obvious damage?	Yes
Comment	Electrical socket in block 23-34. Back patress broken. Job already raised prior to audit.
Valid Electrical Installation Condition Reports held on file? (Common Areas & General Needs Flats)	Yes
Comment	Next due date July 2026.
Electrical App/PA Testing - tested within past 12 months?	N/A
Comment	
Absence of trailing leads and adapters?	Yes
Comment	
Evidence that mobility scooters are not being stored/charged in common areas?	Yes
Comment	
Is there a purpose built mobility scooter store/charging area?	No

Double socket patress broken and requires replacing. This job has been previously raised and is due for completion soon.

Internal - Medium

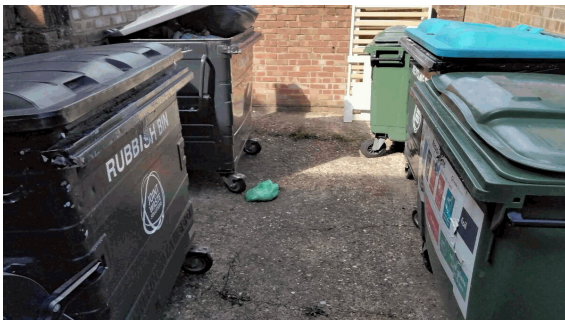
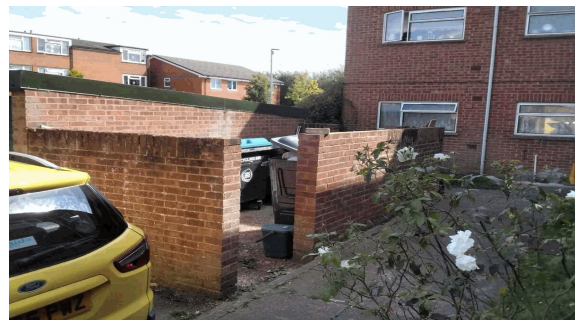
Satisfactory location of the bin area.

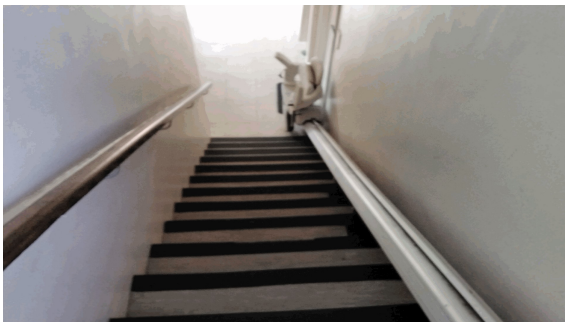
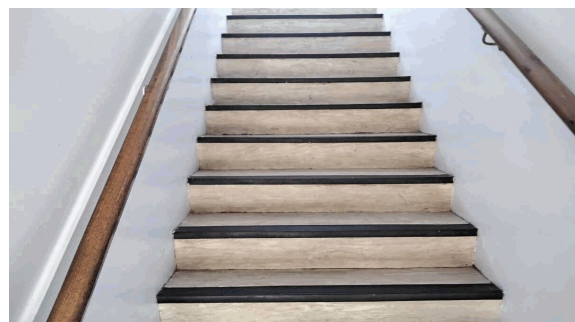
Main evacuation areas clear at the time of the audit.

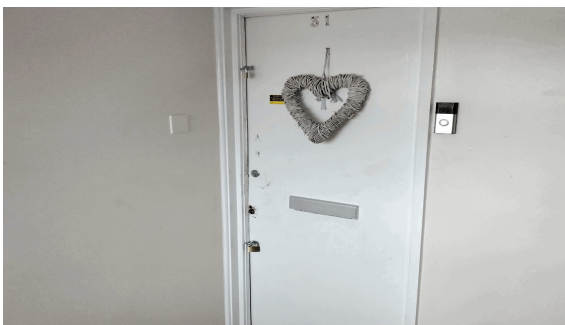
Observation	Priority	Referred To	Required By:	Task ID
Flat 31. Door requires replacing following a forced entry. This still offers protection and can be secured hence a medium risk.	Internal - Medium	Project Manager (Building Safety)	02/12/2024	1858829

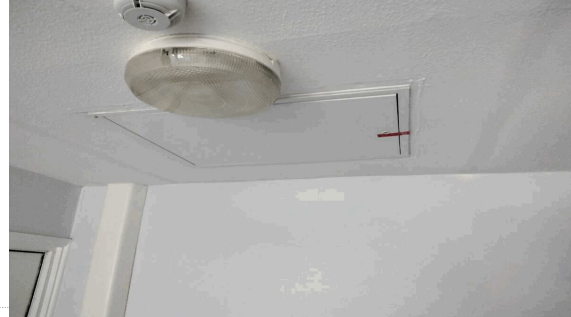
Observation	Priority	Referred To	Required By:	Task ID
Loft hatches metal and offers 1 hour fire rating.

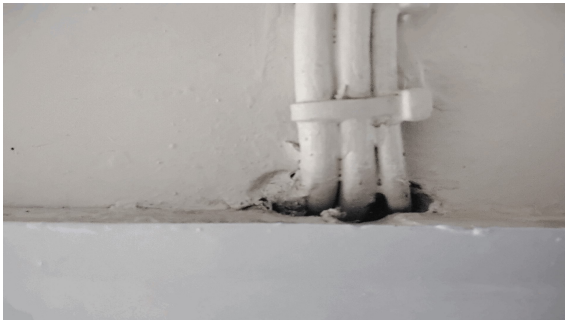
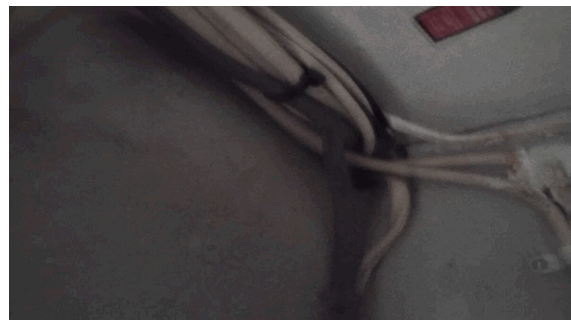
Some areas have new cables going through walls. These need to be fire stopped. Job raised.

Observation	Priority	Referred To	Required By:	Task ID
Some cables require fire stopping within the electrical cupboard block 20-30	Internal - Low	Project Manager (Building Safety)	02/12/2024	1858830

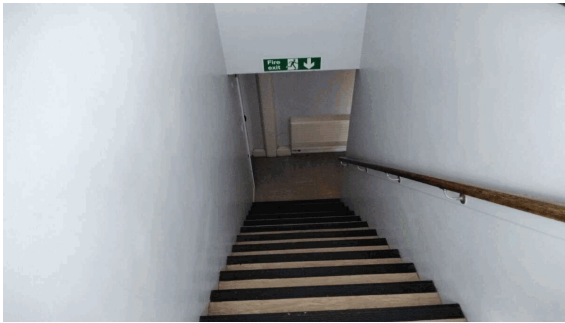
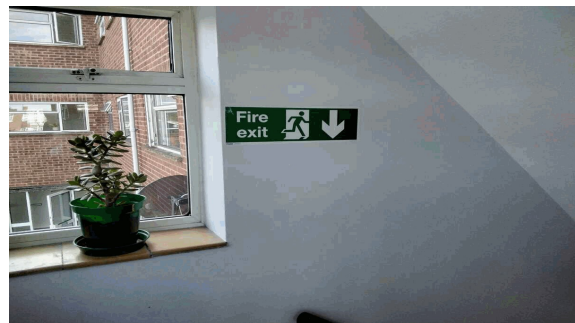
Observation	Priority	Referred To	Required By:	Task ID
Satisfactory signage throughout both blocks.

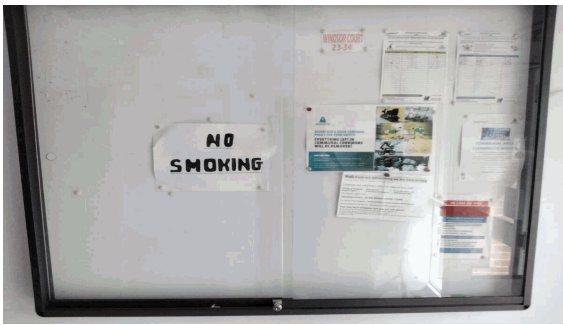
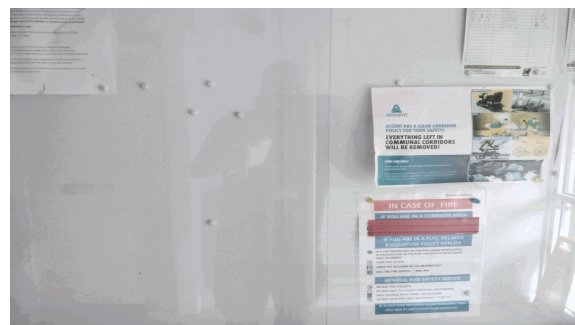
All evacuation information is posted throughout the blocks.
