Scheme Details		Sullivan Road
Region:	South	
Scheme Name:	Sullivan Road	
Site Address:	Street:	1-47 Sullivan Road
	Town:	Camberley, Surrey
	Post Code:	GU15 3AZ
Block & Asset No.	Block 1-11. Block 25033	
Block & Asset No.	Block 13-23. Block 25034	
Block & Asset No.	Block 25-35. Block 25035	
Block & Asset No.	Block 37-47. Block 25036	
Scheme Tel. No:	-	
Date of this Assessment	14/03/2022	
Date of Next Review	14/03/2025	
Fire Risk Assessment Frequency	3 Yearly	
Health & Safety Assessment Frequency	3 yearly	
Purpose of Fire Risk Assessment	3 Year Re-Assessment	
Fire & Safety Assessor	Gary Bredin	
Director of Customer Experience	Rob Mills	
Customer Partnership Manager	Kat Wilson	
Contract Manager	Olakunle Joseph	
Scheme Manager/Customer Partner	Zara Byrne	
Other staff in attendance	-	
Use of Building	General Needs	
Approximate Number of occupants	50+	
Occupancy Profile	Families	
Familiarity of the occupants	Slightly Familiar

Significant Findings - Health & Safety

Sullivan Road

14/03/2022

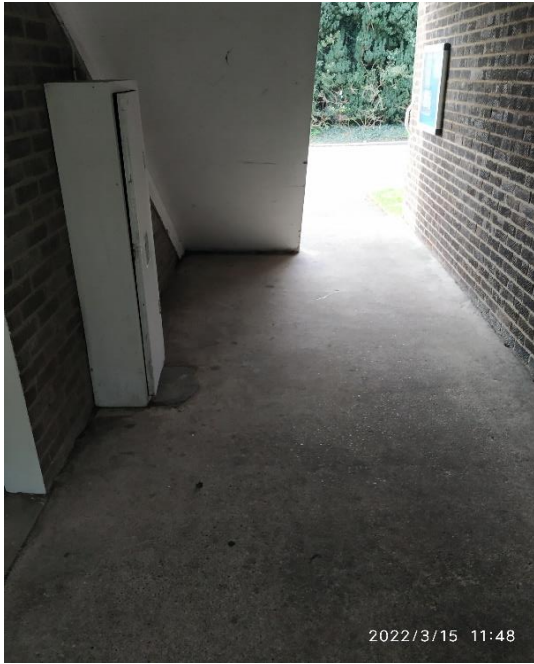
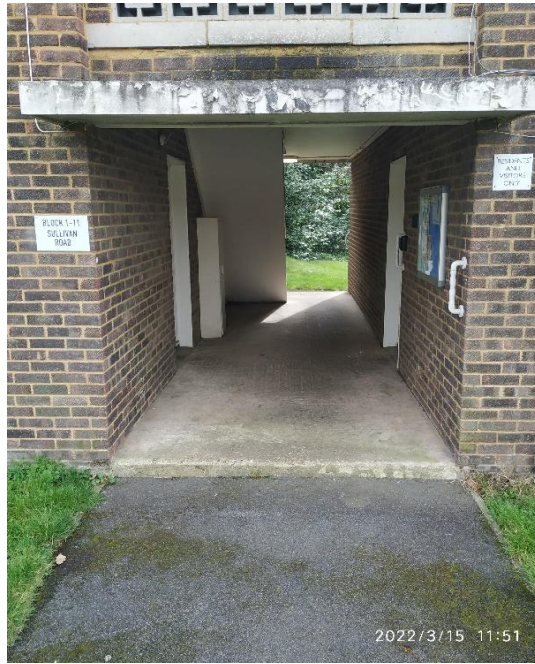
Photo No. 1

Observation - Open access to all flats at all levels.

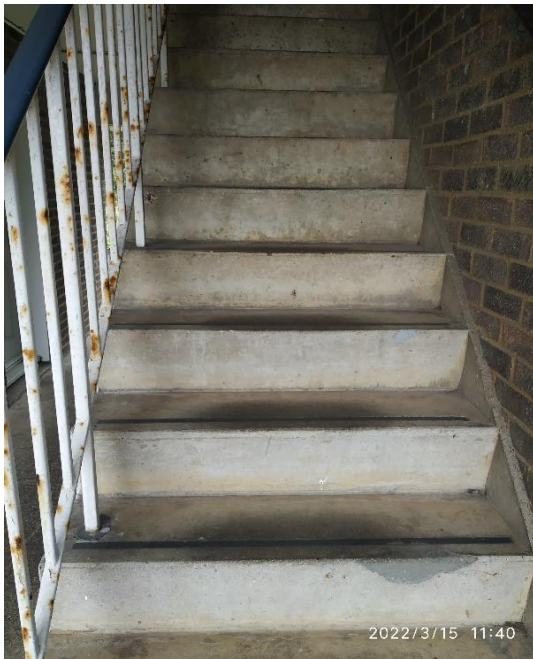
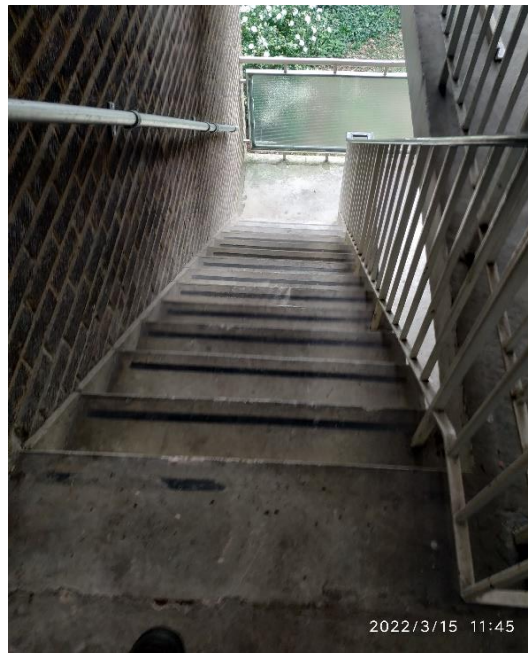
Photo No. 2

2.3	Evidence that exceptions raised are being addressed and the portal updated.	N/A		.		
3 Maintenance of common internal access routes						
3.1	Satisfactory condition of floor & floor covering	No	Block 27-32 floor coverings in need of attn: CP to monitor. See photo no 2- H&S	.

Observation - Stair treads and risers were found to be in good order.

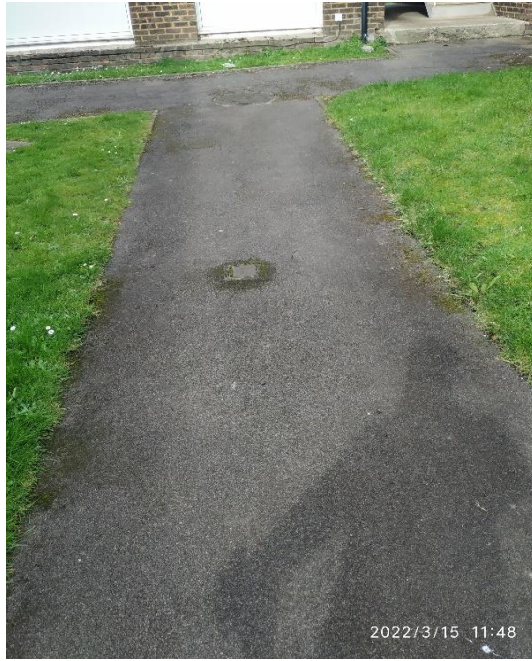
Photo No. 3

Observation: External walkways laid with concrete and Tarmac..

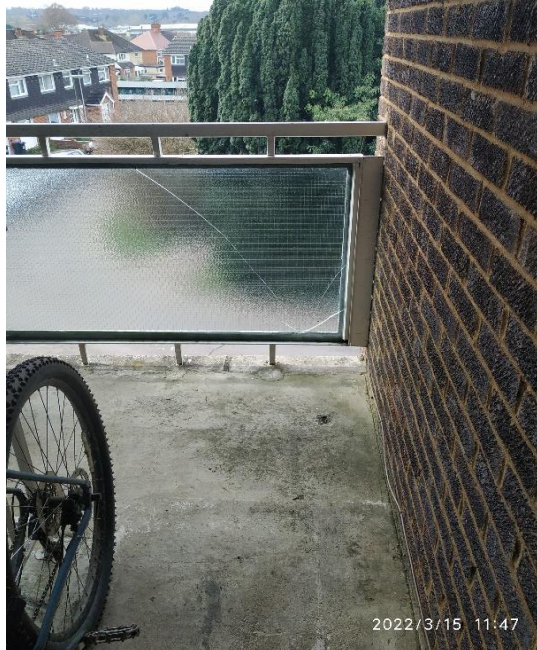
Photo No. 4

Observation- Safety georgian wired glass in block 13 -23 broken but secure. Customer partner to monitor.

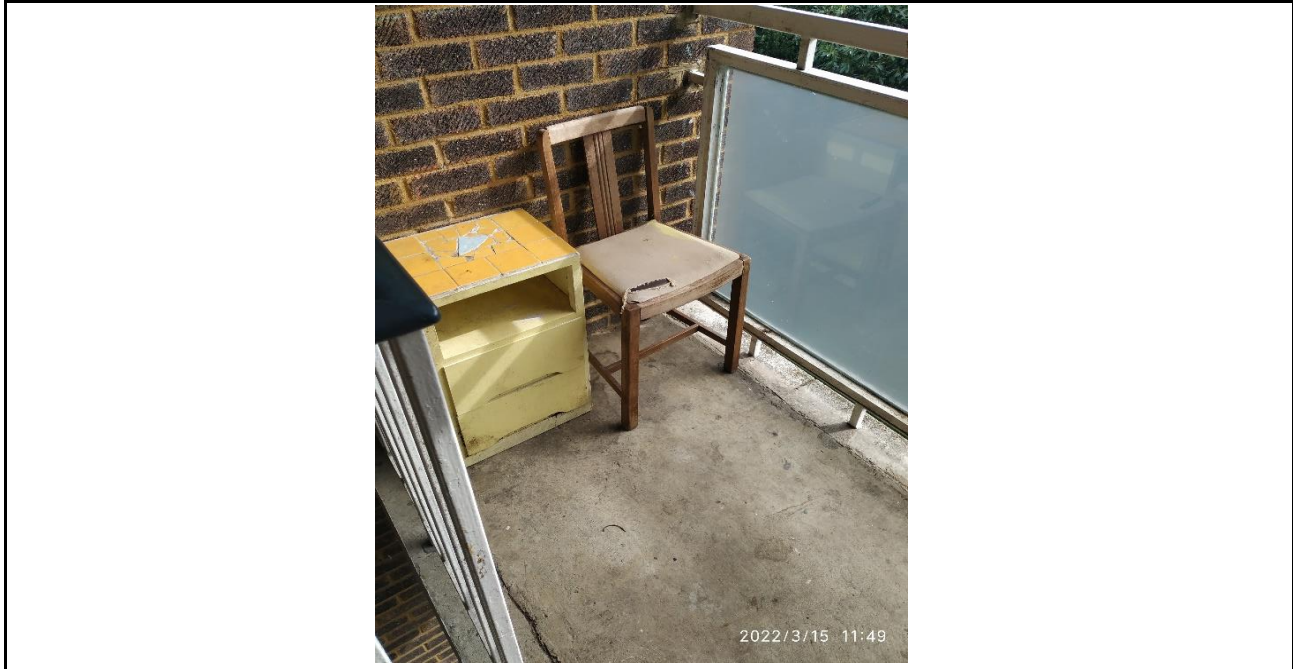
Photo No. 5

Observation: Side of block 1-11 items being stored in the common areas. Customer Partner to deal.

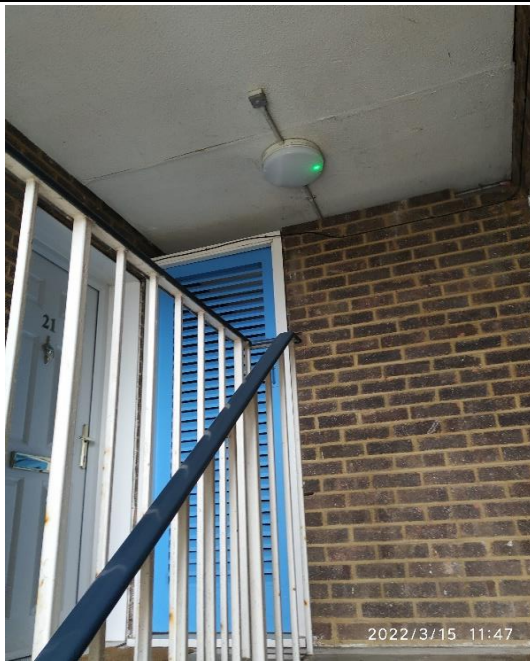
Photo No. 6

Emergency lighting in all blocks.

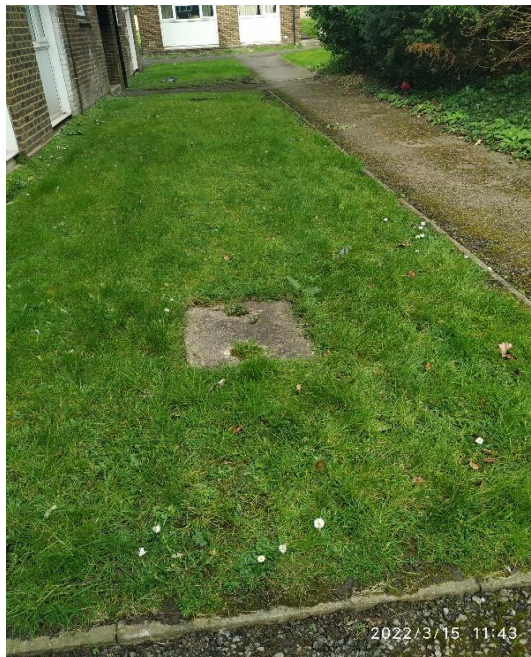
Photo No. 7

Observation. Rear of the buildings clear and well kept.
