ACCENT HOUSING - HEALTH & SAFETY ASSESSMENT

Region :	East	
Scheme Name :	Cedar Court	
Scheme Address :	Kettering NN16 9GZ	0
Date of Assessment:	15/02/2022	
Date of Next Assessment:	14/02/2025	
H&S Frequency:	3 Yearly	
Fire & Safety Assessor	Lynn Betteridge

Cedar Court

15/02/2022

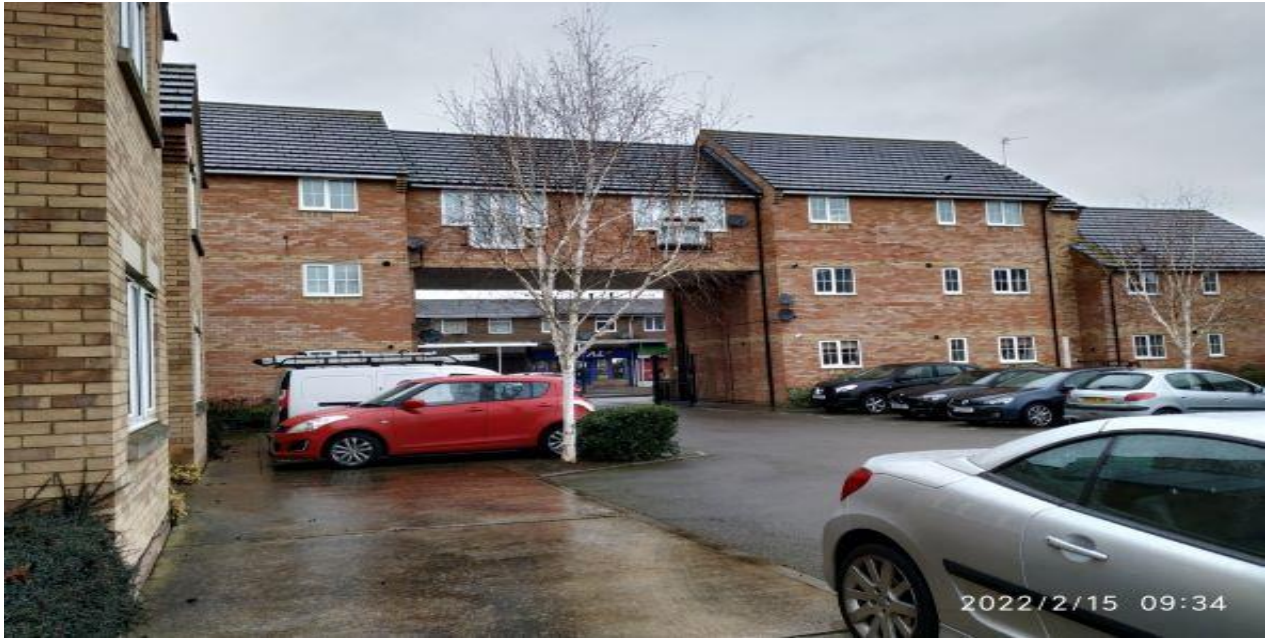
Photo No. 1

Note: Internal Carpark and rear view of Building court yard.

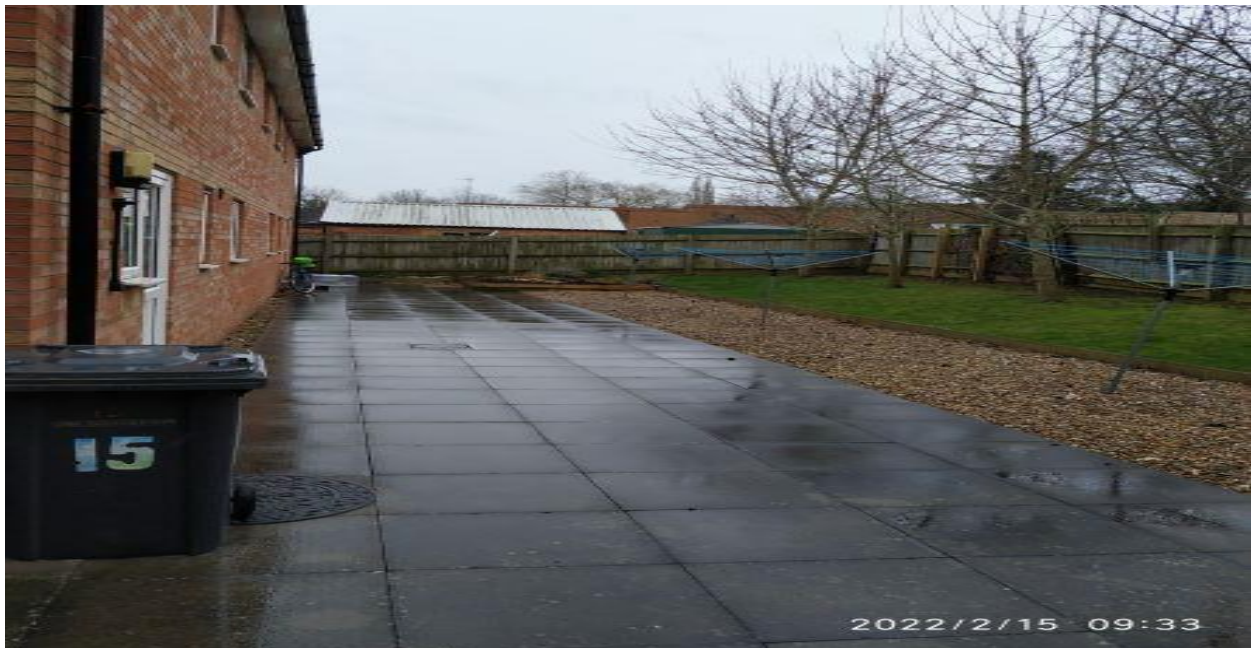
Photo No. 2

Note: External areas of Blocks.
