**Asset ID: 9567**      **7-10 Red House Court Block 7-10 Red House Court, Stokesley**

## Cover Sheet

Date of Fire Risk Assessment	24 Jan 2023
Date of Next Fire Risk Assessment	24 Jan 2026
FRA Frequency (Months)	36
Purpose of Fire Risk Assessment	3 year Re-Assessment
Type of Fire Risk Assessment	Type 1 (Common Parts Only - Non Destructive)
Fire & Safety Assessor

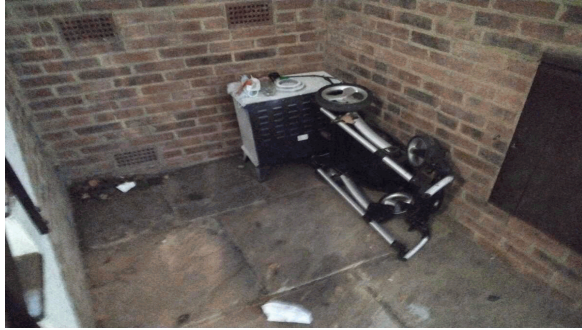
Stove and pram stored under stair

Items stored under staircase

Internal - Low

Customer Safety  
Manager

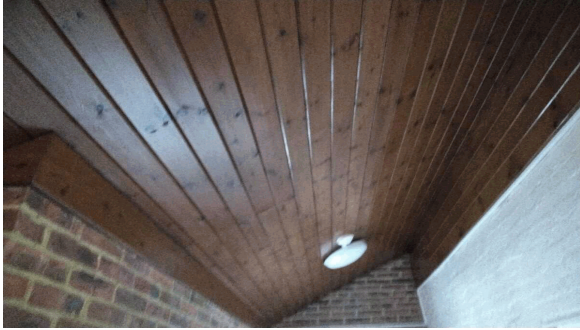
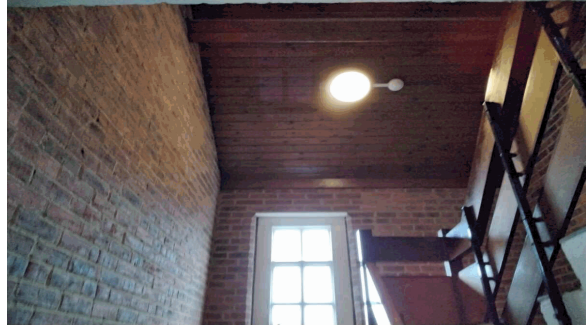
Observation	Priority	Referred To	Required By:	Task ID
Timber ceiling covering fire spread ,fire loading	Repair - Non Emergency	Customer Partner	01/02/2023	1613188

Timber tongue and groove ceiling on 2nd floor ceiling and stair from 1st to 2nd floor. The risk of fire developing within the stairwell is negligible as the walls and floors are exposed stone and brick construction. The second floor ceiling height is elevated to a vaulted room space and will provide extended travel distances. Housekeeping is good clear and free of combustible materials, minimum electrical fittings are present therefore the likelihood of the paneling supporting the spread of fire is negligible.

Ceilings in stairway,

Unknown surface material on existing ceilings

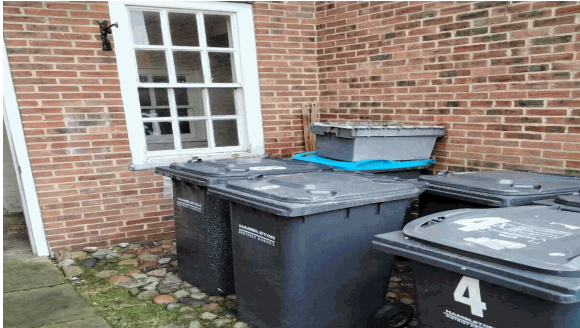
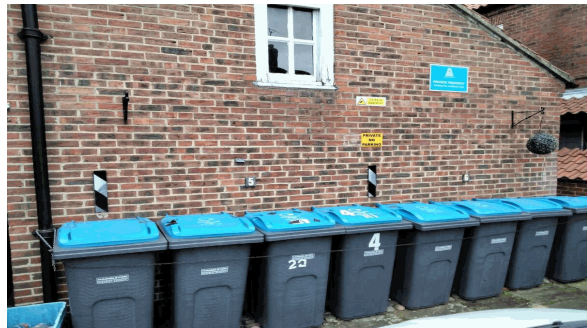
Bins stored next to escape route windows

Bins stored against property, wooden boards left next to escape route window

Bins stored adjacent to window on escape route

Observation	Priority	Referred To	Required By:	Task ID
Bins stored next to escape route window	Internal - High	Customer Partner	31/01/2023	1613187

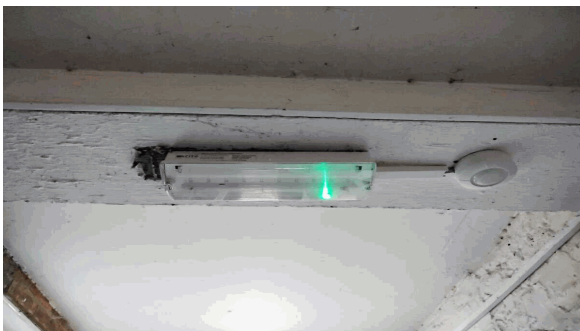
Appears to be installed correctly on all floors

Appears in good condition

Observation	Priority	Referred To	Required By:	Task ID
Emergency lighting installations	No Action

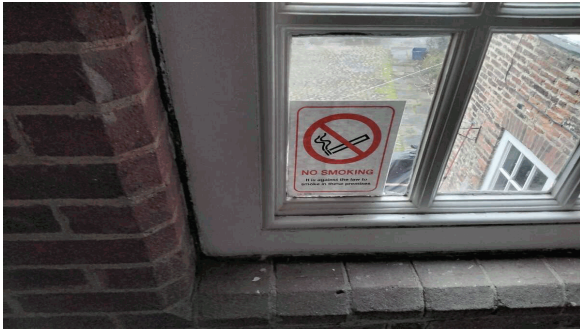
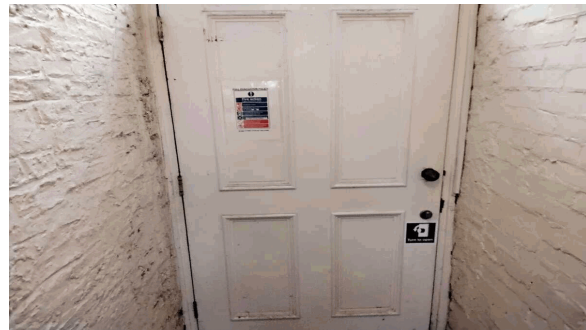
Signage on all final exit doors

Signage throughout premises
