This report shows all the responses to the Fire Risk Assessment survey, including raised tasks.

Asset ID: 9029 **4 Spa Lane Block 1-3 Spa Lane, Harrogate**

Date of Fire Risk Assessment	10 Aug 2023
Date of Next Fire Risk Assessment	10 Aug 2024
FRA Frequency (Months)	12
Purpose of Fire Risk Assessment	Annual Re-Assessment
Type of Fire Risk Assessment	Type 1 (Common Parts Only - Non Destructive)
Fire & Safety Assessor	Kevin Jones

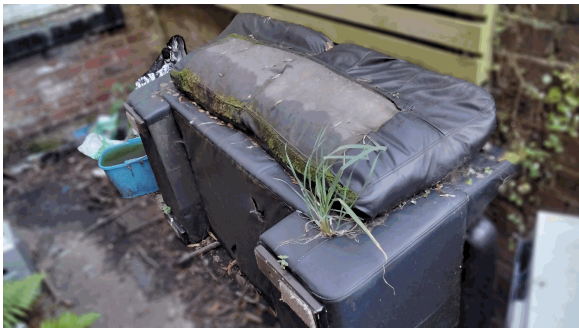
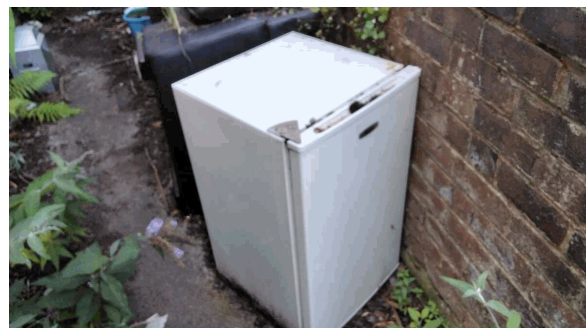
Rear escape route partially blocked by settee and fridge dumped in rear yard.

Observation	Priority	Referred To	Required By:	Task ID
Means of escape partially blocked to rear	Internal - Medium	Housing Partner	20/09/2023	1700503

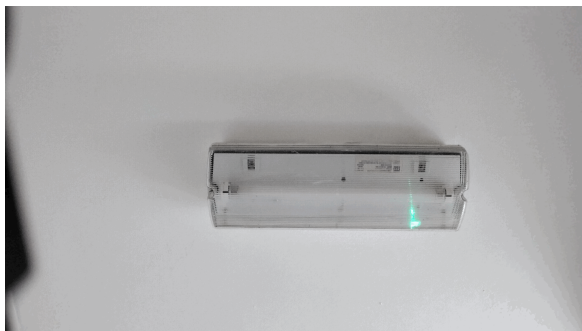
Is the emergency lighting correctly specified and installed as per current standards?	Yes
Comment	
Emergency lighting units in good condition and securely fixed to walls/ceilings?	Yes
Comment	Appears to be in good condition
Records of monthly/annual testing available?	Yes
Comment	Uploaded to Active H

Observation	Priority	Referred To	Required By:	Task ID
Emergency lighting in good condition	No Action

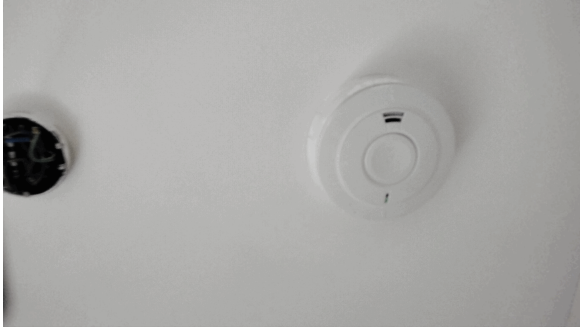
Observation	Priority	Referred To	Required By:	Task ID
Fire detector heads in good condition	No Action
