ACCENT HOUSING - FIRE RISK ASSESSMENT

Region :	South
Scheme Name :	15-25 Deanside
Scheme Address :	Deanside, Camberley Camberley GU15 4DZ
Date of Assessment:	11/10/2022
Date of Next Assessment:	11/10/2025
FRA Frequency:	3 Year Re-Assessment
Fire & Safety Assessor	Gary Bredin

Scheme Details		15-25 Deanside
Region:	South	
Scheme Name:	15-25 Deanside	
Site Address:	Street:	Deanside, Camberley
	Town:	Camberley
	Post Code:	GU15 4DZ
Block & Asset No.	Block 15-25 Asset No.25221	
Scheme Tel. No:	-	
Date of this Assessment	11/10/2022	
Date of Next Review	11/10/2025	
Fire Risk Assessment Frequency	3 Years	
Health & Safety Assessment Frequency	3 Years	
Purpose of Fire Risk Assessment	3 Year Re-Assessment	
Fire & Safety Assessor	Gary Bredin	
Director of Customer Experience	Louise Graham Smith.	
Customer Partnership Manager	Nathalie Antoinet	
Contract Manager	-	
Scheme Manager/Customer Partner	Paul Hills	
Other staff in attendance	-	
Use of Building	General Needs	
Approximate Number of occupants	20+	
Occupancy Profile	Families	
Familiarity of the occupants	Slightly Familiar	
Likely state of the Occupants	Alert	
PEEPs in place where necessary	N/A	
Number of on-site Accent staff	None	
Number of

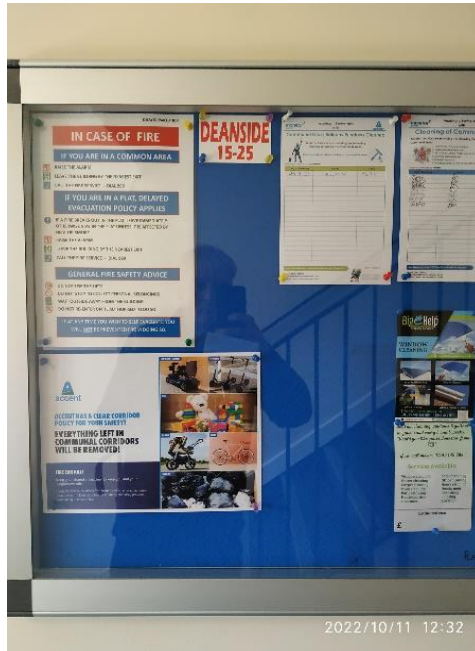
Photo No. 1

Observation - Notice board showing evacuation policy .

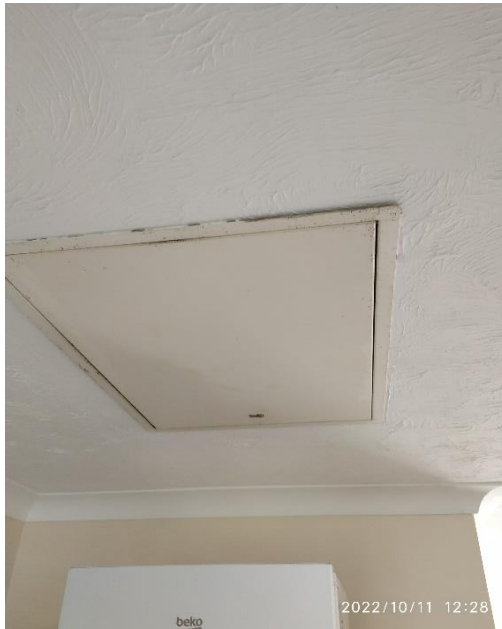
Photo No. 4

Observation- Loft hatch metal construction tight fitting and locked shut.

11.4	Compartmentation within roof spaces of a satisfactory standard?	Other	Findings previously submitted to compartment survey project	.		
11.5	Loft hatches fire resisting?	Yes	Communal area roof hatch's are close fitting and of 1hr fire rated steel construction.	.

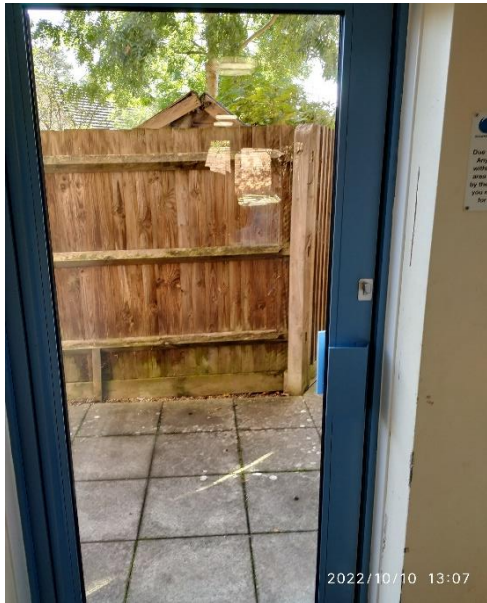
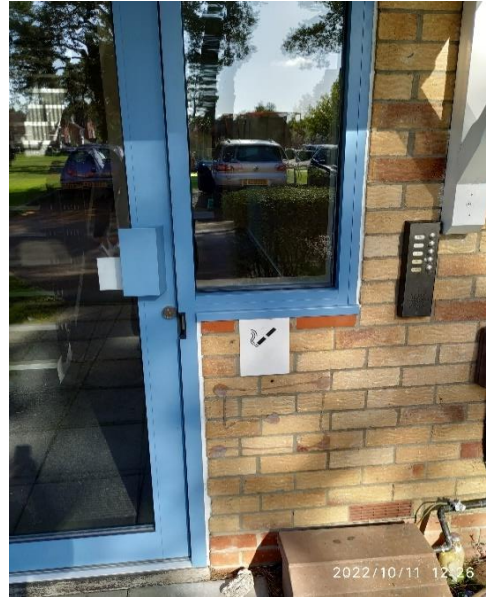
Photo No. 7

Observation - External electronic door entry system in place and manual on exit. Thumb turn exit sign installed during the audit.

10.2	Escape routes unobstructed and safe to use?	Yes		.		
10.3	Exits easily and immediately openable where necessary, without a key?	Yes	All exit doors are of the push bar, push pad or thumb turn type	.
