This report shows all the responses to the Fire Risk Assessment survey, including raised tasks.

Asset ID: 9675 **1-6 Red House Block 1-6 Red House, Stokesley**

Cover Sheet

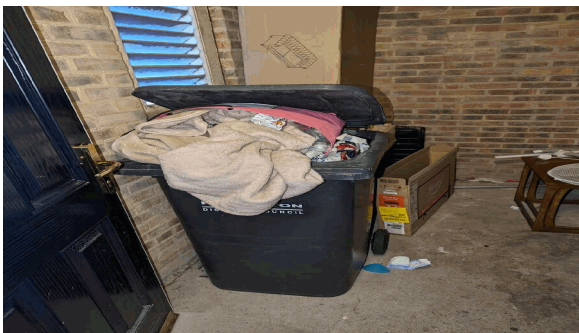
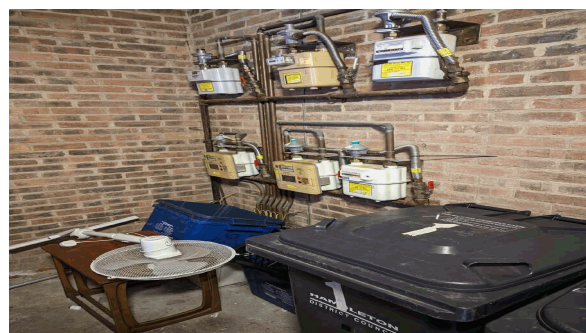
Large amount of combustibles stored in gas meter cupboard, HP contacted to remove and manage , dust sheet left under stairs on ground floor HP contacted for removal and to manage areas.

Large amount of combustible materials stored in gas meter cupboard, HP contacted for removal and management of the cupboard.

Internal - Medium

Housing Partner

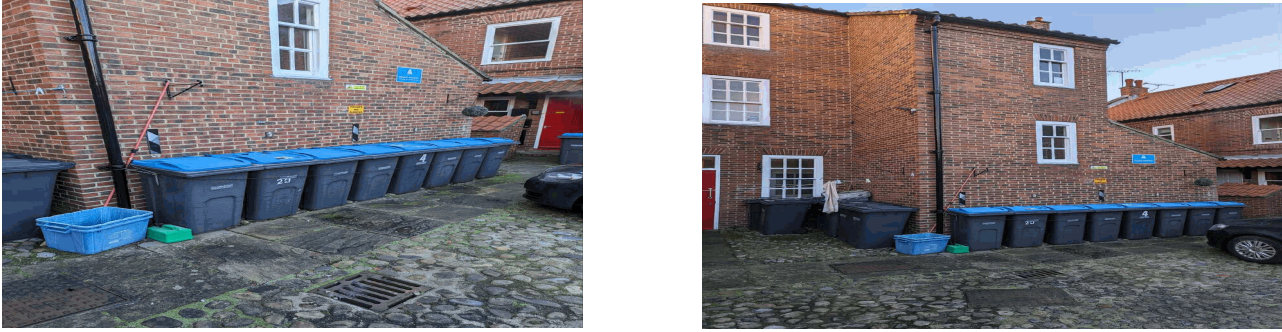
Wheelie bins stored underneath single glazed wooden windows from single escape route staircase and adjacent to rear final exit fire escape door and single glazed window. Housing Partner contacted to move bins to safe place, contract manager requested to complete project to create secure and safe location

| Observation | Priority | Referred To | Required By: | Task ID |
|--|---|---|---|---|
| <p>Wheelie bins stored under and adjacent to windows and final exit doors</p> | Internal - Medium | Building Safety Manager | | |
