This report shows all the responses to the Fire Risk Assessment survey, including raised tasks.

Asset ID: 8691 **1-18 Crow Nest Court Block 1-18 Crow Nest Court, Mirfield**

Cover Sheet

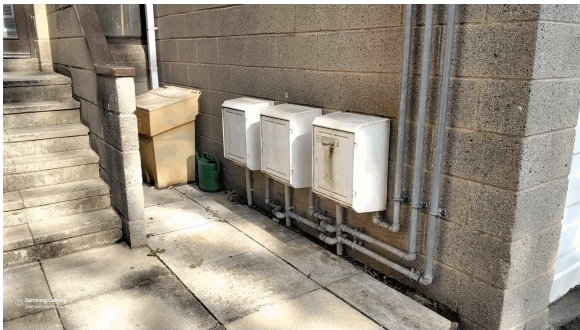
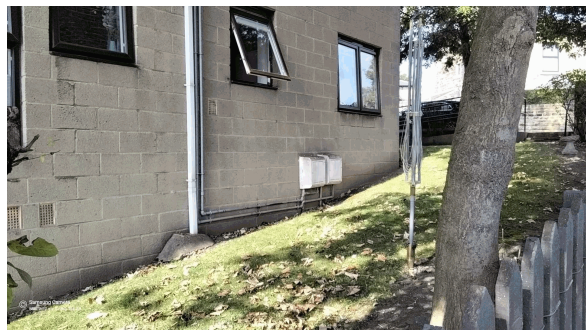
There are gas supplies to residents flats. Not all residents have a connected gas supply.

Gas supply to some flats within the building

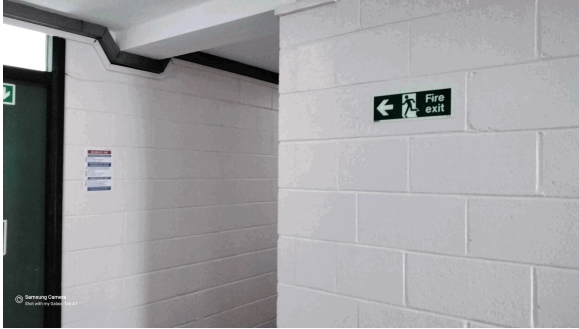
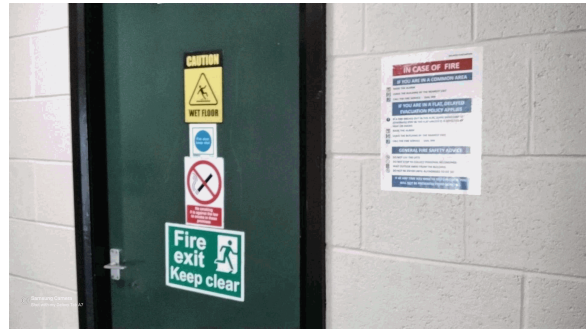
Fire signage and action plan

Comment	Notices are displayed throughout the building.
Directional fire escape signage in place and adequate?	Yes
Comment	Notices are displayed throughout the building.
Is there suitable LIFT signage i.e. do not use in case of fire?	N/A
Comment	No lift fitted.
Do common area fire doors display the correct signage on both sides where applicable?	Yes
Comment	All signs in place at the time of inspection.

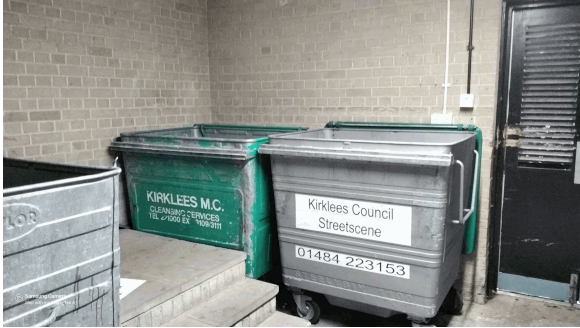
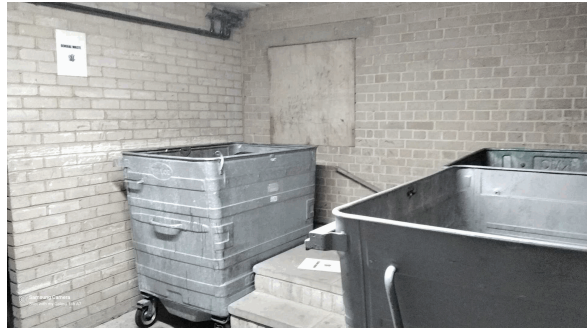
Comment	There is a fob entry system to the front and rear of the building.
Are refuse/recycling bin areas managed and suitably located?	Yes
Comment	There refuse store is part of the building, and was neat and tidy at the time of inspection.
Are there communal cooking facilities at this scheme?	No
Comment

Internal bin store

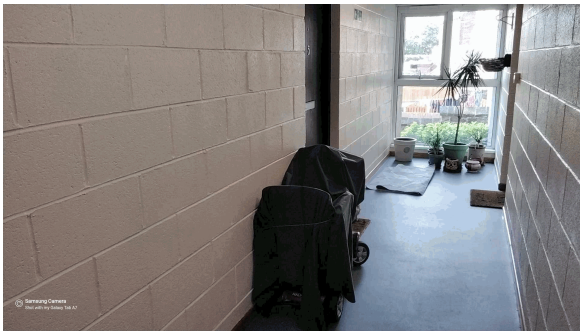
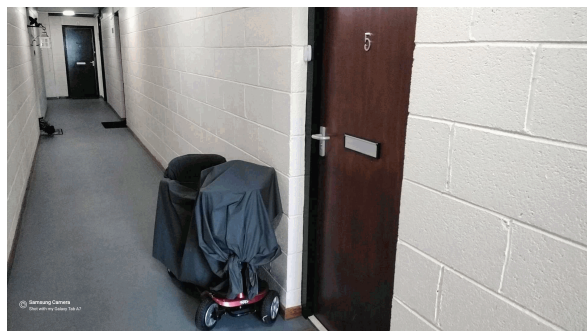
1865098

A mobility scooter was found outside Flat No 5, Housing Partner informed. Resident needs to store within their flat or outside.

Mobility scooter in communal corridor outside flat 5 needs to be stored within the flat

Internal - High

Housing Partner

02/10/2024
