## **ACCENT HOUSING - FIRE RISK ASSESSMENT**

Region :	North West
Scheme Name :	Cowhill Lane
Scheme Address :	35, 43, 49 Cowhill Lane Ashton-Under-Lyne OL6 6HJ
Date of Assessment:	08/08/2024
Date of Next Assessment:	08/08/2026
FRA Frequency:	2 Yearly Re-Assessment
Fire & Safety Assessor	lan Potter

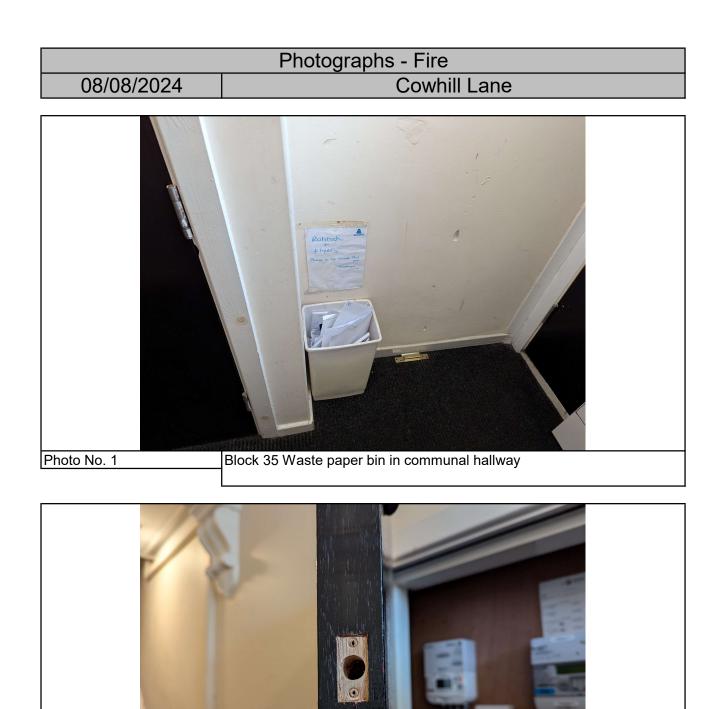
Photo No. 2

7.2	Are all electrical/intake/service cupboards secure and free from general waste, contractors waste and residents personal items.	No	Block 35: Locks on service cupboard missing and require replacing.	Med	31/8/24	Fire Safety Manager

Block 35 Locks removed on service cupboard doors
