Asset ID: 9144 **2-6 Oak Street Block 2-6 Oak Street, Accrington**

Date of Fire Risk Assessment	18 Jan 2024
Date of Next Fire Risk Assessment	18 Jan 2027
FRA Frequency (Months)	36
Purpose of Fire Risk Assessment	3 year Re-Assessment
Type of Fire Risk Assessment	Type 1 (Common Parts Only - Non Destructive)
Fire & Safety Assessor	Ian Potter

Fire Risk Assessment Survey Results

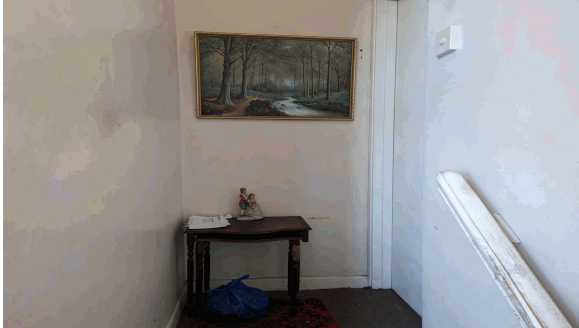
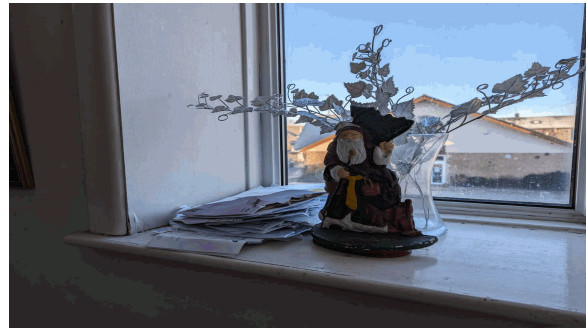
Comment Personal items and junk mail in communal area.

Observation	Priority	Referred To	Required By:	Task ID
A number of personal items and junk mail were found on the landing and outside the front door of the upstairs flat. These were stickered to notify the customer to remove them. HP to ensure items have	Internal - Low	Housing Partner	29/02/2024	1767179

Personal items outside Flat 2
