Asset ID: 9675 **1-6 Red House Block 1-6 Red House, Stokesley**

Cover Sheet

Date of Fire Risk Assessment	08 Jan 2025
Date of Next Fire Risk Assessment	08 Jan 2026
FRA Frequency (Months)	12
Purpose of Fire Risk Assessment	Annual Re-Assessment
Type of Fire Risk Assessment	Type 1 (Common Parts Only - Non Destructive)
Fire & Safety Assessor	Kevin Jones

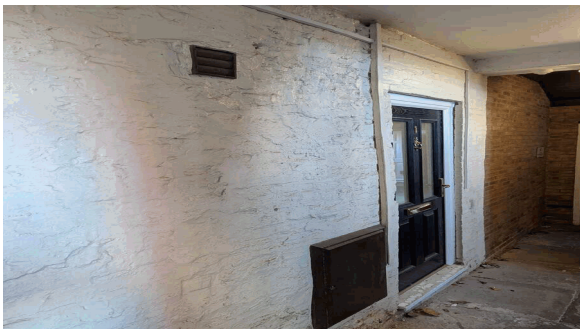
Observation	Priority	Referred To	Required By:	Task ID
cooker ventilation exits from flat 1 into means of escape on ground fkoor	Internal - Medium	Project Manager (Building Safety)	09/04/2025	1905980

Cooker exhaust vent from flat 1 exits into ground floor corridor and effects escape route

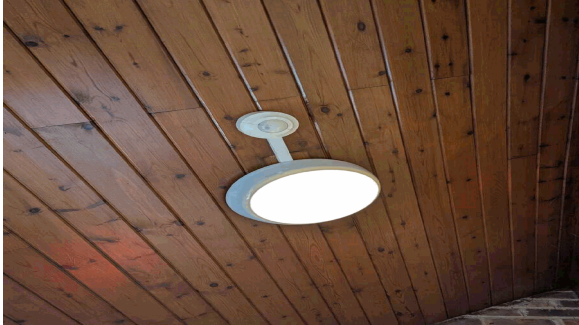
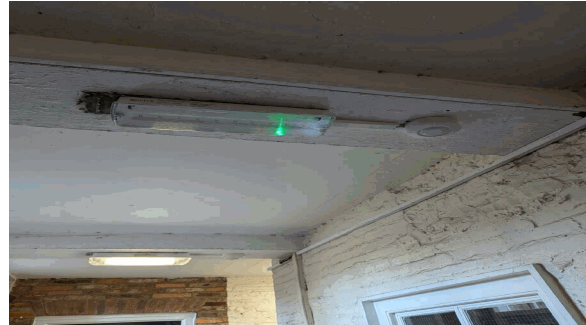
Is the emergency lighting correctly specified and installed as per current standards?	Yes
Comment	
Emergency lighting units in good condition and securely fixed to walls/ceilings?	Yes
Comment	All appear to be in good condition and secure

lighting appears in good condition

No Action

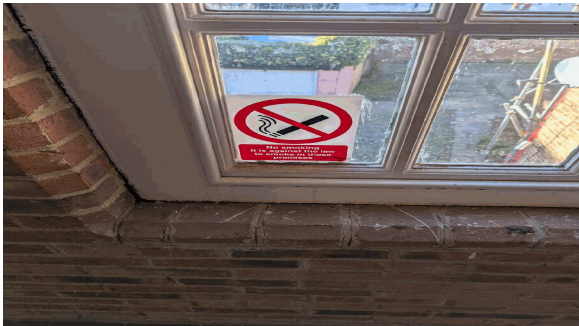
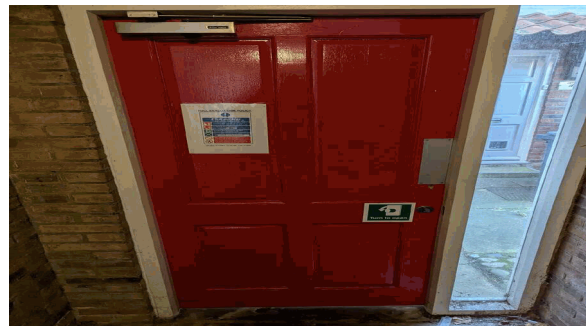
Gas meter cupboard

signage within premis

No Action
