This report shows all the responses to the Fire Risk Assessment survey, including raised tasks.

Asset ID: 24629 **Rosemount Point**

Cover Sheet

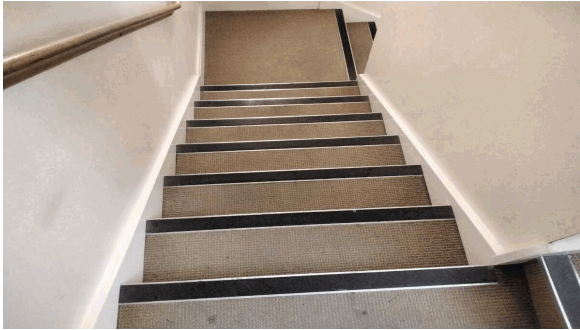
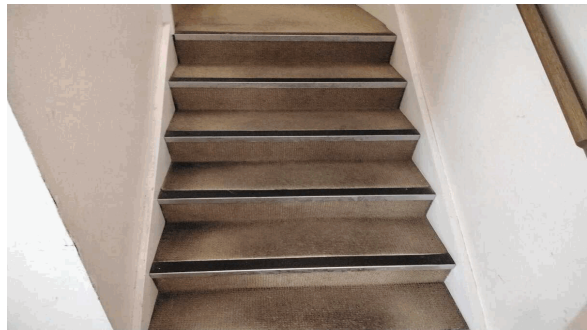
Communal areas clear at the time of the audit.

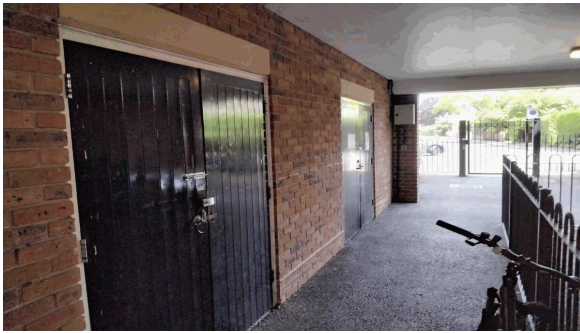
Bin are clear at the time of the audit.

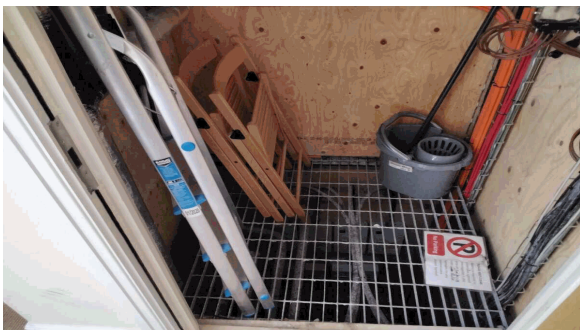
1848547

Are all electrical/intake/service cupboards secure and free from general waste, contractors waste and residents personal items? No
Comment Grated floor system located in each cupboard.
Some had customers items stored within. Housing partner dealing.
Are unnecessary accumulations of combustible materials or waste avoided? Yes
Comment

Items are being stored in the electrical cupboards. These must be locked shut. Housing partner to deal.

Housing Partner

02/08/2024

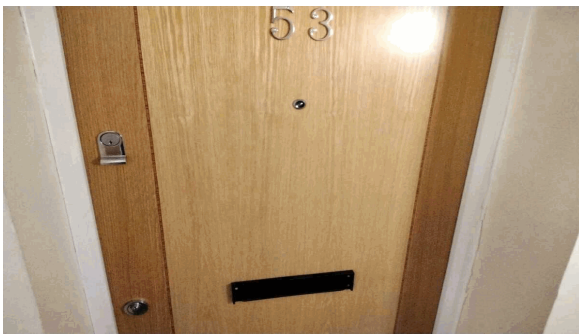
Observation	Priority	Referred To	Required By:	Task ID
Letter plate missing from flat door no 53.	Internal - Medium	Project Manager (Building Safety)	01/09/2024	1848548

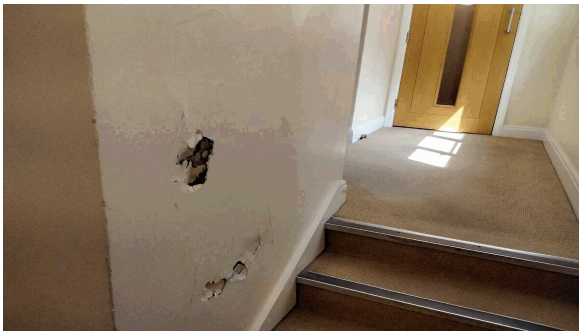
Some damage to the walls inthe communal area. Surveyor informed and a job has already been raised to repair the damage.

Observation	Priority	Referred To	Required By:	Task ID
Communal wall damaged and could aid fire spread. Surveyor informed. Job already raised.	Internal - Medium
