This report shows all the responses to the Fire Risk Assessment survey, including raised tasks.

Asset ID: 8883 **1-35 Thornfield Hall Block 1-35 Thornfield Hall, Bradford**

Date of Fire Risk Assessment	06 Jun 2024
Date of Next Fire Risk Assessment	06 Jun 2025
FRA Frequency (Months)	12
Purpose of Fire Risk Assessment	Annual Re-Assessment
Type of Fire Risk Assessment	Type 1 (Common Parts Only - Non Destructive)
Fire & Safety Assessor	Steven Manners

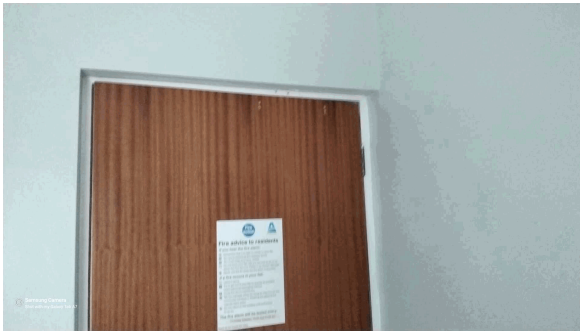
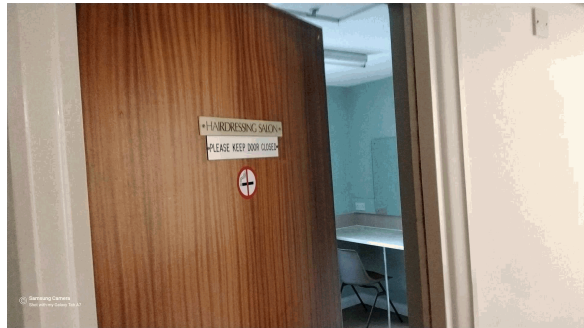
Observation	Priority	Referred To	Required By:	Task ID
Door to Hairdressers requires self-closing device	Repair - Non Emergency	Project Manager (Building Safety)	01/08/2024	1824515

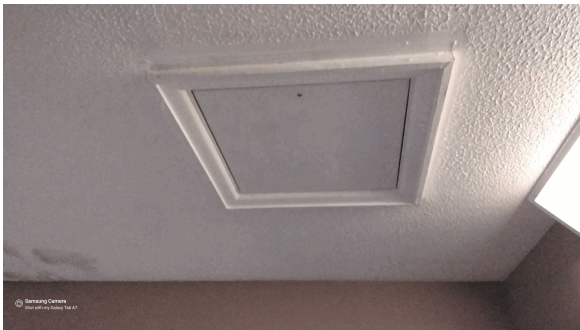
All loft hatches are 1 hour fiire resistant. See photo.

Observation	Priority	Referred To	Required By:	Task ID
Loft hatches 1 hour fire resisting no access at the time of inspection

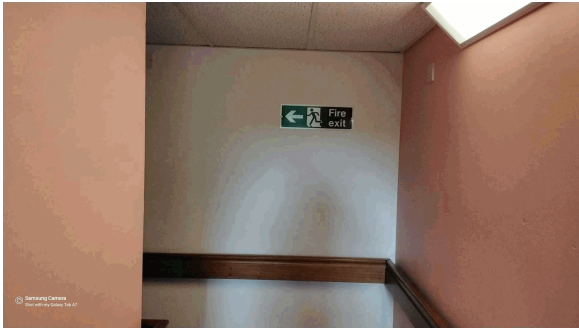
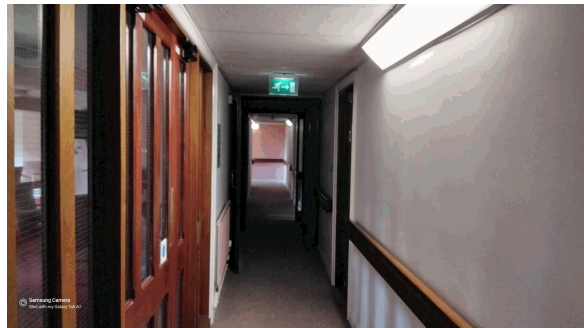
Fixed signage and maintained Fire exit signage is present throughout the building.

Fire exit signage throughout the building

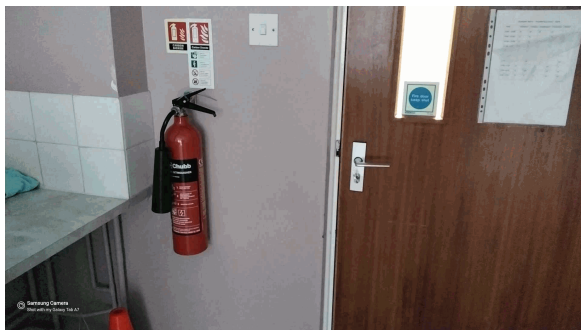
All extinguishers are labeled with the last test date. certificates are available on ActiveH.

Fire extinguishers in laundry
