This report shows all the responses to the Fire Risk Assessment survey, including raised tasks.

Asset ID: 6448 **Oatfield Court/bankfields, Middlesbrough**

Fire Risk Assessment Survey Results

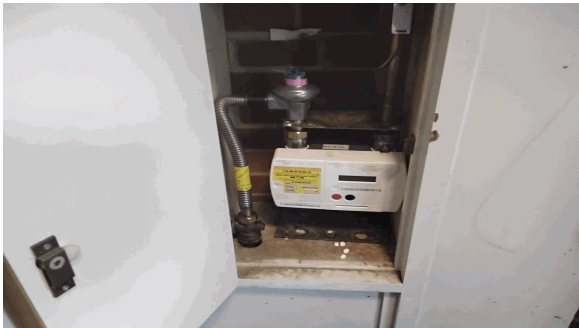
Gas meter

No Action

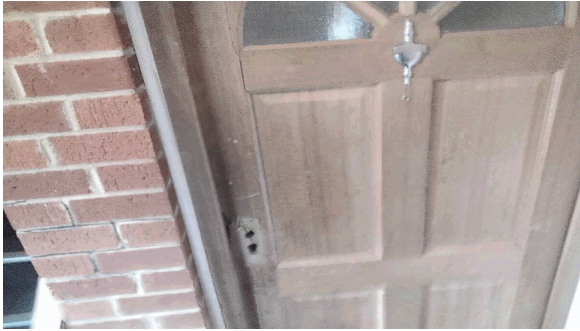
Is it considered that the building is provided with reasonable means of escape in case of fire? No

Number of flat entrance doors not fire door standard

Observation	Priority	Referred To	Required By:	Task ID
Number of flat entrance fire doors do not meet BS 8214 full door survey and repair request to follow.	Repair - Non Emergency	Senior Homeownership Specialist	31/05/2023	1663509

Some flat entrance doors not correct fire door standard carrying out a full door survey to identify the full extent of the fire door conditions.

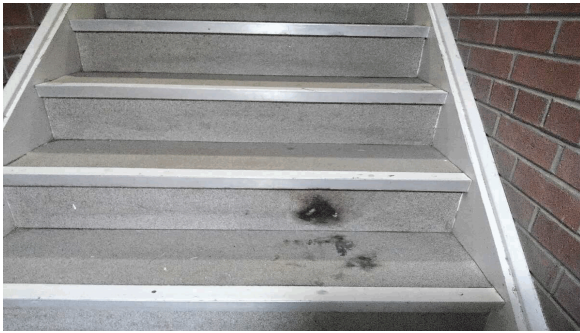
Observation	Priority	Referred To	Required By:	Task ID
Signs of missuse of fire starting	Internal - Medium	Fire & Safety Manager	31/05/2023	1663510

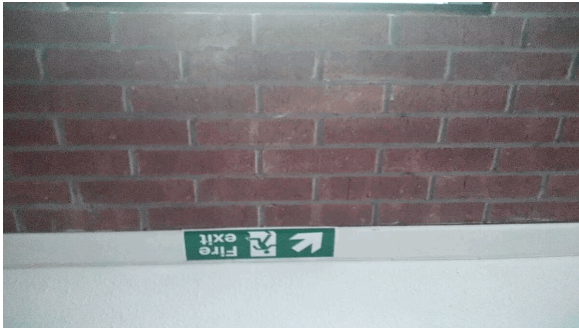
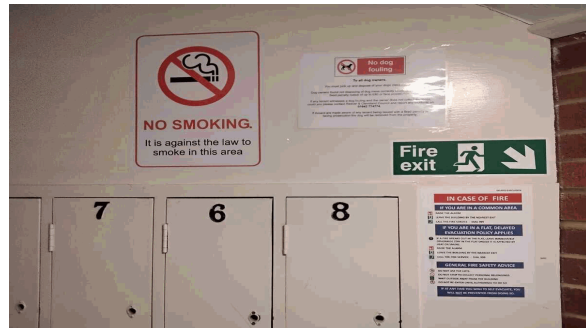
Signage throughout the blocks

No Action
