This report shows all the responses to the Fire Risk Assessment survey, including raised tasks.

Asset ID: 33221 **23-25 Willow Court Block 23-25a Recreation Road, Pickering**

Cover Sheet

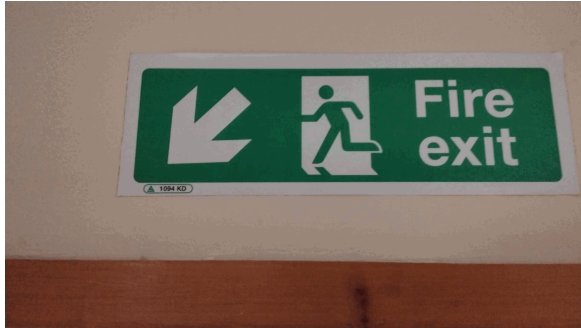
All internal doors are standard ply flush 32mm doors,accepted the risk that Scheme manager understands risk, keeps all doors closed and is alone working from office part time.Smokedetectors in landing and kitchen areas.

Signage throughout scheme managers office
