This report shows all the responses to the Fire Risk Assessment survey, including raised tasks.

Asset ID: 8651 **1-3a Station Road Block 1-1a & 3-3a Station Road, Peterlee**

Date of Fire Risk Assessment	05 Oct 2023
Date of Next Fire Risk Assessment	05 Oct 2024
FRA Frequency (Months)	12
Purpose of Fire Risk Assessment	Annual Re-Assessment
Type of Fire Risk Assessment	Type 1 (Common Parts Only - Non Destructive)
Fire & Safety Assessor	Kevin Jones

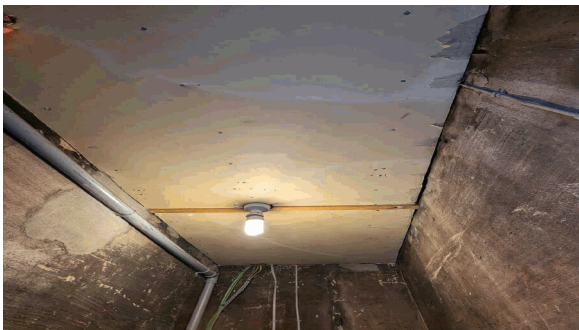
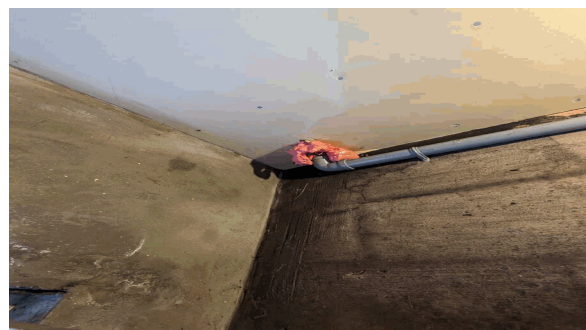
Compartmentation breach in electrical intake cupboard, works requested . Job no 099991

Combustible materials left in electrical intake cupboard compartmentation breach identified in ceiling

Compartmentation breach in electrical intake cupboard. job no 099991	Internal - High	Building Safety Manager		
---	-----------------	----------------------------	--	--

Comment Compartmentation in electrical intake cupboard

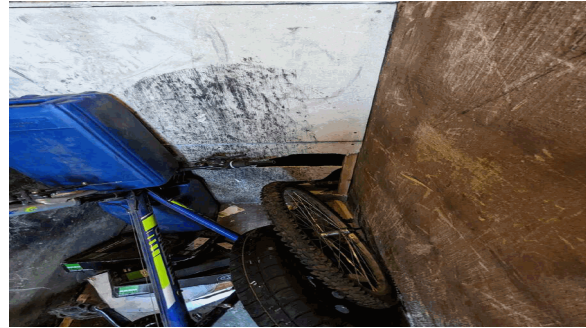
Combustible materials left in electrical intake cupboard HP informed to remove

Observation	Priority	Referred To	Required By:	Task ID
Combustibles left in electrical intake cupboard HP informed to deal with.	Internal - Medium	Housing Partner

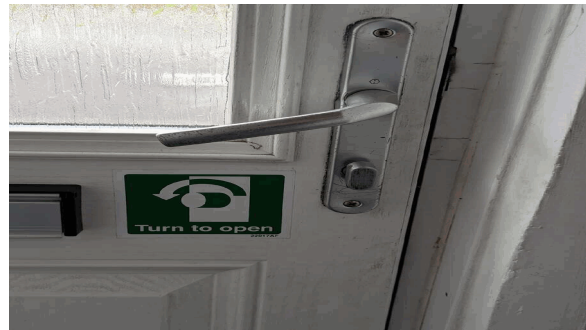
Signs installed during FRA

No Action
