This report shows all the responses to the Fire Risk Assessment survey, including raised tasks.

**Asset ID: 33110**      **1 Beech Close Block 1-6, Harrogate**

## Cover Sheet

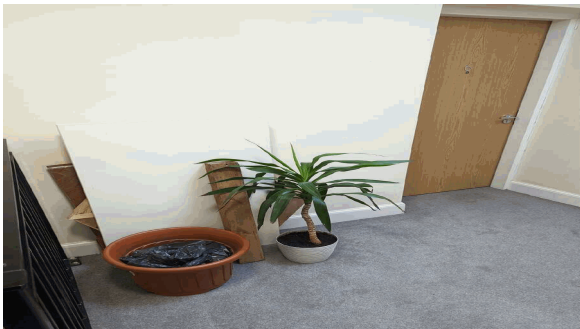
Combustible materials left on 2nd floor landing

Observation	Priority	Referred To	Required By:	Task ID
Items of combustible materials left on landing on 2 nd floor	Internal - Medium	Housing Partner	27/10/2023	1724071

Unauthorised items were found in communal areas and arrangements were made for their removal. Yes
