This report shows all the responses to the Fire Risk Assessment survey, including raised tasks.

Asset ID: 5966 **St Phillips Court, Bradford**

Cover Sheet

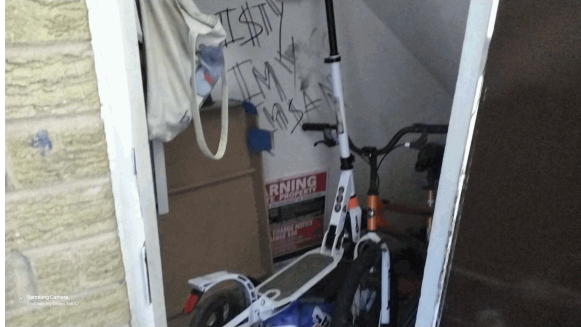
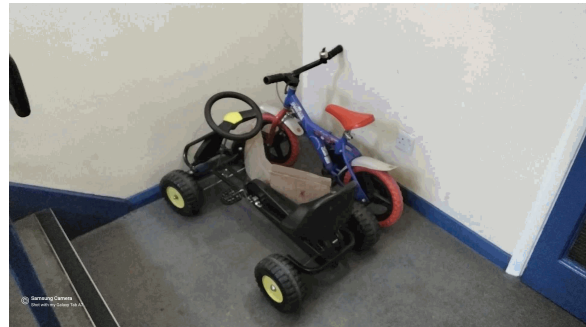
Electrical cupboard leading to flats 7 and 8 have combustible items stored

Combustible items stored in electrical cupboard block 1
To 6 children's toys on escape route

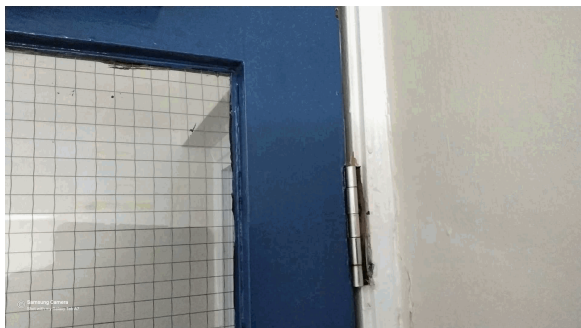
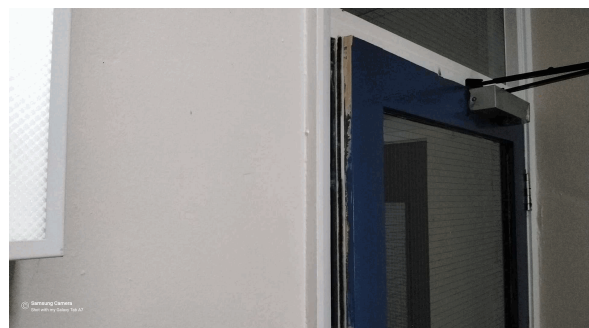
Observation	Priority	Referred To	Required By:	Task ID
Communal Fire door leading to flats 9 and 10 requires repairing. Hinges need replacing and door adjusting to fit to rebate Order No. 1122777	Repair - Non Emergency	Building Safety Manager

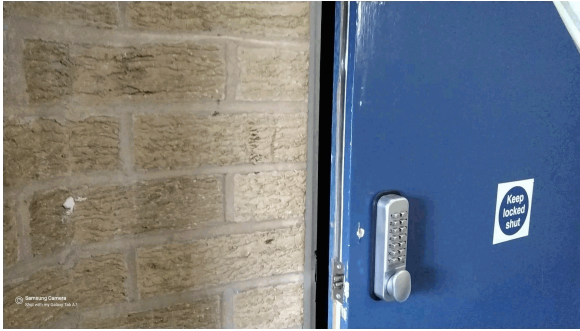
Observation	Priority	Referred To	Required By:	Task ID
Electric cupboard door in block 7 to 12 requires adjusting to allow door to close to rebate code C2014 Order No 1122781	Repair - Non Emergency	Building Safety Manager

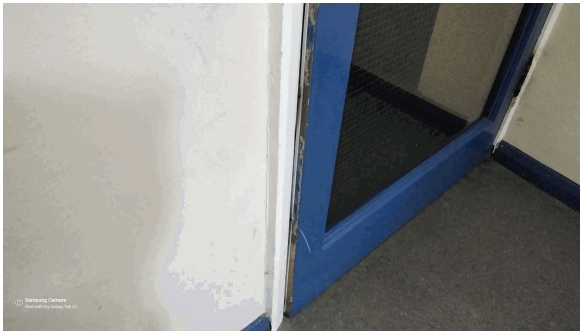
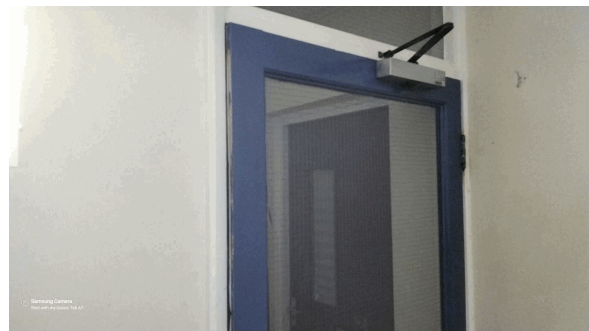
Observation	Priority	Referred To	Required By:	Task ID
Communal door leading to flats 1 and 2 requires adjusting to close to rebate. Renew smoke seal and hinges Order Number 1122784	Repair - Non Emergency	Building Safety Manager
