This report shows all the responses to the Fire Risk Assessment survey, including raised tasks.

Asset ID: 9659 **35 Durham Road Block 35a-35b Durham Road, Stockton-on-Tees**

Fire Risk Assessment Survey Results

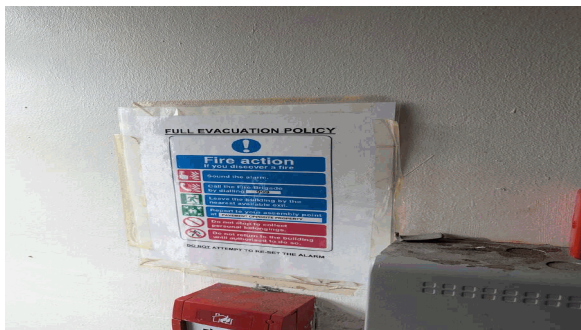
Observation

Evacuation notice

No Action

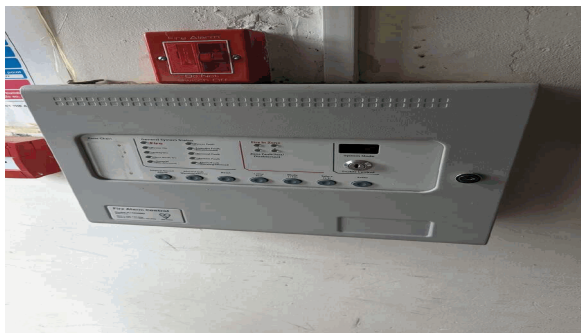
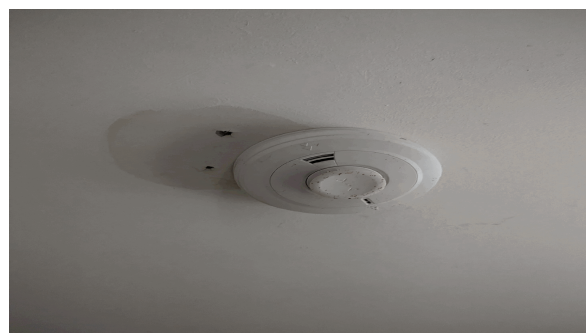
Uploaded to Active H . No electrical supply to property so unable to confirm if panel,alarm,or detectors operate satisfactorily.

Observation	Priority	Referred To	Required By:	Task ID
Fire panel and detectors	No Action
