This report shows all the responses to the Fire Risk Assessment survey, including raised tasks.

Asset ID: 6448 **Oatfield Court/bankfields, Middlesbrough**

Cover Sheet

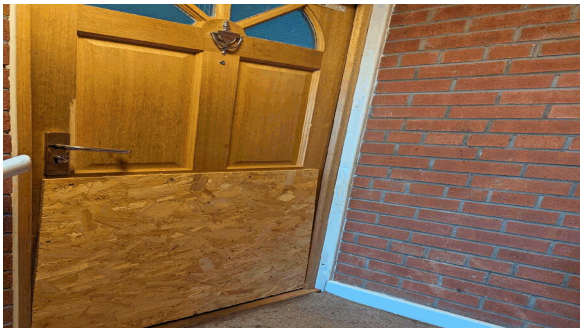
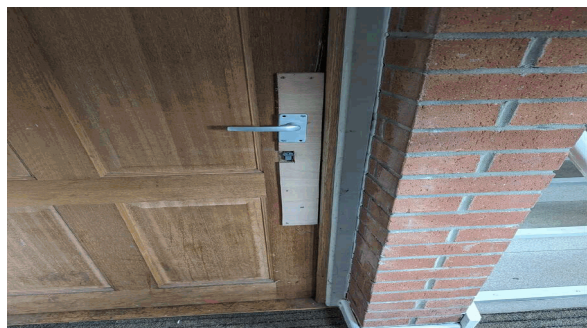
Observation	Priority	Referred To	Required By:	Task ID
Damaged flat doors repair requested on repairs portal and Works progress traker	Internal - High	Customer Safety Manager	16/05/2024	1809439

Comment	Number of flat doors require repair.10,12,18,31&34.
Can work be conducted without the need for an asbestos survey. If no, task Customer Safety Surveyor - Asbestos.	Yes

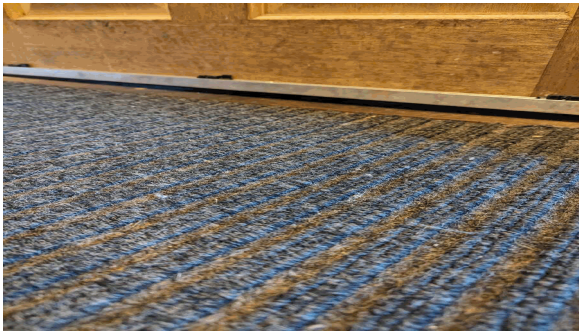
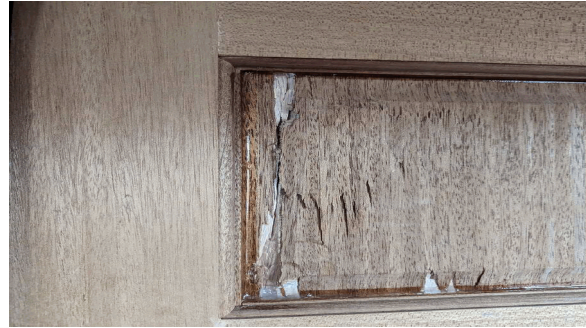
Observation	Priority	Referred To	Required By:	Task ID
Damage to flat entrance door	Internal - High	Customer Safety Manager	16/05/2024	1809440
