This report shows all the responses to the Fire Risk Assessment survey, including raised tasks.

Asset ID: 33482 **1 Silverdale Street, Barrow In Furness**

Scheme Name	Silverdale Street Hostel
Scheme Address	1 Silverdale Street, Barrow In Furness
Postcode	LA14 1AT
Region	North West
Scheme Manager	
Scheme Tel. No	N/A
Scheme Inspection Completed	Yes
Enforcing Fire Authority	Cumbria
Other staff in attendance	None
Number of on-site Accent staff	None
Number of other (non-Accent) staff	Contract Cleaners in common areas

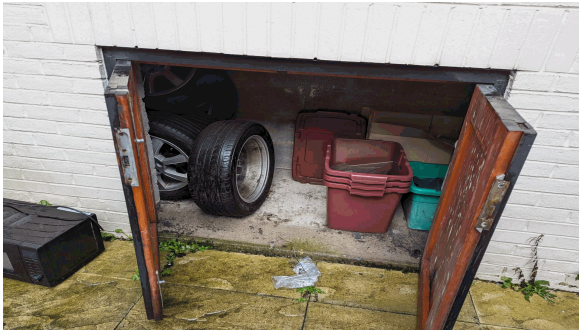
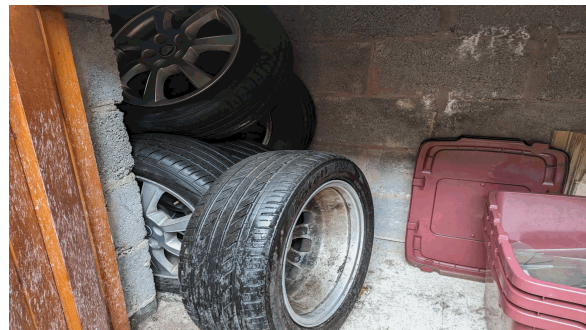
Outdoor yard store was open and contained combustible items - mainly tyres. This store is directly under the main staircase. HP to arrange removal and secure doors

Observation	Priority	Referred To	Required By:	Task ID
Flammable Items such as tyres stored in external rear store under staircase. Store is insecure. Items need removing and doors securing to prevent further personal storage	Internal - High	Housing Partner	12/02/2024	1754619

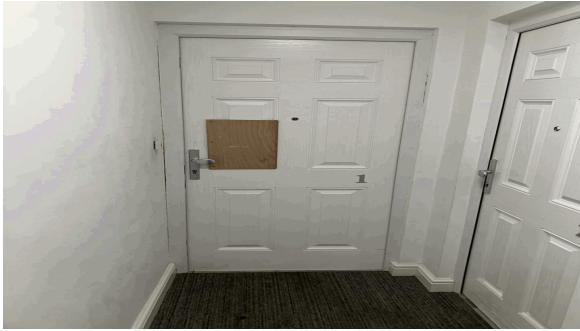
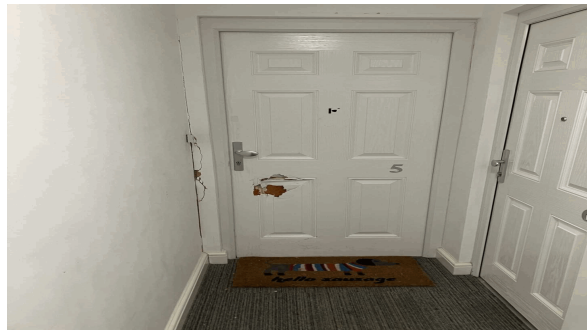
Flat front doors for 1, 5 and 7 are badly damaged and require replacing. Quotes requested

Repair - Non
Emergency

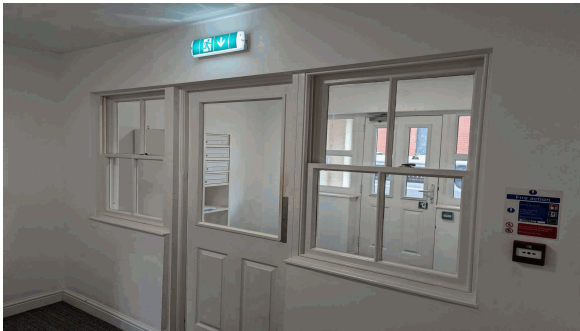
Glazed Screens between the entrance lobby and the hallway don't appear to be fitted with fire resisting glazing and will require replacing
Flat doors for 1, 5 and 7 were damaged and will require replacement
Some smoke seals and Intumescent straps missing

The glazed screens between the entrance foyer and the gf hallway doesn't appear to be FR and requires replacing

Repair - Non
Emergency

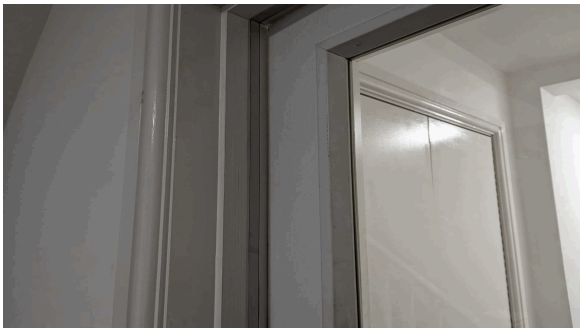
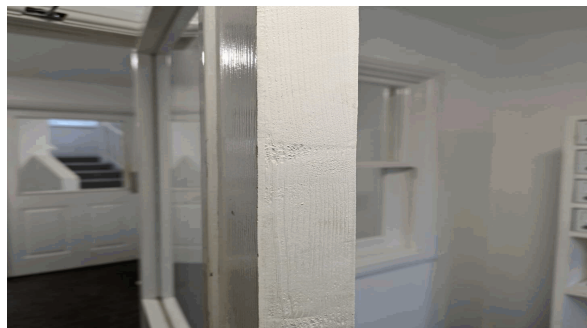
All the communal doors have not been fitted with smoke seals and the door between the foyer and the gf hallway has neither Intumescent strips and smoke seals. The door into thr corridor for flats 1 &

Repair - Non
Emergency
