This report shows all the responses to the Fire Risk Assessment survey, including raised tasks.

Asset ID: 24411 **Bracknell Road**

Date of Fire Risk Assessment	27 Sep 2024
Date of Next Fire Risk Assessment	27 Sep 2027
FRA Frequency (Months)	36
Purpose of Fire Risk Assessment	3 year Re-Assessment
Type of Fire Risk Assessment	Type 1 (Common Parts Only - Non Destructive)
Fire & Safety Assessor	Gary Bredin AlfireE

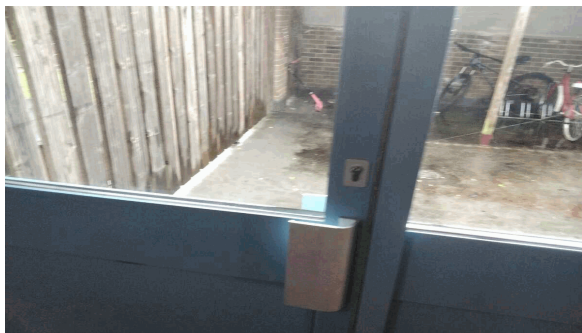
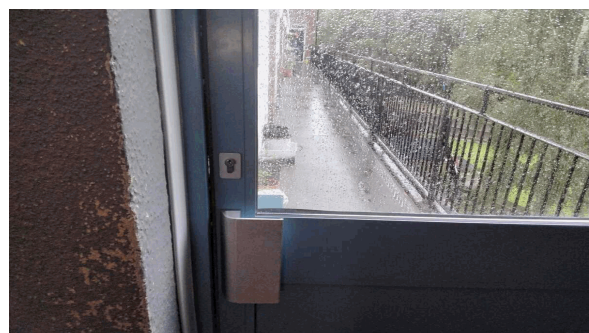
Key barrels require removing from the drying area doors and doors to the maisonettes in all blocks.

The final doors to the maisonettes and the drying areas have locks fitted. These need to be removed. Surveyor dealing as a high priority and works have started.

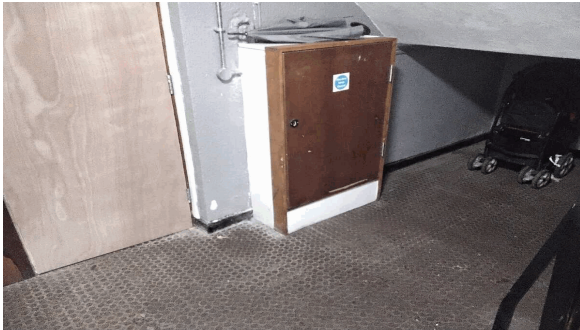
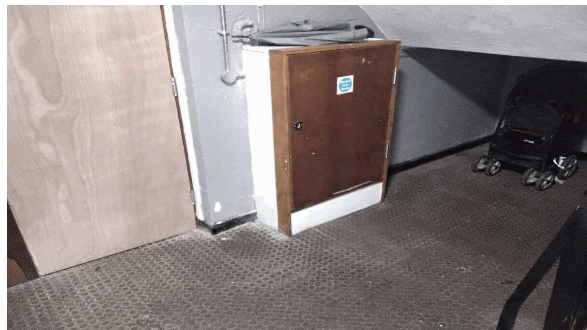
All electrical cupboards require replacing as do not conform to the latest standards.

Observation	Priority	Referred To	Required By:	Task ID
Electrical cupboards in all blocks require replacing to meet the current requirements.	Internal - Medium	Project Manager (Building Safety)	01/01/2025	1867530

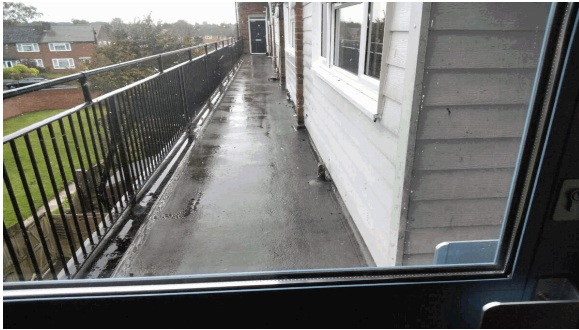
All areas were clear at the time of the audit.

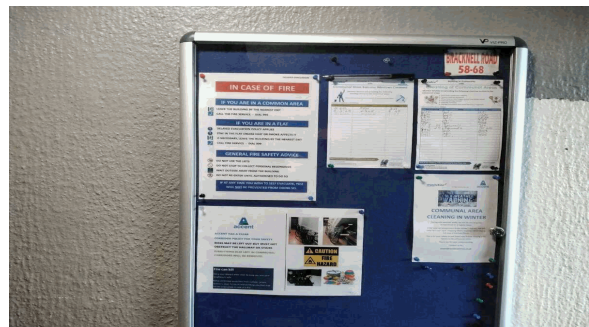
These are posted on the information board in all blocks.

All fire and safety related information are posted in the notice boards in all blocks.
