## **ACCENT HOUSING - FIRE RISK ASSESSMENT**

Scheme Name: Stark St

Scheme Address: Ramsden St

Date of Assessment: 01/08/2024

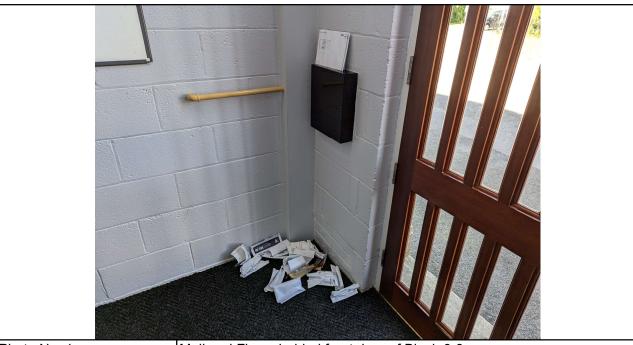
Photo No. 1

6.1	Does the building have a lightning protection system, If so, is it adequately maintained?	N/A	Not required due to height			
7	Housekeeping:					
7.1	Is the standard of housekeeping adequate?	oN	Housekeeping generally good Block 6-8, Mail and paper flyers scattered on the floor nr the main entrance Block 14-18, Kitchen cabinets in second floor hallway. HP to arrange removal - Emailed 09/08/24	Med	31/8/24	Customer Partner
	Are all electrical/intake/service cupboards secure and free from general waste, contractors waste and residents personal items.	Yes	None seen at time of inspection

Mail and Flyers behind front door of Block 6-8

Action Plan - Fire					
Stark St		01/08/2024			
Trivial					
Potential area of fire risk	Observation/Comments / Actions Required	Risk Rating	Completion Date	Referred To:	Task ID No.
Fire Hazards					
Housekeeping:					
Is the standard of housekeeping adequate?	Housekeeping generally good Block 6-8, Mail and paper flyers scattered on the floor nr the main entrance Block 14-18, Kitchen cabinets in second floor hallway. HP to arrange removal - Emailed 09/08/24	Med	31/08/24	Customer Partner

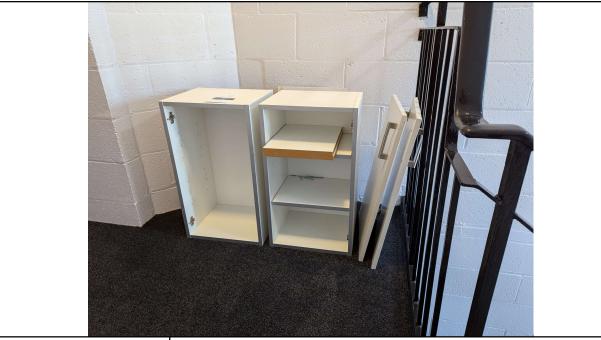
Photo No. 2

Kitchen cabinets in 2nd Floor stairway Block 14-16
