This report shows all the responses to the Fire Risk Assessment survey, including raised tasks.

**Asset ID: 31130**      **Harton Lea**

## Cover Sheet

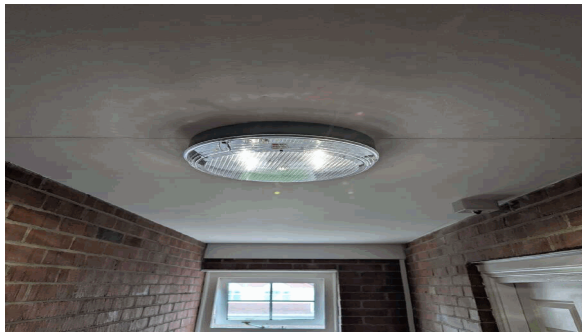
Observation	Priority	Referred To	Required By:	Task ID
Holes in ceiling repairs work order 1257753	Internal - Medium	Project Manager (Building Safety)	14/03/2025	1920722

Bin store door requires ease and adjusting,  
Emergency light survey  
Holes in ceiling next to flat 6  
Block 1-8 doors 1,2,4,6,7 and 8 require survey to replace as not within standards

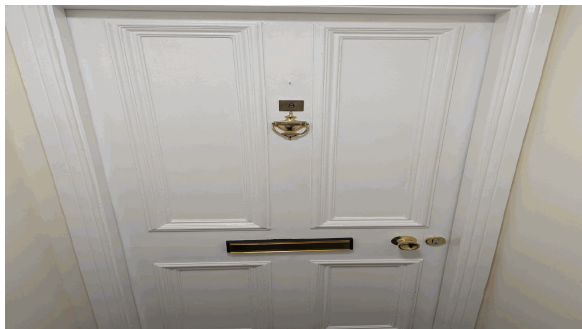
Observation	Priority	Referred To	Required By:	Task ID
Number of doors require survey to check for confirmation to standards.Flat doors 1,2,4,6,7 & 8	Internal - Medium	Project Manager (Building Safety)	15/05/2025	1920723

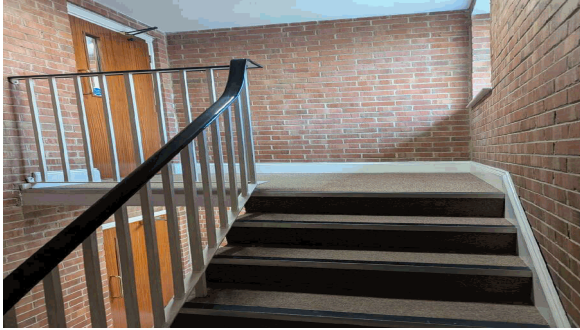
Observation	Priority	Referred To	Required By:	Task ID
Sterile means of escape routes identified during assessment	No Action

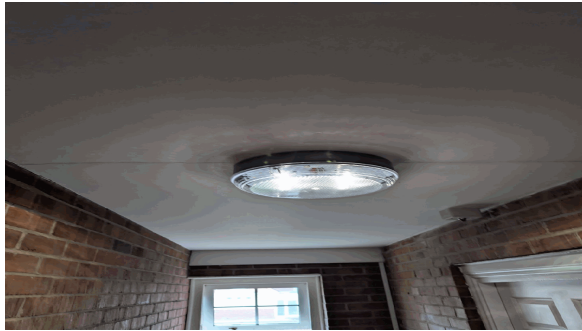
Block 1-8 up to standard  
 Block 9-12 up to standards  
 Block 14-19 only 1 lighting unit, assessment requested through repairs portal

only 1 emergency light fitted in block 14 - 19 survey requested works no 1257730	Internal - Medium			
--	-------------------	--	--	--

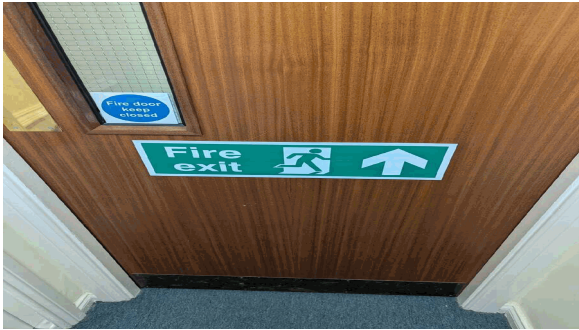
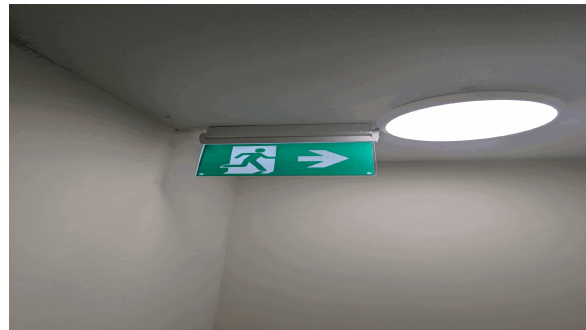
Correct directional signage throughout the property
