This report shows all the responses to the Fire Risk Assessment survey, including raised tasks.

Asset ID: 1030 **1-16 Keyworth Court Block 1-16 Princes Street, Huntingdon**

Cover Sheet

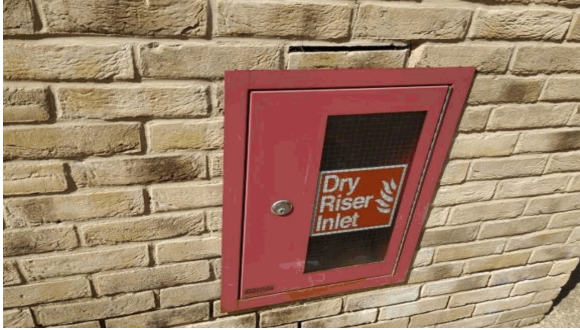
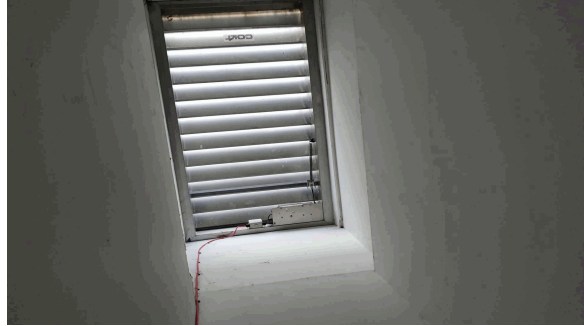
Is fire extinguishing equipment and/or fixed fire fighting installations provided at this scheme?	Yes
Comment	Dry risers located each floor.
Portable fire extinguishers - appropriate type/number/position?	No
Comment	
Correct signage displayed by each fire extinguisher?	N/A
Comment	
Fire blanket in communal kitchen, secured to the wall, complete with signage?	N/A
Comment	
Dry risers - Inlet/outlet boxes secured and/or securing straps fitted to outlet valves?	Yes
Comment	All checked on day of inspection at each floor level.
Records available of fire fighting equipment servicing within past 12 months?	Yes
Comment	The Dry Riser annual check has been serviced by Morgan Fire on 19/8/2024.

Observation	Priority	Referred To	Required By:	Task ID
Dry riser requires an annual inspection testing.This is now completed dated 19/8/2024.	Internal - Medium	Project Manager (Building Safety)	30/08/2024	1856295
