This report shows all the responses to the Fire Risk Assessment survey, including raised tasks.

Asset ID: 8869 **Holmefield House Harrogate Road, Ripon**

Cover Sheet

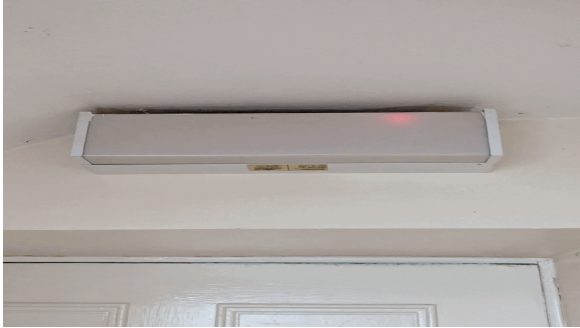
Is the emergency lighting correctly specified and installed as per current standards?	Yes
Comment	Appears to be fitted to the corret standard
Emergency lighting units in good condition and securely fixed to walls/ceilings?	Yes
Comment	All appear to be in good condition and secure
Records of monthly/annual testing available?	Yes
Comment	Last inspection 23/09/2024

Observation	Priority	Referred To	Required By:	Task ID
In good condition and secured	No Action

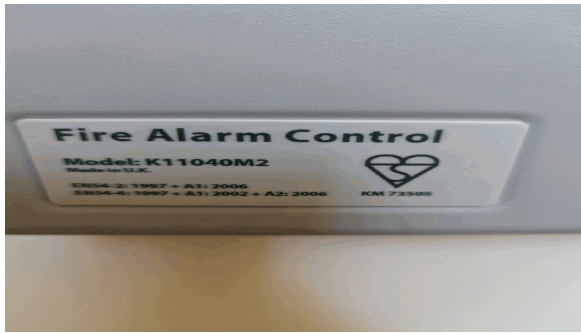
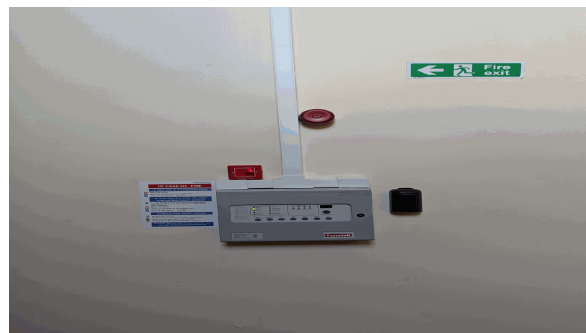
Is the scheme fitted with a communal area fire alarm?	Yes
Comment	
Is fire detection and warning system appropriate for occupancy and fire risk, as per BS 5839-1:2017?	No
Comment	Change of evacuation strategy identified. Fire alarm system inspection requested to upgrade to full evacuation strategy system. WO orks order 1220500
Is the fire detection and warning system maintained/tested and all certificates saved on file?	Yes
Comment	
Fire alarm components in good condition and securely fixed to walls/ceilings?	Yes
Comment	Appears to be in good condition and secure
Hold open devices operate at the sounding of the alarm and are in a serviceable condition?	N/A

Fire alarm system requires assessment and upgrade to meet full evacuation strategy. work order no.1220500

Internal - High

Project Manager
(Building Safety)

07/11/2024

1872365

Building has been converted into flats and compartmentation can not be fully relied upon. Change to Full evacuation strategy with a fire alarm system upgrade to allow for the full evacuation strategy to be implemented. Customer information campaign is required to inform of the change.
