This report shows all the responses to the Fire Risk Assessment survey, including raised tasks.

Asset ID: 33125 **Accent Business Centre Block Barkerend Road, Bradford**

Cover Sheet

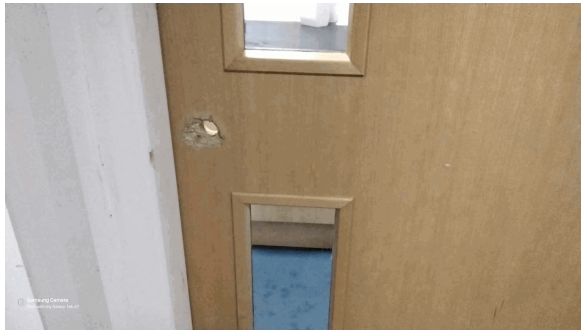
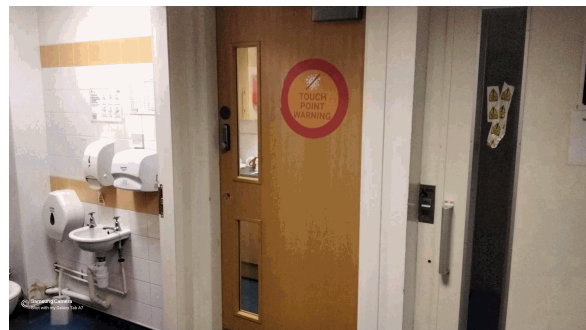
Observation	Priority	Referred To	Required By:	Task ID
Door to kitchen on ground floor has hole in it. Requires repair to BMTRADA compliance or replacing. Door survey requested for all communal door within the building. Works order 1250472	Repair - Non Emergency	Project Manager (Building Safety)	30/04/2025	1911265

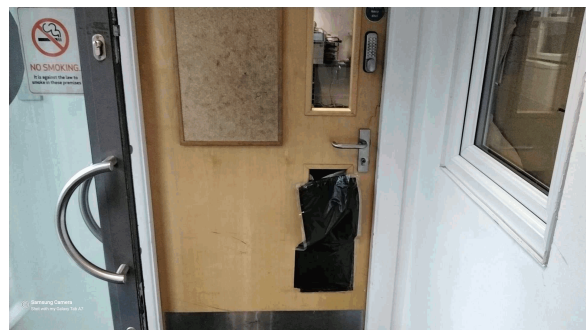
Observation	Priority	Referred To	Required By:	Task ID
Fire Door to Site office damaged due to break in. Replace doorset with FD30S. With digilock code 3849Z thumb turn internal. Door survey requested for all communal door within the building. Works order 1250472	Repair - Non Emergency	Project Manager (Building Safety)	30/04/2025	1911267

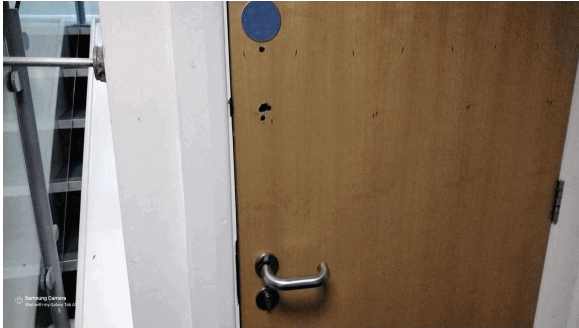
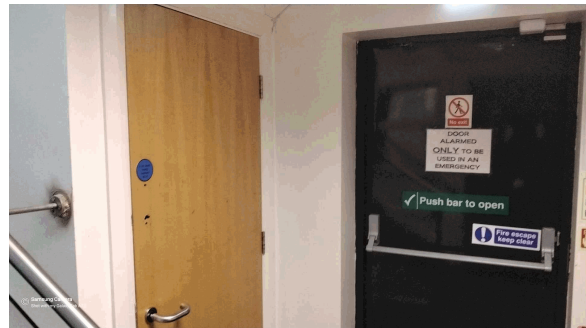
Observation	Priority	Referred To	Required By:	Task ID
Hole in fire door to cleaners store cupboard ground floor requires repairing to BMTRADA compliance or replacing Door survey requested for all communal door within the building. Works order 1250472	Repair - Non Emergency	Project Manager (Building Safety)	30/04/2025	1911268

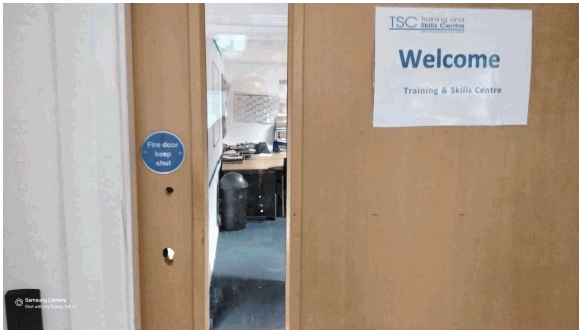
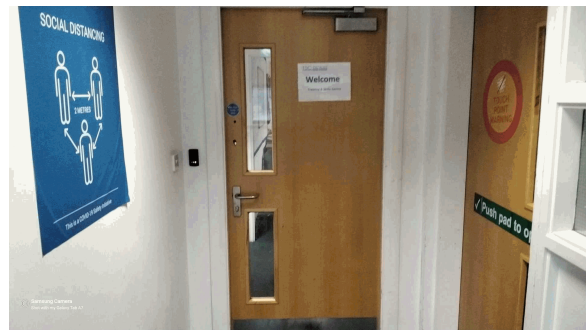
Observation	Priority	Referred To	Required By:	Task ID
Hole in fire door to TSC Training requires repairing to BMTRADA compliance or replacing Door survey requested for all communal door within the building. Works order 1250472	Repair - Non Emergency	Project Manager (Building Safety)	30/04/2025	1911266

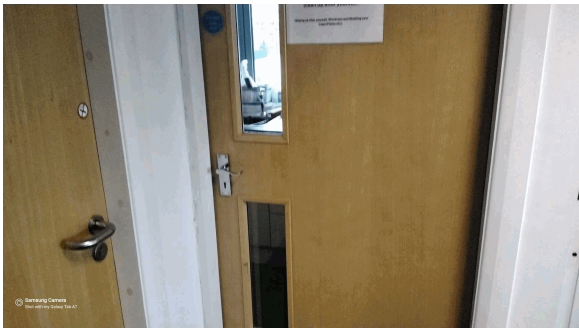
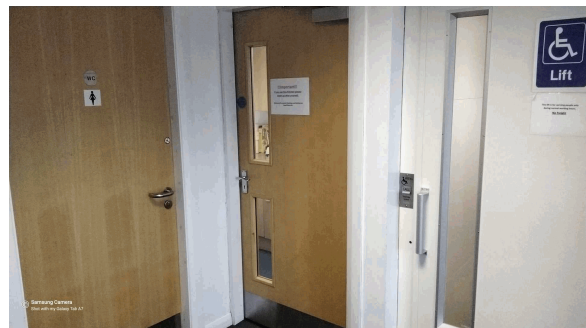
Observation	Priority	Referred To	Required By:	Task ID
Replace door handle and lock on 3rd floor kitchen door. Door survey requested for all communal door within the building. Works order 1250472	Repair - Non Emergency	Project Manager (Building Safety)	30/04/2025	1911269

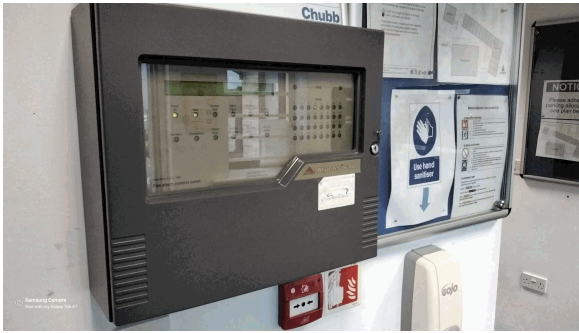
Fire alarm panel and zone plan

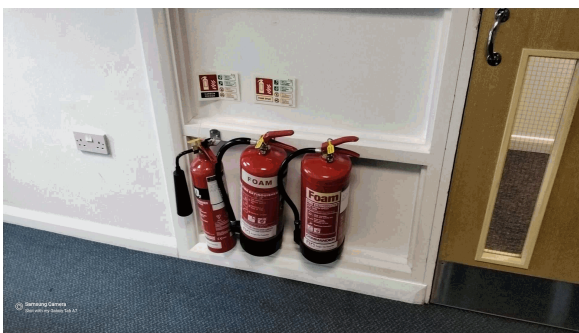
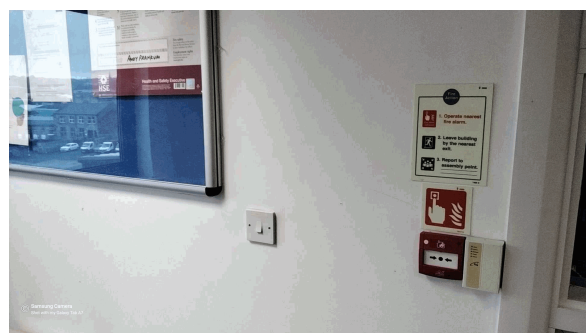
Fire extinguishers and call points
