ACCENT HOUSING - FIRE RISK ASSESSMENT

Region :	North West
Scheme Name :	Richard Watson Gardens 5-24
Scheme Address :	Brunswick St Nelson BB9 9DU
Date of Assessment:	25/07/2024
Date of Next Assessment:	25/07/2026
FRA Frequency:	2 Yearly Re-Assessment
Fire & Safety Assessor	Ian Potter

This Fire Risk Assessment has been conducted upon the instruction of Accent Housing.

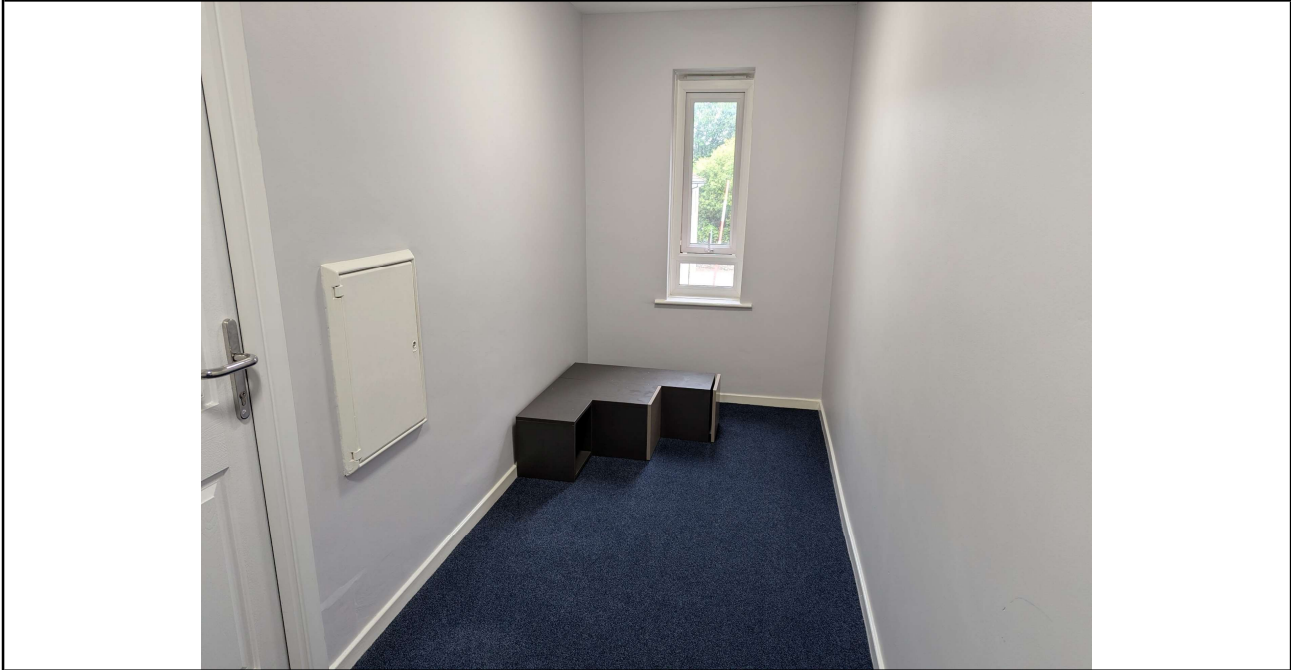
Photo No. 1

Furniture left in Communal Hallway Block 5-16

7.1	Is the standard of housekeeping adequate?	No	Block 5-16, Wooden storage unit located in hallway on 2nd floor. Canvas print on wall. HP to arrange removal	Low	31st August 24	Customer Partner

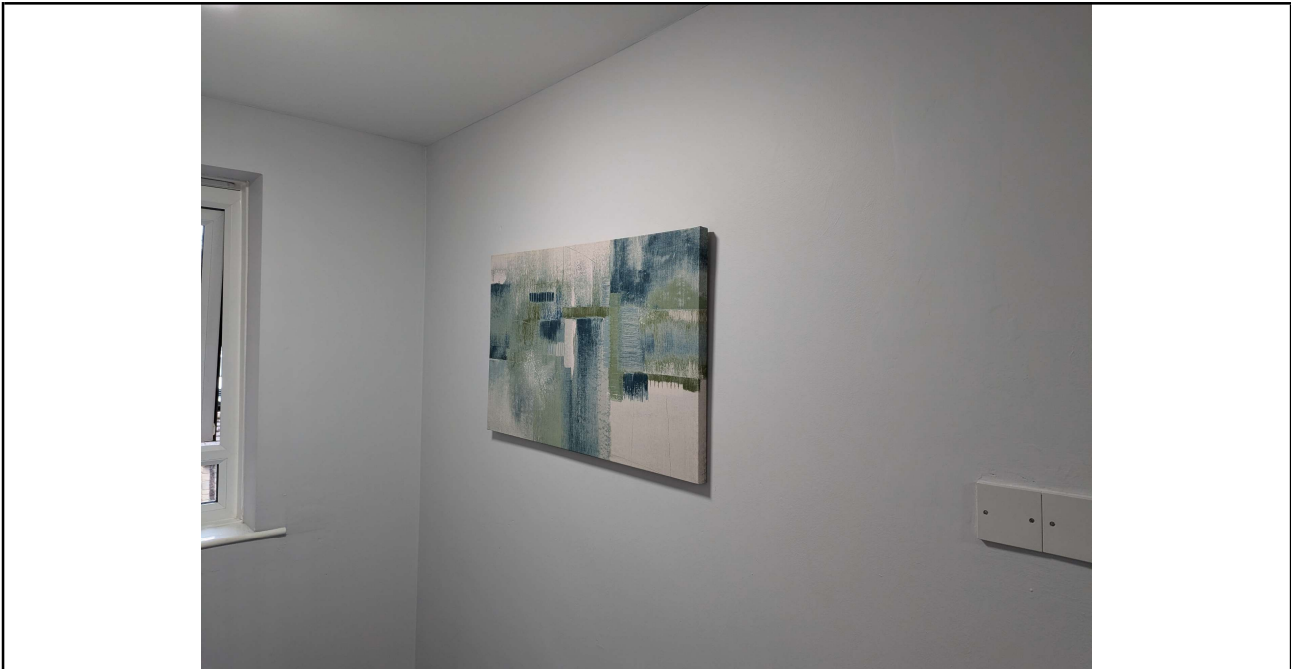
Photo No. 2

Canvas print on wall in hallway

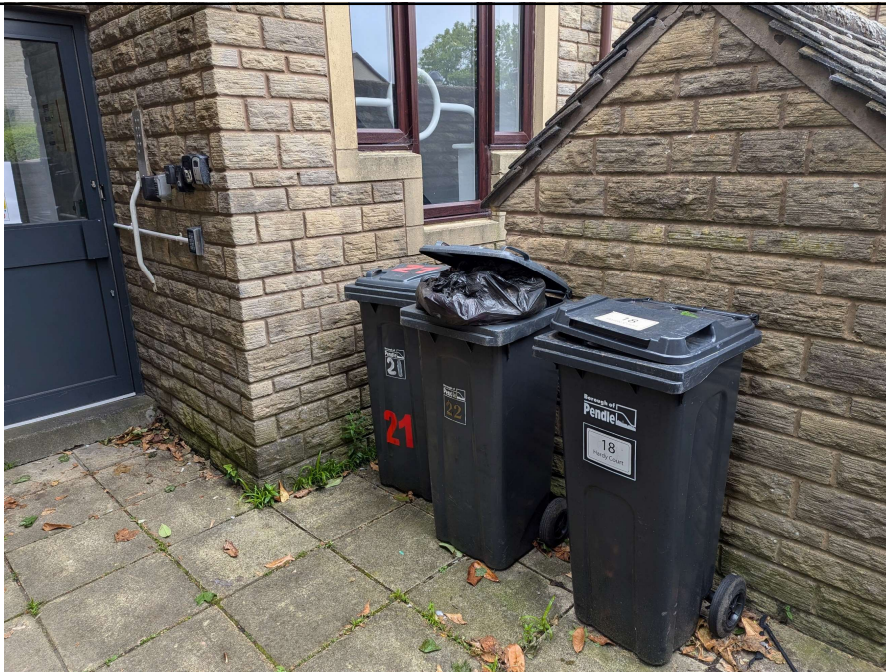
Photo No. 3

Bins stored nr building Block 17-24

3.2	Is there an absence of unnecessary fire load in close proximity to building?	No	Block 17-24. Bins were stored outside of designated storage area and immediately adjacent to the building. HP to remind residents to keep their bins in the dedicated store.	Med	31st August 24	Customer Partner
4	Heating Installations (Portable/fixed) Gas Installations - Common Areas & General Needs Residential flats.

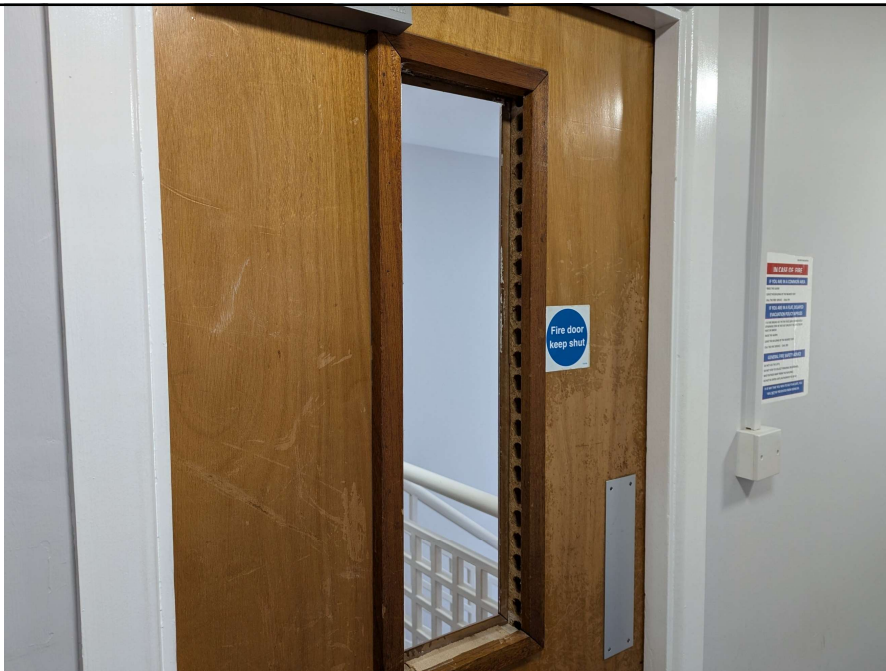
Photo No. 4

FR Glazing missing from Staircase Fire door Block 17-24

12.1	Communal fire doors to FD30s standard and in a serviceable condition,	No	Block 17-24, Fire resisting glazing missing from staircase door nr Flats 23 and 24. Repair raised by HP Work order 1186879	Med	31st August 24	Customer Partner

Communal Area Fire Doors (Inspection to include - construction, closure devices, intumescent/smoke seal condition, glazing systems and maximum gaps between door and frame.					
Fire doors to FD30s standard and in a serviceable condition,	Block 17-24, Fire resisting glazing missing from staircase door nr Flats 23 an 24. Repair raised by HP Work order 1186879	Med	31st August 24	Customer Partner
