## ACCENT HOUSING - FIRE RISK ASSESSMENT

<b>Region :</b>	<b>South</b>
<b>Scheme Name :</b>	<b>Cordwalles Crescent</b>
<b>Scheme Address :</b>	<b>27-43 Cordwalles Crescent Camberley, Surrey GU15 4DY</b>
<b>Date of Assessment:</b>	<b>09/11/2022</b>
<b>Date of Next Assessment:</b>	<b>09/11/2025</b>
<b>FRA Frequency:</b>	<b>3 Year Re-Assessment</b>
<b>Fire &amp; Safety Assessor</b>	<b>Gary Bredin</b>

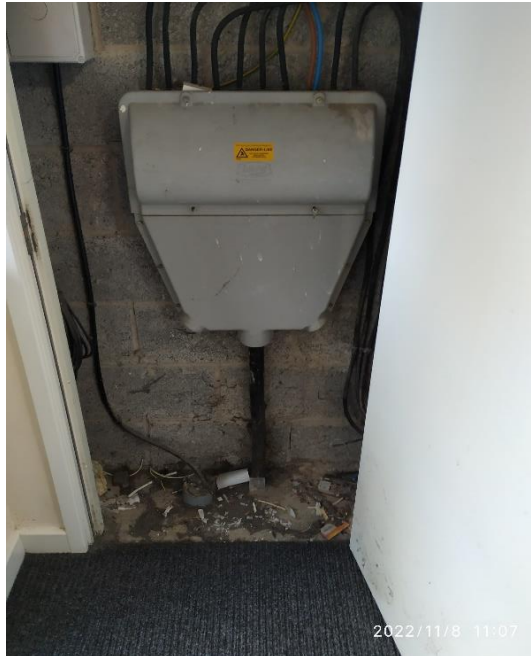
Photo No. 3

Observation - Electrical cupboard clear at the time of the audit.

7.1	Is the standard of housekeeping adequate?	Yes		.	
7.2	Are all electrical/intake/service cupboards secure and free from general waste, contractors waste and residents personal items.	Yes	All cupboards secure and clear at time of inspection	.

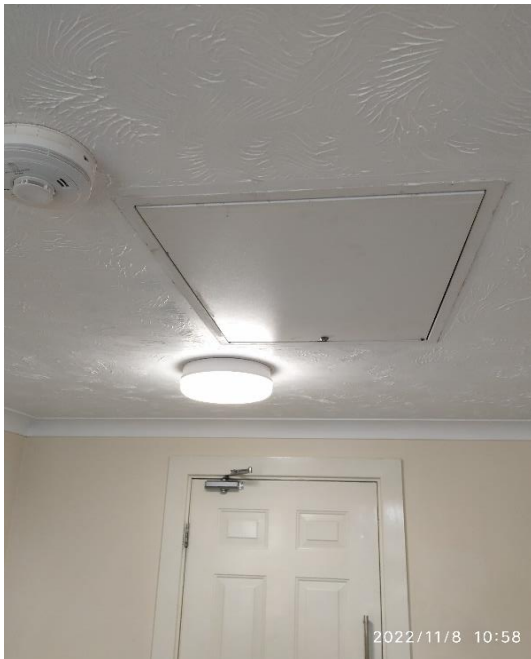
Photo No. 4

Observation- - Loft hatch metal construction tight fitting and locked shut.

11.4	Compartmentation within roof spaces of a satisfactory standard?	Other	Findings previously submitted to compartment survey project	.		
11.5	Loft hatches fire resisting?	Yes	Communal area roof hatch's are close fitting and of 1hr fire rated steel construction.	.
