This report shows all the responses to the Fire Risk Assessment survey, including raised tasks.

Asset ID: 9637 **1-11 Radcliffe Crescent Block 1-11 Radcliffe Crescent, Stockton-on-Tees**

Cover Sheet

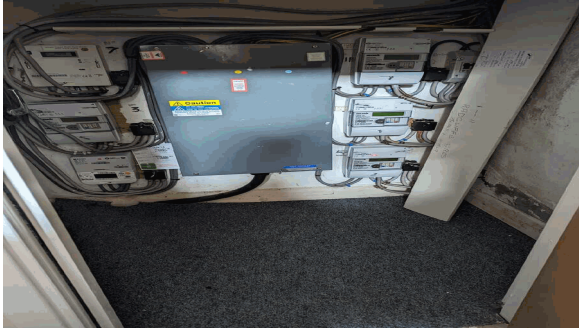
Electrical intake cupboard

No Action

Comment Fire door to small intake cupboard under the ground floor stair

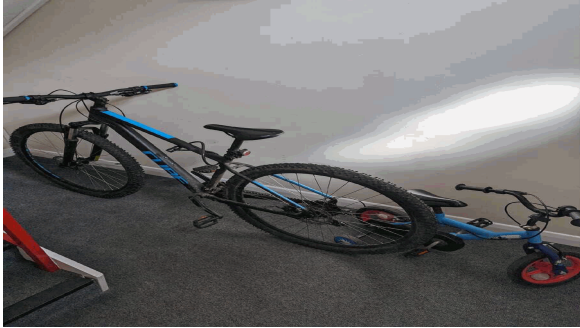
Sterile environment observed during inspection except for 2 cycles stored in ground floor entrance hall. HP informed to action.

Observation	Priority	Referred To	Required By:	Task ID
2 cycles stored in entrance hall	Internal - Medium	Housing Partner	28/06/2024	1824466

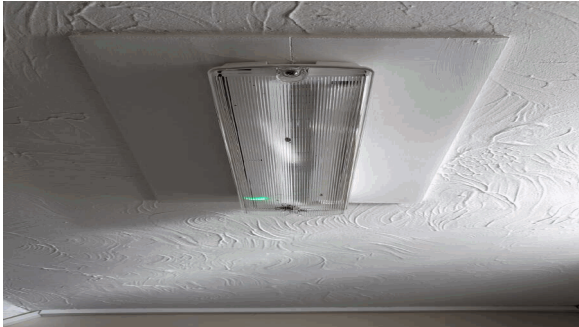
Appears to be in good condition and secured

Observation	Priority	Referred To	Required By:	Task ID
Emergency lighting in good condition	No Action

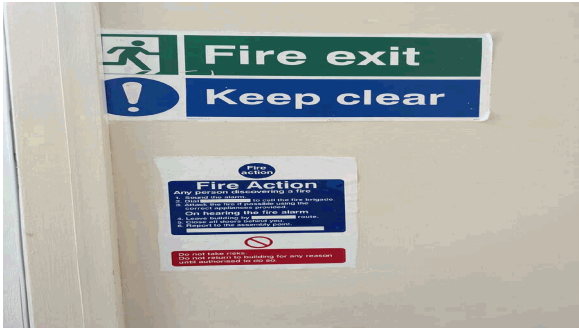
Observation	Priority	Referred To	Required By:	Task ID
Signage clearly visible	No Action
