## ACCENT HOUSING - FIRE RISK ASSESSMENT

<b>Region :</b>	<b>South</b>
<b>Scheme Name :</b>	<b>Chapel Road</b>
<b>Scheme Address :</b>	<b>17-72 Chapel Road Camberley, Surrey GU15 3LT</b>
<b>Date of Assessment:</b>	<b>14/05/2022</b>
<b>Date of Next Assessment:</b>	<b>14/05/2025</b>
<b>FRA Frequency:</b>	<b>3 Year Re-Assessment</b>
<b>Fire &amp; Safety Assessor</b>	<b>Gary Bredin</b>

This Fire Risk Assessment has been conducted upon the instruction of Accent Housing.

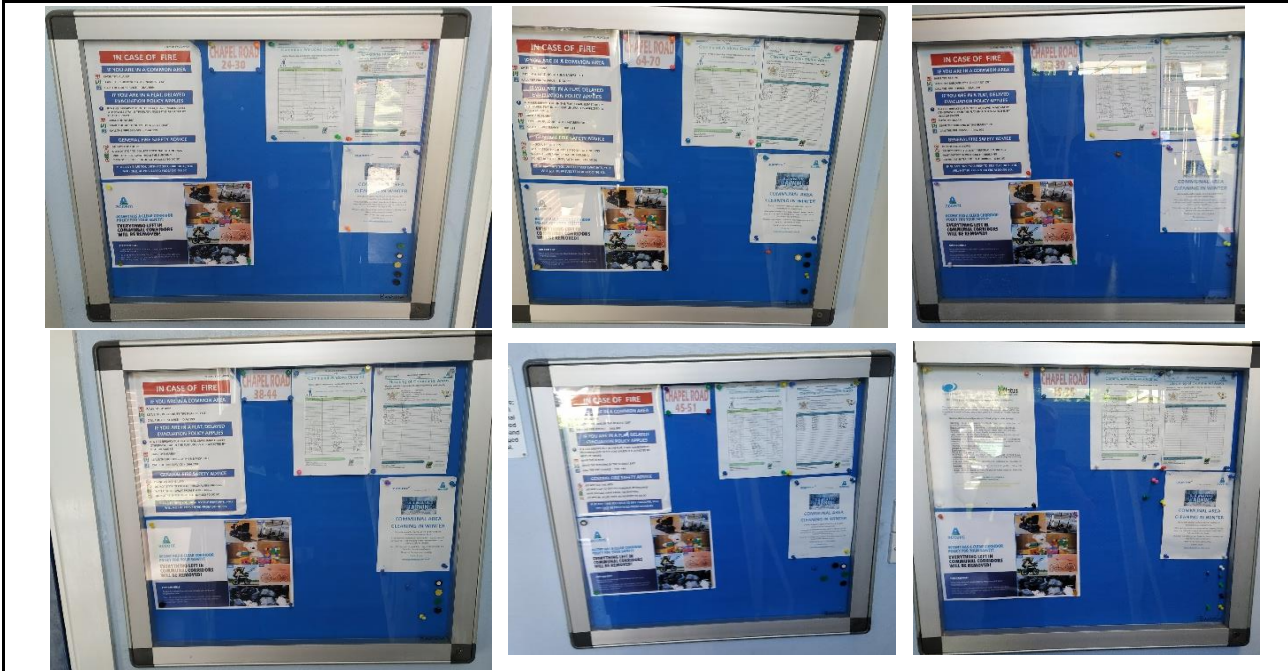
Photo No. 1

Observation - Notice board showing evacuation policy .

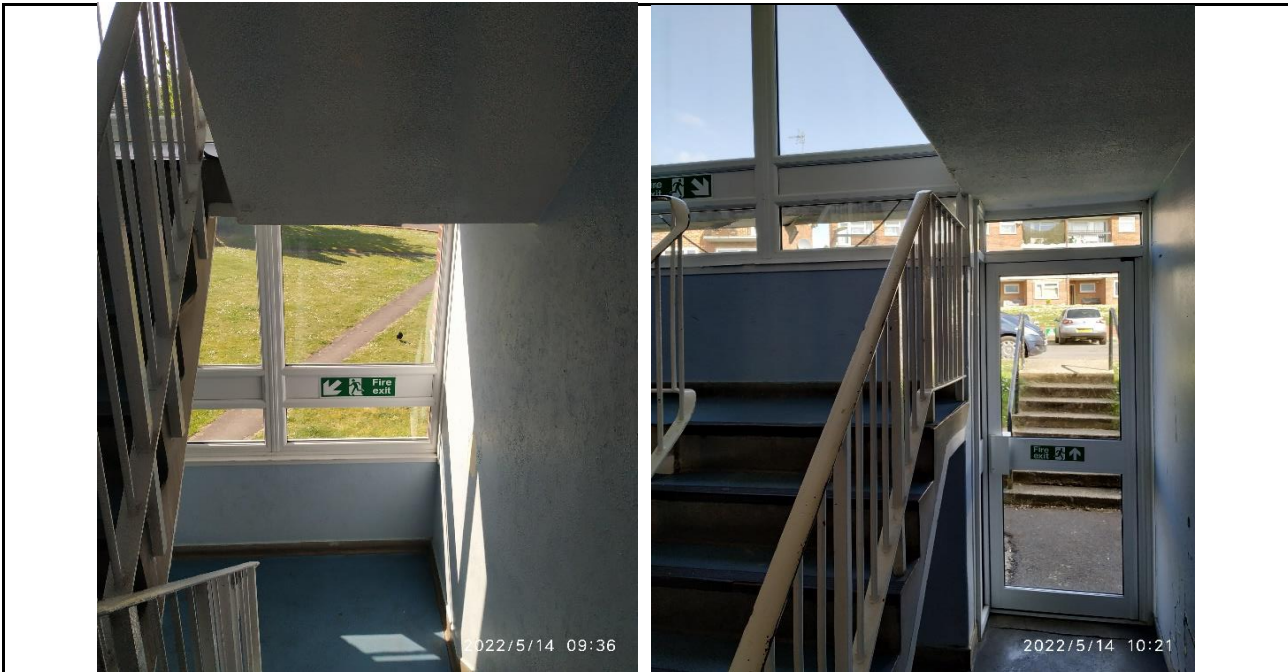
Photo No. 2

Observation - Emergency action signage.

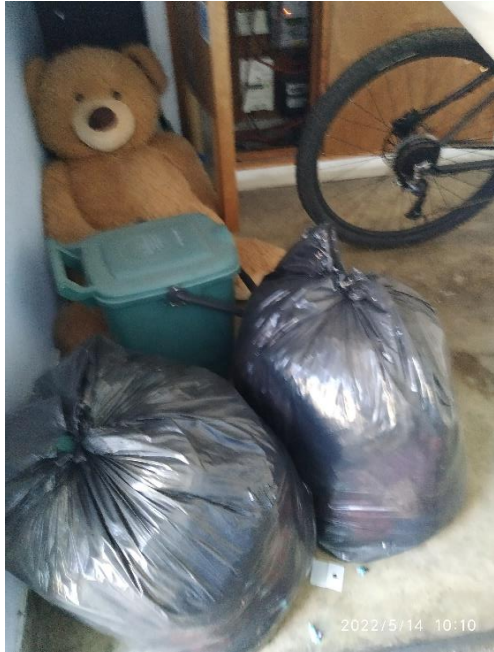
Photo No. 3

Observation - Fly tipping through out all blocks.Customer Partner to deal.

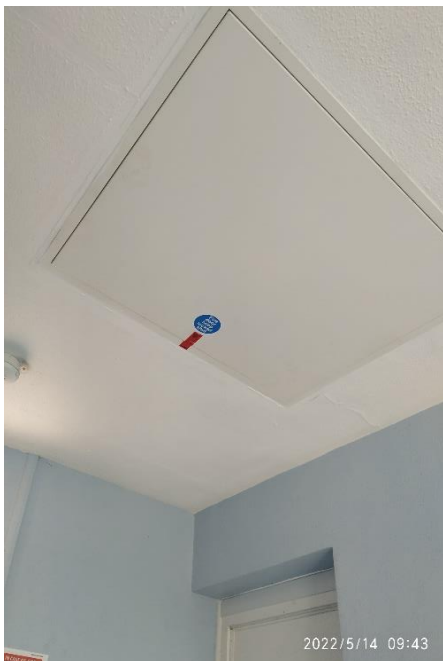
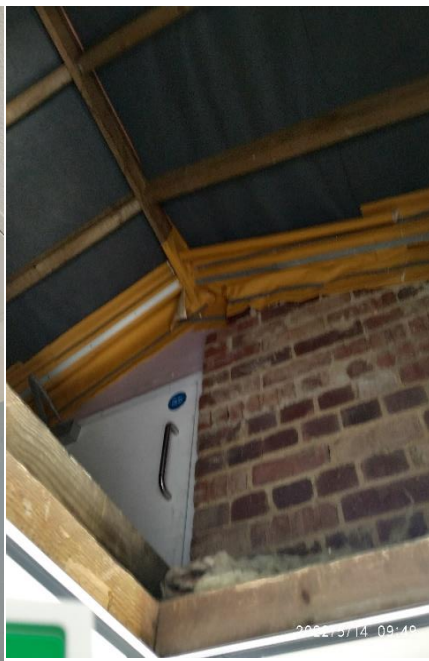
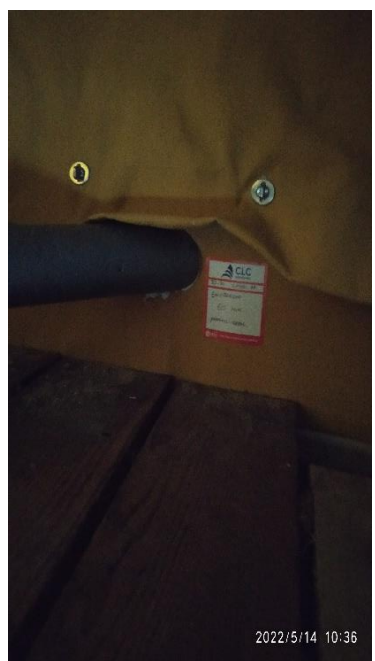
Photo No. 4

11.3	Are fire dampers/shutters provided in ducts/refuse chutes to protect means of escape against fire, smoke and combustion products?	N/A		.		
11.4	Compartmentation within roof spaces of a satisfactory standard?	Yes	The loft fire curtains have been assessed and the loft hatches have been fitted with a tamper proof tag.	.

11.5	Loft hatches fire resisting?	Yes	Communal area roof hatch's are close fitting and of 1hr fire rated steel construction. Lock missing and hatch screwed shut in block 64-70. Axis 994403	<b>Med</b>	<b>1/12/22</b>	<b>Fire Safety Manager</b>

Observation- Loft hatch metal construction tight fitting an locked shut. Loft clear and smoke curtain in good condition with no breaches. All hatches tagged. Next check 2023

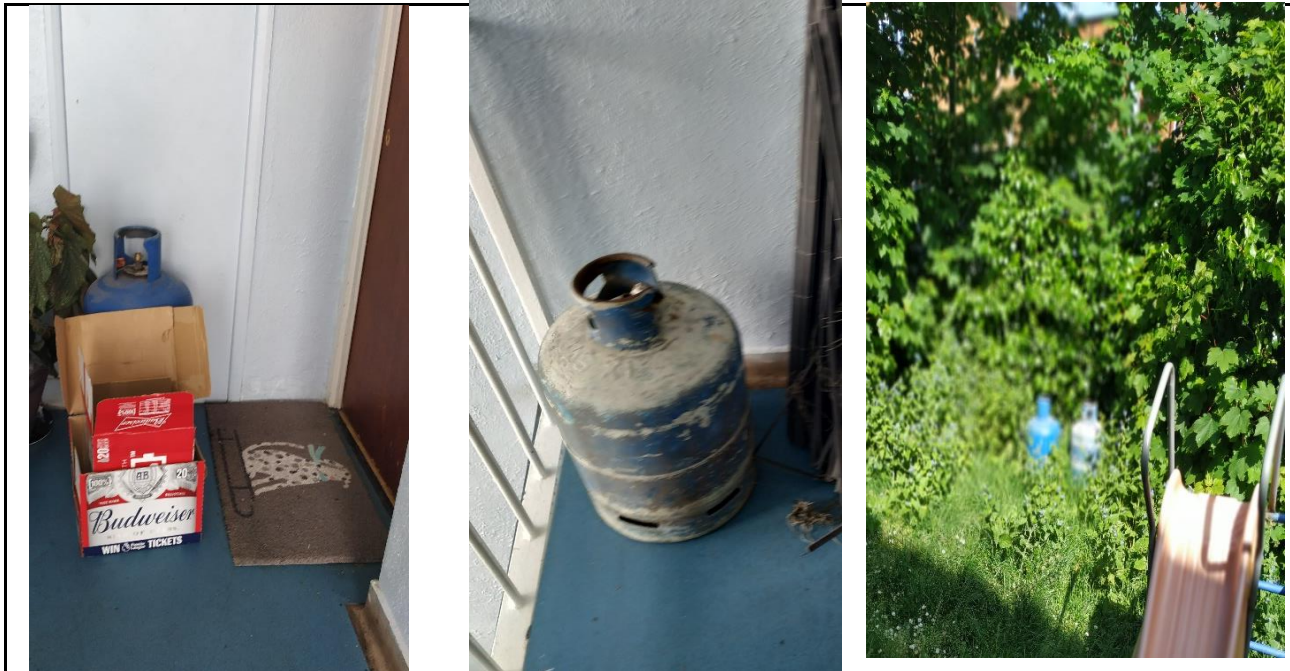
Photo No. 5

7.3	Are combustible materials separated from ignition sources and stored appropriately?	No	Gas cylinders are being stored in the means of escape. These were removed to a safe place away from the block by the assessor. Customer partner to speak the the offending customers.	High	1/5/22	Partnership Manager 2

Observation- Gas cylinders are being stored in the means of escape. These were removed to a place away from the block by the assessor. Customer partner to speak the the offending customers.

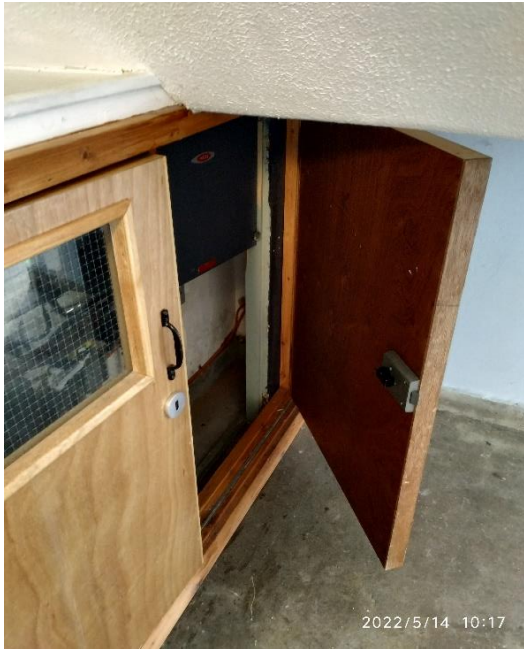
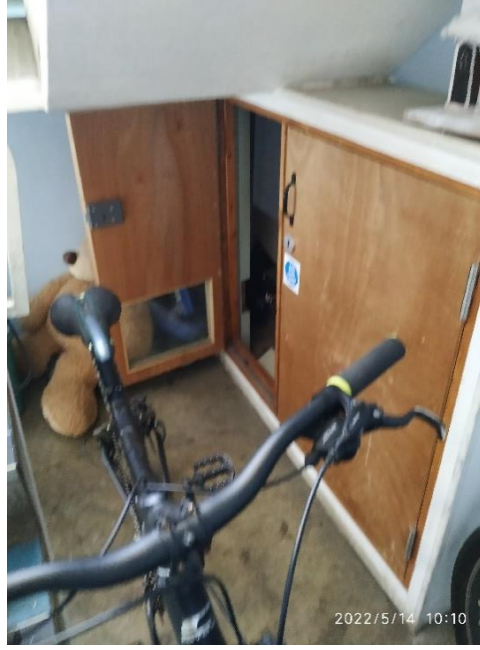
Photo No. 7

7.1	Is the standard of housekeeping adequate?	Yes		.		
7.2	Are all electrical/intake/service cupboards secure and free from general waste, contractors waste and residents personal items.	No	Electrical cupboards are being left open by customers. During a fire these will offer little to no protection for persons leaving the building. Customer Partner to deal.	Med	1/7/22	Partnership Manager 2

Observation - Electrical cupboards left open and not secure. Customer Partner to talk to all customers.

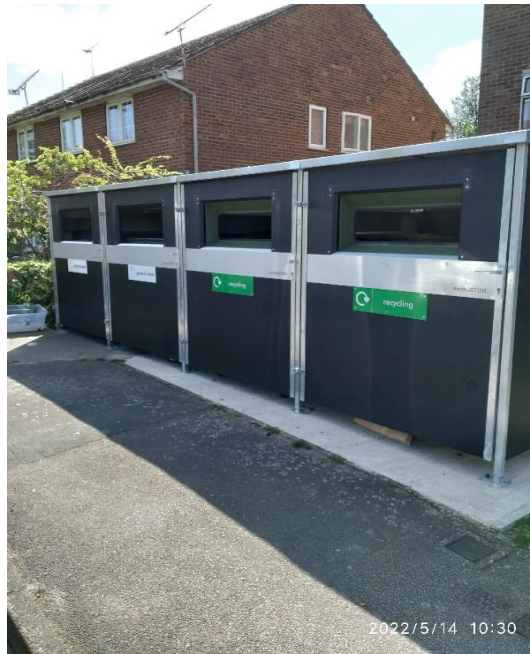
Photo No. 8

3.2	Is there an absence of unnecessary fire load in close proximity to building?	Yes	Refuse bin areas provided away from building	.		
<b>4</b>	<b>Heating Installations (Portable/fixed) Gas Installations - Common Areas &amp; General Needs Residential flats.</b>

Observation - Satisfactory location of newly installed bin area.

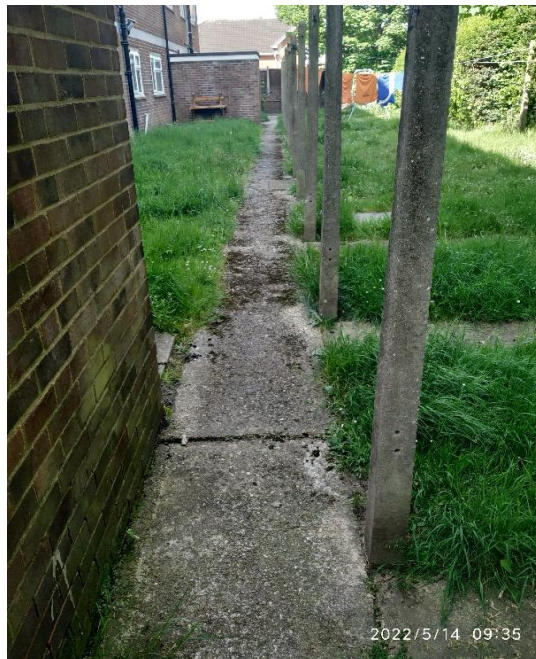
Photo No. 9

Observation: External walkways laid with paving slabs.
