This report shows all the responses to the Fire Risk Assessment survey, including raised tasks.

**Asset ID: 1031**      **17-36 Keyworth Court Block 17-36 Princes Street, Huntingdon**

## Cover Sheet

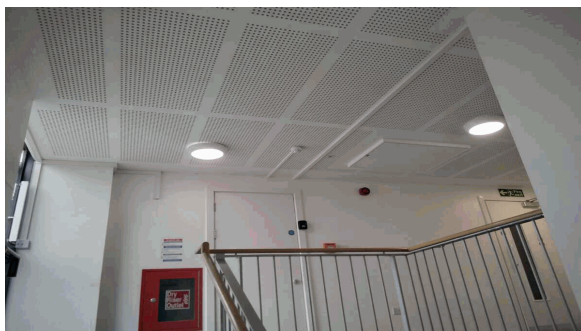
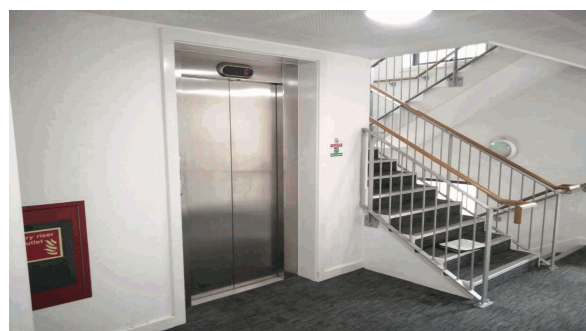
All doors denoted both sides.

Observation	Priority	Referred To	Required By:	Task ID
Replacement of signage.	No Action

The fire action notices are located in all the communal areas on the ground floor adjacent to final exit. New signs installed on the day of inspection.
