This report shows all the responses to the Fire Risk Assessment survey, including raised tasks.

Asset ID: 33765 **Blk3 36-62 Fitzwilliam Street, Peterborough**

Date of Fire Risk Assessment	12 Feb 2024
Date of Next Fire Risk Assessment	12 Feb 2027
FRA Frequency (Months)	36
Purpose of Fire Risk Assessment	3 year Re-Assessment
Type of Fire Risk Assessment	Type 3 (Common Parts and Flats - Non Destructive)
Fire & Safety Assessor	Lynn.betteridge@accentgroup.org

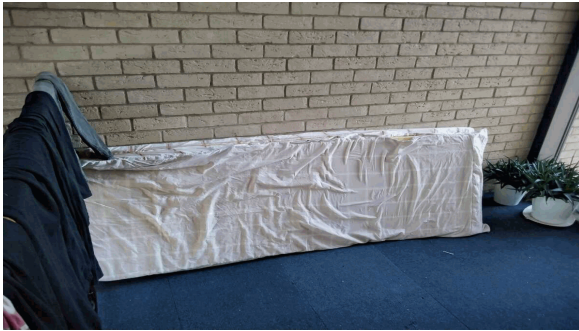
Observation	Priority	Referred To	Required By:	Task ID
One child mattress to be removed by resident Housing partner I formed to check removal. Flat 44	Internal - High	Housing Partner	13/02/2024	1766394

On the day of inspection there was a visible sign of a fire Hazard. I identified a small child mattress in the communal area I spoke with the resident to remove she agreed I have contacted Housing partner to check that it has been removed from number 44.
