This report shows all the responses to the Fire Risk Assessment survey, including raised tasks.

**Asset ID: 6277**      **The Martindales Ltd Hag, Chorley**

Date of Fire Risk Assessment	13 Sep 2023
Date of Next Fire Risk Assessment	13 Sep 2026
FRA Frequency (Months)	36
Purpose of Fire Risk Assessment	3 year Re-Assessment
Type of Fire Risk Assessment	Type 1 (Common Parts Only - Non Destructive)
Fire & Safety Assessor	Ian Potter

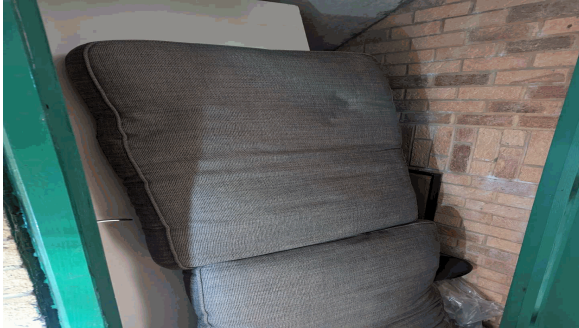
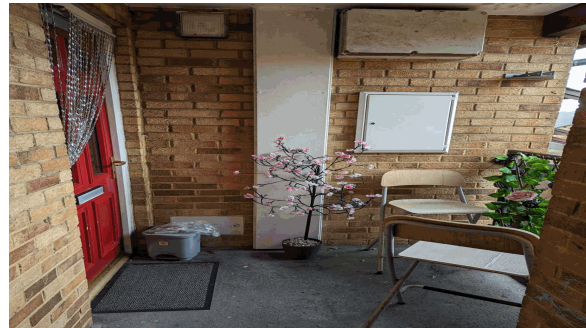
Are all electrical/intake/service cupboards secure and free from general waste, contractors waste and residents personal items?	Yes
Comment	None seen
Are unnecessary accumulations of combustible materials or waste avoided?	No
Comment	Many balconies have flammable materials stored
Are combustible materials and substances separated from ignition sources and stored appropriately?	Yes
Comment

Observation	Priority	Referred To	Required By:	Task ID
Multiple instances of residents storing flammable materials on their balcony in majority of blocks. This increases risk of arson and may affect means of escape. Seating areas and storage cupboards sho	Internal - Medium	Housing Partner	31/10/2023	1710527

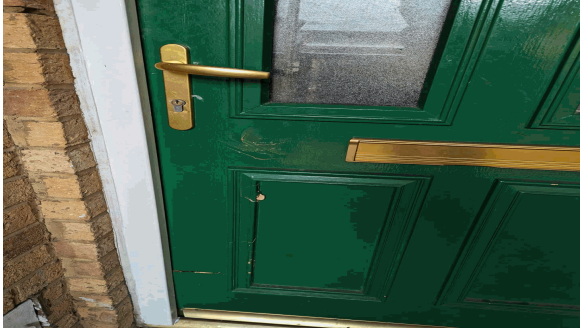
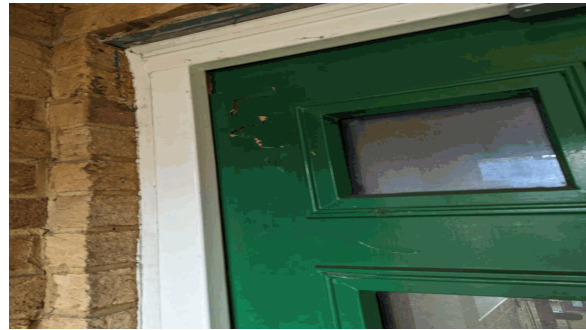
Observation	Priority	Referred To	Required By:	Task ID
The flat front door of no41 has been damaged by forced entry and requires repair or replacement	Repair - Non Emergency	Building Safety Manager	30/11/2023	1710528

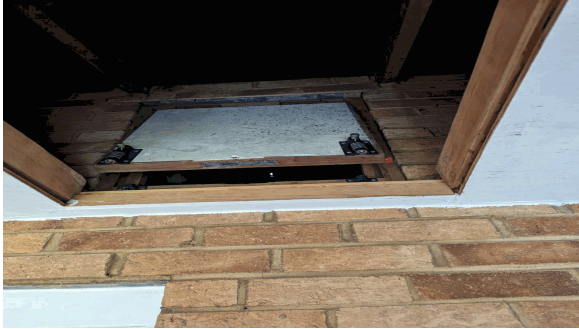
2 missing from block 7-12

Observation	Priority	Referred To	Required By:	Task ID
2 loft hatches were missing from the top floor of block 7-12. These need replacing with loft hatches with a min 30 minute fire rating work order 1114857	Repair - Non Emergency	Building Safety Manager	31/10/2023	1710530
