ACCENT HOUSING - FIRE RISK ASSESSMENT

Region :	Yorkshire
Scheme Name :	Blenheim Road
Scheme Address :	Blenheim Road Bradford BD8 7LH
Date of Assessment:	17/11/2023
Date of Next Assessment:	17/11/2026
FRA Frequency:	3 Year Re-Assessment
Fire & Safety Assessor	Steve Manners

This Fire Risk Assessment has been conducted upon the instruction of Accent Housing.

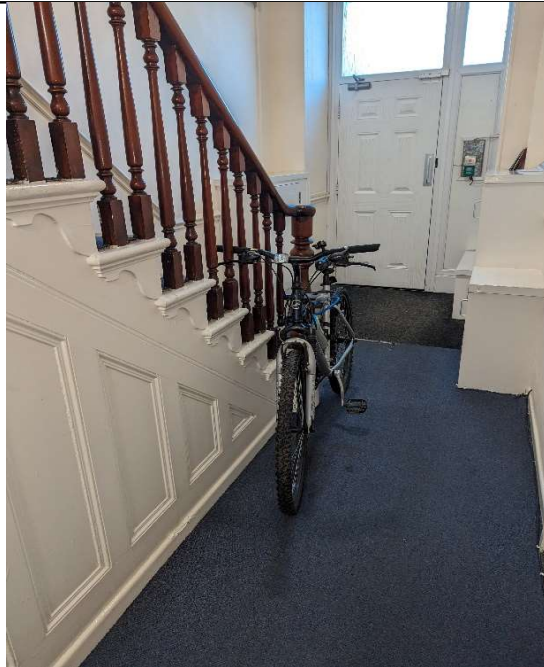
Photo No. 1

10.2	Escape routes unobstructed and maintained in a sterile condition?	No	Some combustable items were found on escape routes at the time of inspection. See Photos. Housing Partner informed	Med	1/2/24 Partnership Manager 1

1 Blenheim Road. Outside flat 1

Action Plan - Fire					
Blenheim Road				17/11/2023	
Enter Risk Rating and Colour Code Here					
Potential area of fire risk	Observation/Comments / Actions Required	Risk Rating	Completion Date	Referred To:	Task ID No.
Fire Hazards					
Housekeeping:					
Is the standard of housekeeping adequate?	Some combustable items were found on escape routes at the time of inspection. See Photos. Housing Partner informed	Med	01/02/24	Partnership Manager 1	
Fire Protection Measures					
Means of Escape from Fire:					
Escape routes unobstructed and maintained in a sterile condition?	Some combustable items were found on escape routes at the time of inspection. See Photos. Housing Partner informed	Med	01/02/24	Partnership Manager 1

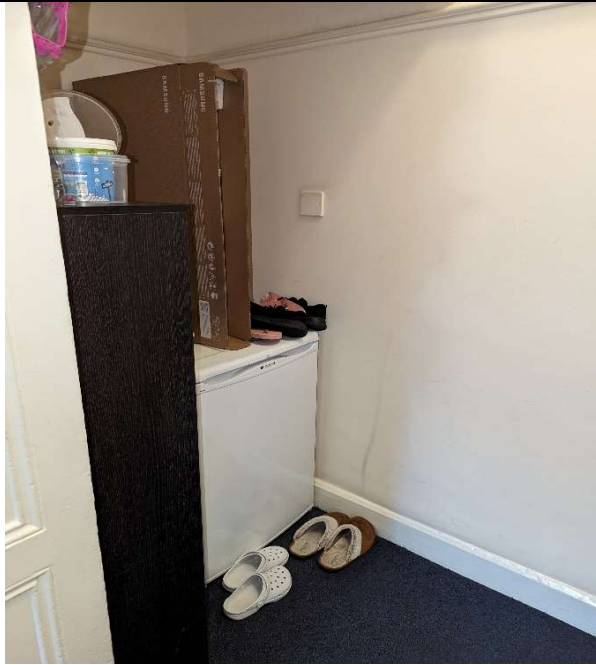
Photo No. 3

20 Blenheim Road. Outside Flat 1

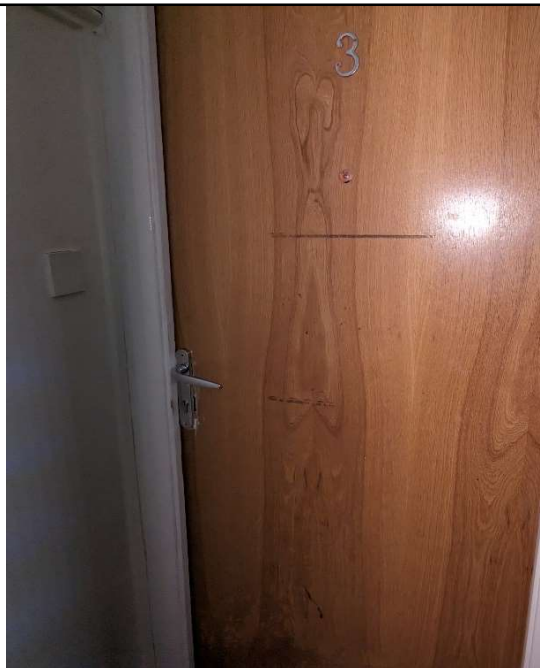
Photo No. 4

3	No		18 Blenheim External inspection only, door and furniture in good condition.	-		
				-		
1	No		20 Blenheim External inspection only, door and furniture in good condition.	-		
2	No		20 Blenheim External inspection only, door and furniture in good condition.	-		
3	No	14573	20 Blenheim External inspection only, Door has some damage around the lock. Repair or replace. See photo	Low	31/03/24	Fire Safety Manager
				-		
1	No		24 Blenheim External inspection only, door and furniture in good condition.	-		
2	No		24 Blenheim External inspection only, door and furniture in good condition.	-		
3	No		24 Blenheim External inspection only, door and furniture in good condition.	-

20 Blenheim Road. Flat 3 door requires repair or replace.

Action Plan - Residents Front Doors						
Blenheim Road				17/11/2023		
Flat No.	Asset No.	Observation/Comments / Actions Required	Risk Rating	Completion Date	Referred To:	Task ID No.
3	14573	20 Blenheim External inspection only, Door has some damage around the lock. Repair or replace. See photo	Low	31/03/24	Fire Safety Manager
