This report shows all the responses to the Fire Risk Assessment survey, including raised tasks.

Asset ID: 1028 **28A - 32A Cambridge Road, Cambridge**

Cover Sheet

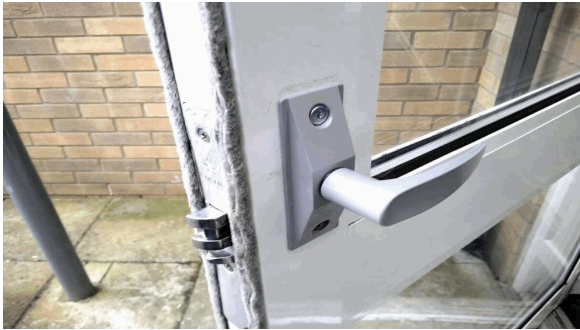
Observation	Priority	Referred To	Required By:	Task ID
Door security works.	No Action

Contractor is carrying out remedial work to main and rear access security doors.
