ACCENT HOUSING - FIRE RISK ASSESSMENT

Region :	South
Scheme Name :	Imperial Court
Scheme Address :	London Road Camberley, Surrey GU15 3HQ
Date of Assessment:	16/11/2021
Date of Next Assessment:	16/11/2024
FRA Frequency:	3 Year Re-Assessment
Fire & Safety Assessor	Gary Bredin

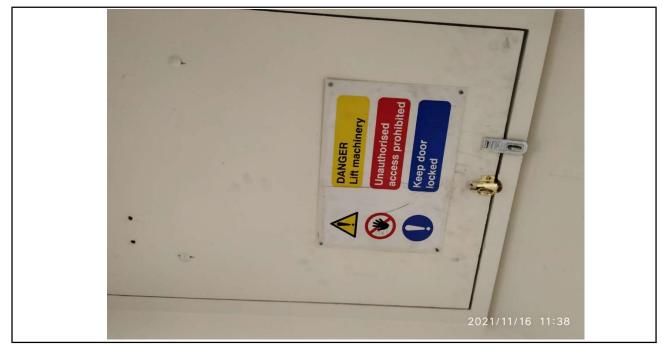
Photo	No. 4

11.4	Compartmentation within roof spaces of a satisfactory standard?	Other	Findings previously submitted to compartment survey project	•		
	Loft hatches fire resisting?	Yes	Communal area roof hatch's are close fitting and fire rated. See Pic- Photo-Fire 4	•
