ACCENT HOUSING - FIRE RISK ASSESSMENT

Region :	North West
Scheme Name :	Heady Hill Court 1-16
Scheme Address :	Bury Old Rd Heywood OL10 3LA
Date of Assessment:	20/08/2024
Date of Next Assessment:	20/08/2026
FRA Frequency:	2 Yearly Re-assessment
Fire & Safety Assessor	Ian Potter

Heady Hill Court 1-16

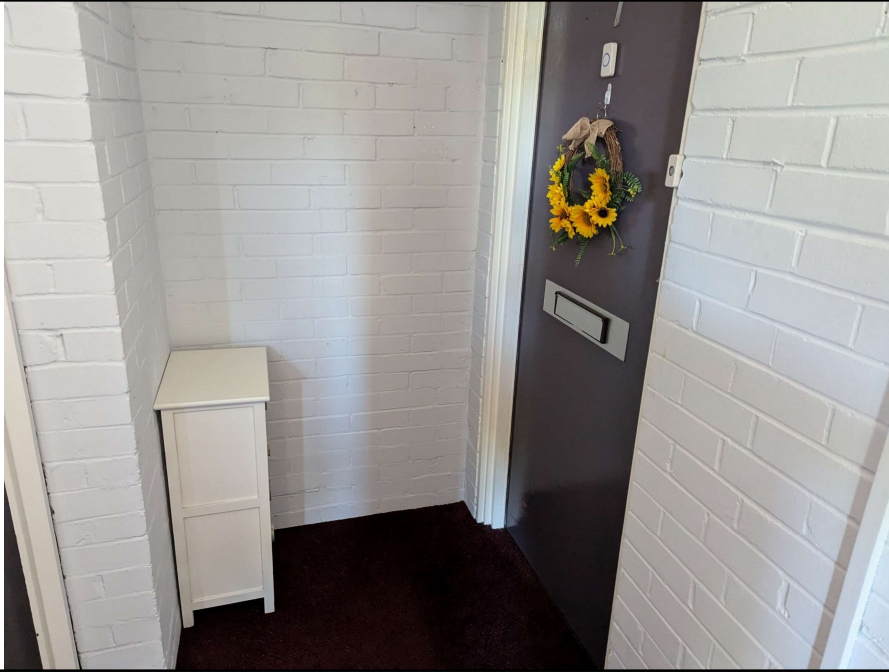
Photo No. 1

6.1	Does the building have a lightning protection system, If so, is it adequately maintained?	N/A	Not required	.		
7 Housekeeping:						
7.1	Is the standard of housekeeping adequate?	No	Items stored in communal areas as follows: Block 7-12: Wooden cabinets outside Flat 7 and 11. HP to be informed to arrange removal.	Med	30/9/24	Customer Partner

Wooden cupboard outside Flat 7

Action Plan - Fire					
Heady Hill Court 1-16				20/08/2024	
Trivial					
Potential area of fire risk	Observation/Comments / Actions Required	Risk Rating	Completion Date	Referred To:	Task ID No.
Fire Hazards					
Housekeeping:					
Is the standard of housekeeping adequate?	Items stored in communal areas as follows: Block 7-12: Wooden cabinets outside Flat 7 and 11. HP to be informed to arrange removal.	Med	30/09/24	Customer Partner

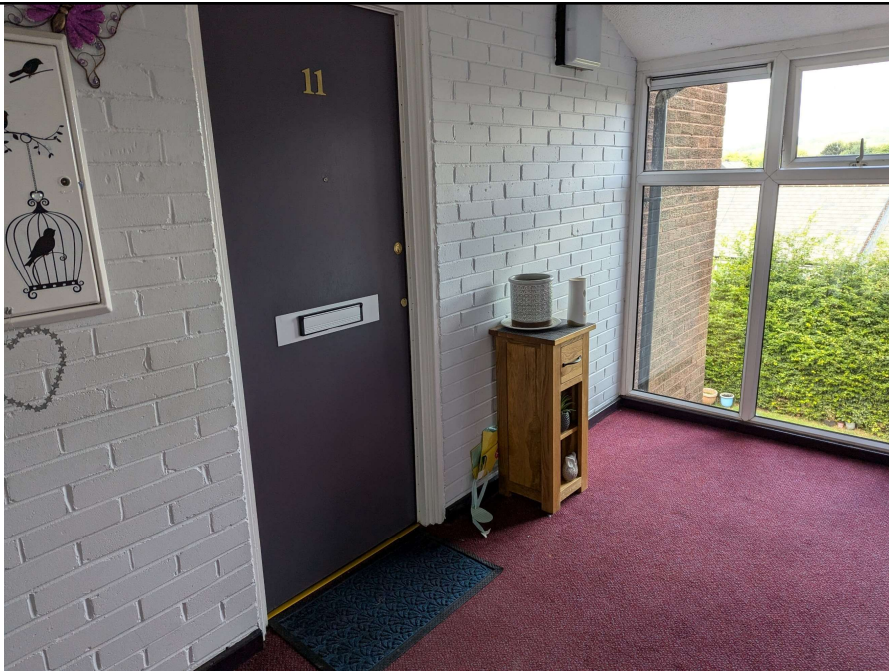
Photo No. 2

Wooden cupboard outside Flat 11

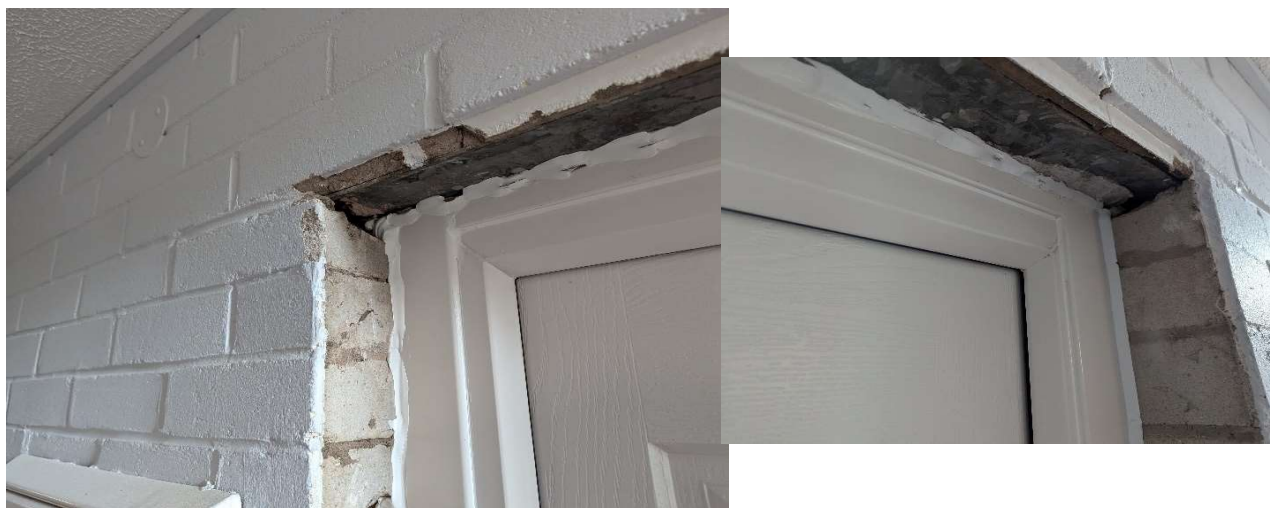
Photo No. 3

14	No	20023	The front door has been replaced recently but has not been finished off. On checking, the door was installed incorrectly and is being replaced. Records show that Martin Collins (Contractor) are now in possession of the door and will install it shortly.	Med	13/09/24	
15	No	20024	Appears from external inspection to be a sturdy door, close fitting squarely into frame and with the appropriate fire rated fittings.	-		
16	No	20025	Appears from external inspection to be a sturdy door, close fitting squarely into frame and with the appropriate fire rated fittings.	-

Flat 14 Front door
