This report shows all the responses to the Fire Risk Assessment survey, including raised tasks.

Asset ID: 9325 **6 Railway Street Block 6 Railway Street, Chorley**

Cover Sheet

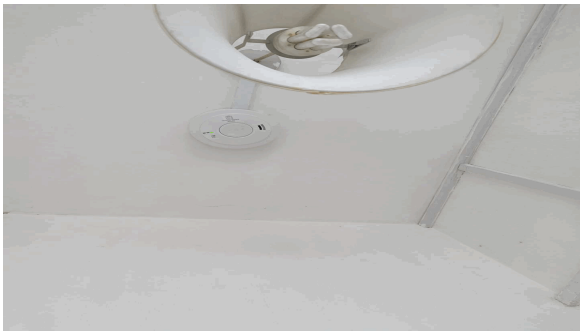
Is the scheme fitted with a communal area fire alarm?	Yes
Comment	Single domestic type smoke detector on ceiling
Is fire detection and warning system appropriate for occupancy and fire risk, as per BS 5839-1:2017?	Yes
Comment	Part 6 alarms in both flats
Is the fire detection and warning system maintained/tested and all certificates saved on file?	No
Comment	Alarm was tested and working at time of inspection Communal alarm needs to be added to the testing programme for Accent
Fire alarm components in good condition and securely fixed to walls/ceilings?	Yes
Comment	
Hold open devices operate at the sounding of the alarm and are in a serviceable condition?	N/A
Comment	None fitted
Are there heat detectors located in the Kitchen, Boiler, Plant Room and Laundry?	N/A
Comment	None
Is the fire alarm panel remotely monitored, and if so are there records of regular testing?	N/A
Comment	No panel

Observation	Priority	Referred To	Required By:	Task ID
Communal alarm not tested . Needs to be added to test contract	Internal - Low
