This report shows all the responses to the Fire Risk Assessment survey, including raised tasks.

Asset ID: 8664 **Blk1 Group Home 11 Moorcroft Drive 11 Moorcroft Drive, Bradford**

Cover Sheet

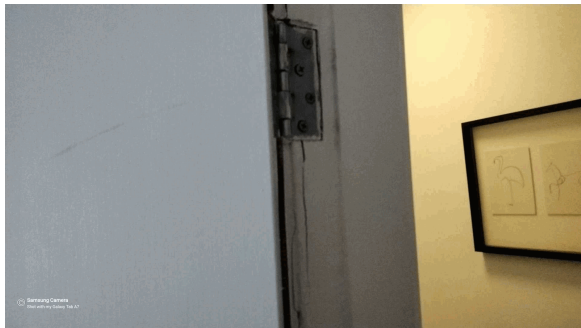
Observation	Priority	Referred To	Required By:	Task ID
Crack in door frame near top hinge	Repair - Non Emergency	Project Manager (Building Safety)	01/01/2025	1870582

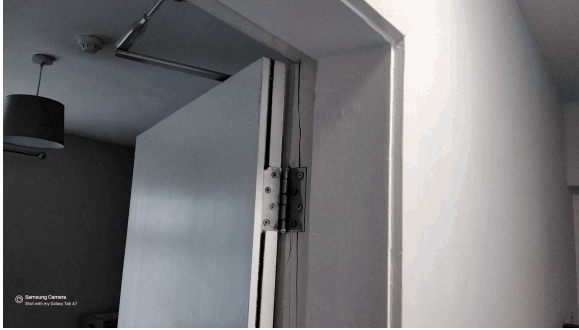
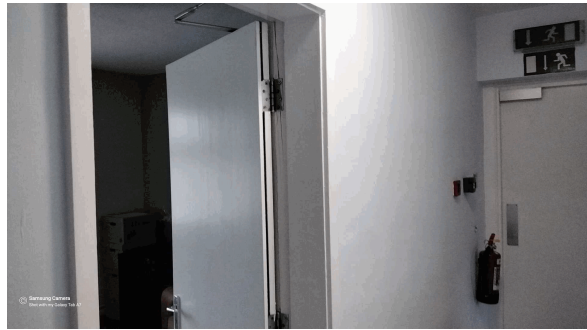
Observation	Priority	Referred To	Required By:	Task ID
Door frame to first floor lounge is split. Requires replacing	Repair - Non Emergency	Project Manager (Building Safety)	01/01/2025	1870581

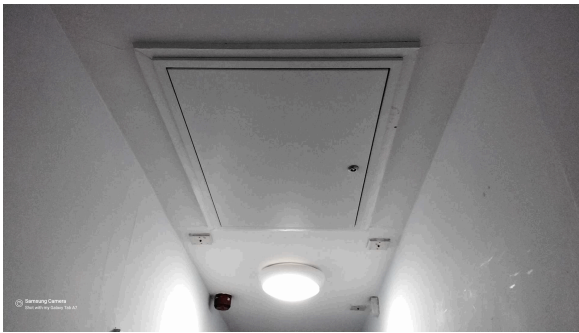
Observation	Priority	Referred To	Required By:	Task ID
Hour rated loft hatch

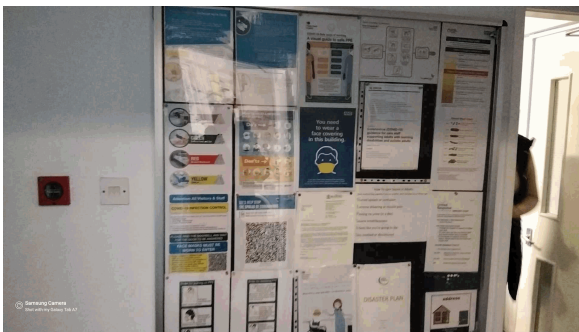
Observation	Priority	Referred To	Required By:	Task ID
Notice board is covered
