This report shows all the responses to the Fire Risk Assessment survey, including raised tasks.

Asset ID: 9057 **Netherton House Clayton Street, Blackburn**

Fire Risk Assessment Survey Results

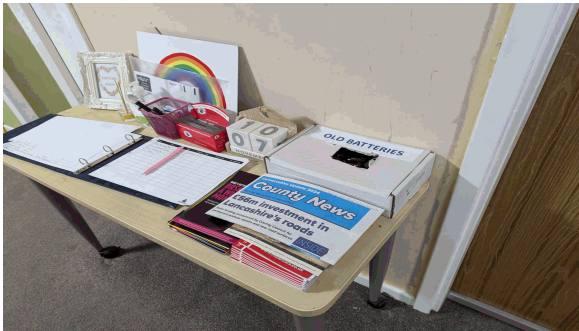
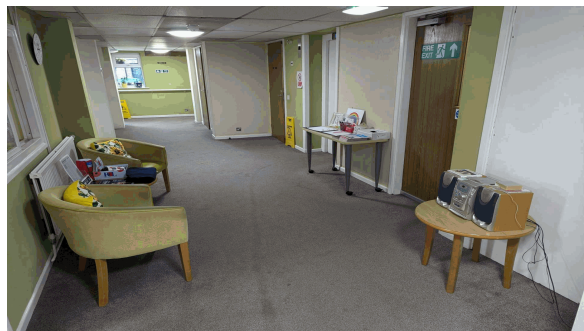
Desks in foyer with leaflets and other flammable materials on. Used battery collection point in foyer. Music system in foyer
Scheme Manager to arrange removal

Desks in foyer with leaflets and other flammable materials on. Used battery collection point in foyer. Music system in foyer. Scheme Manager to arrange removal

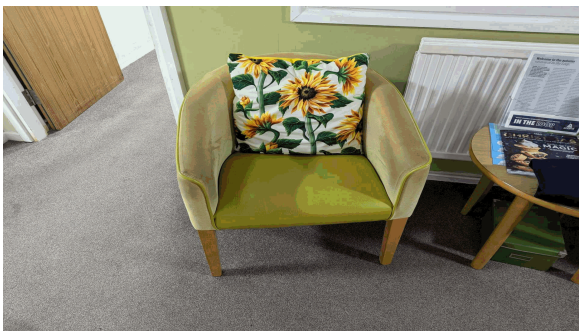
Furnishings in the communal corridors and foyer had no labels attached to indicate that they were compliant

Furniture in communal areas did not display any fire retardant labelling. Scheme Manager to check that Furniture is compliant

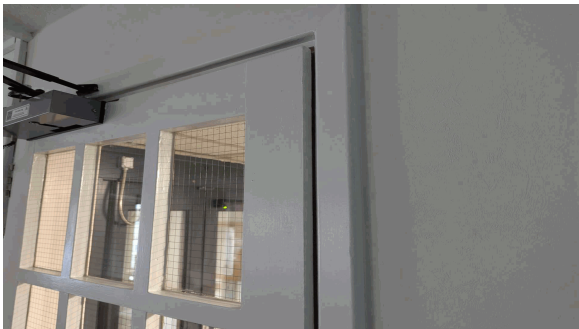
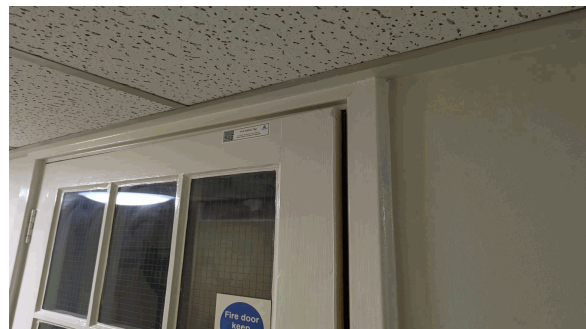
A number of Fire Doors require attention to ensure they are self closing and close fitting in their frames. Unable to check a small number of Fire doors on the First floor due to redcoration contractors working in the area. Will return and check these doors when works are complete

Observation	Priority	Referred To	Required By:	Task ID
<p>A number of Fire doors were found to be in need of repair as follows:</p> <ul style="list-style-type: none"> Door into staircase nr Flat 1 excess gap on hinge side Door into staircase nr Flat 31 excess gap Corridor door nr Flat 29 not self closing Door into staircase nr Flat 28 not self closing Door into staircase nr Flat 39 not self closing Corridor door catching on Emergency light luminarie adjacent to Flat 25 Door into store GF nr refuse area not self closing Door/Panel in main foyer large gap at top Door to small lounge not self closing 	<p>Repair - Non Emergency</p>	<p>Project Manager (Building Safety)</p>	<p>31/12/2024</p>	<p>1886806</p>

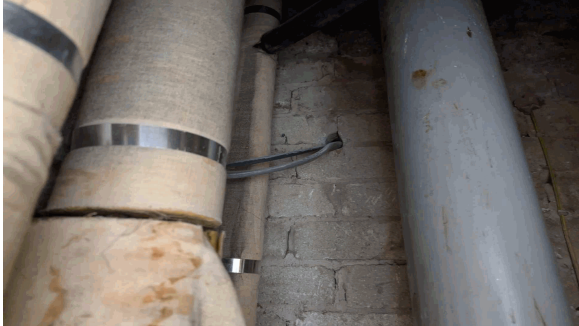
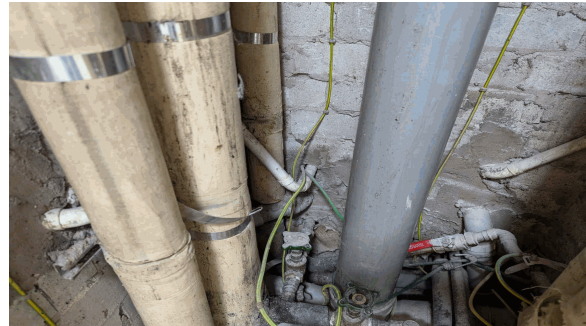
Several breaches were observed in roof spaces and above cross corridor doors. Compartment survey requested last year on FRA. Still not been carried out

Observation	Priority	Referred To	Required By:	Task ID
<p>Several breaches were observed in roof spaces and above cross corridor doors. Compartment survey requested last year on FRA. Still not been carried out New contractor to be requested to carry out the survey</p>	<p>Repair - Non Emergency</p>	<p>Project Manager (Building Safety)</p>	<p>31/12/2024</p>	<p>1886807</p>

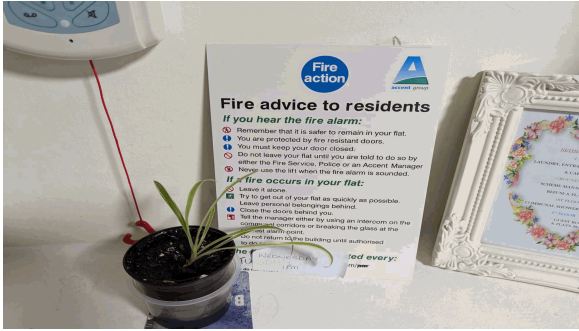
Older style evacuation notices displayed throughout. Internal - Low
 Risk Assessor to provide updated signs once redecoration is complete
